Inspection Report

Property Address:
1927 Older Neighborhood Road
Jacksonville FL

Inspector: Dan Fryer
FL Lic # HI1796
904-657-5577
FryerBD.com

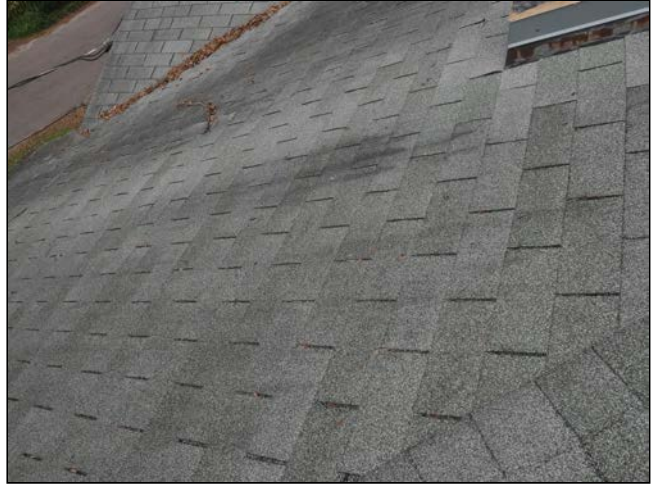
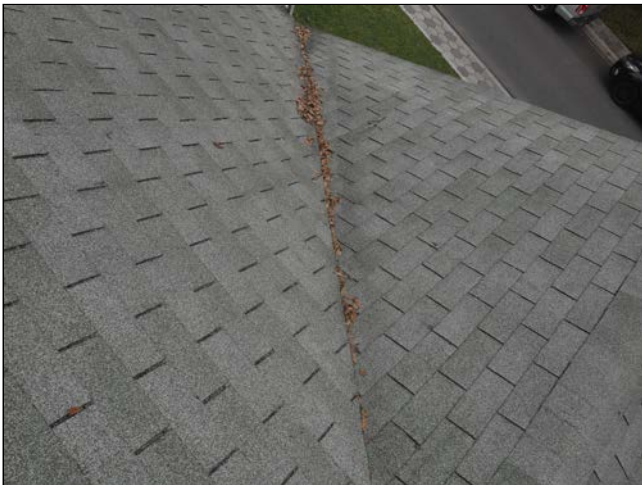
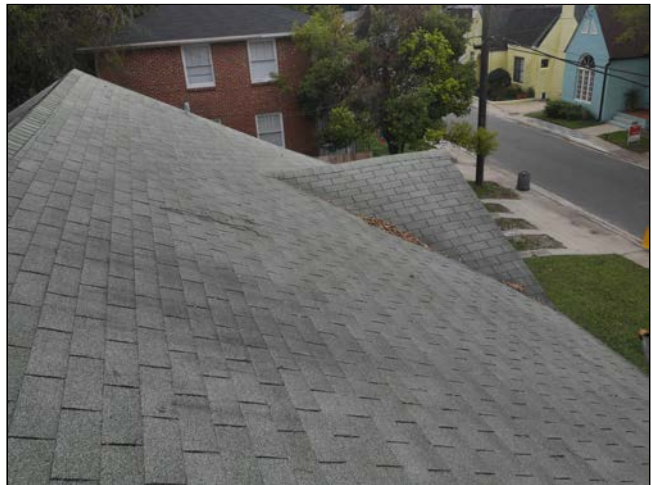
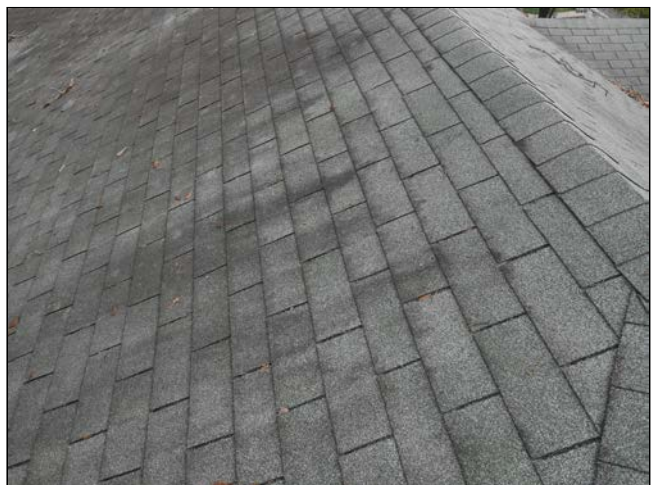
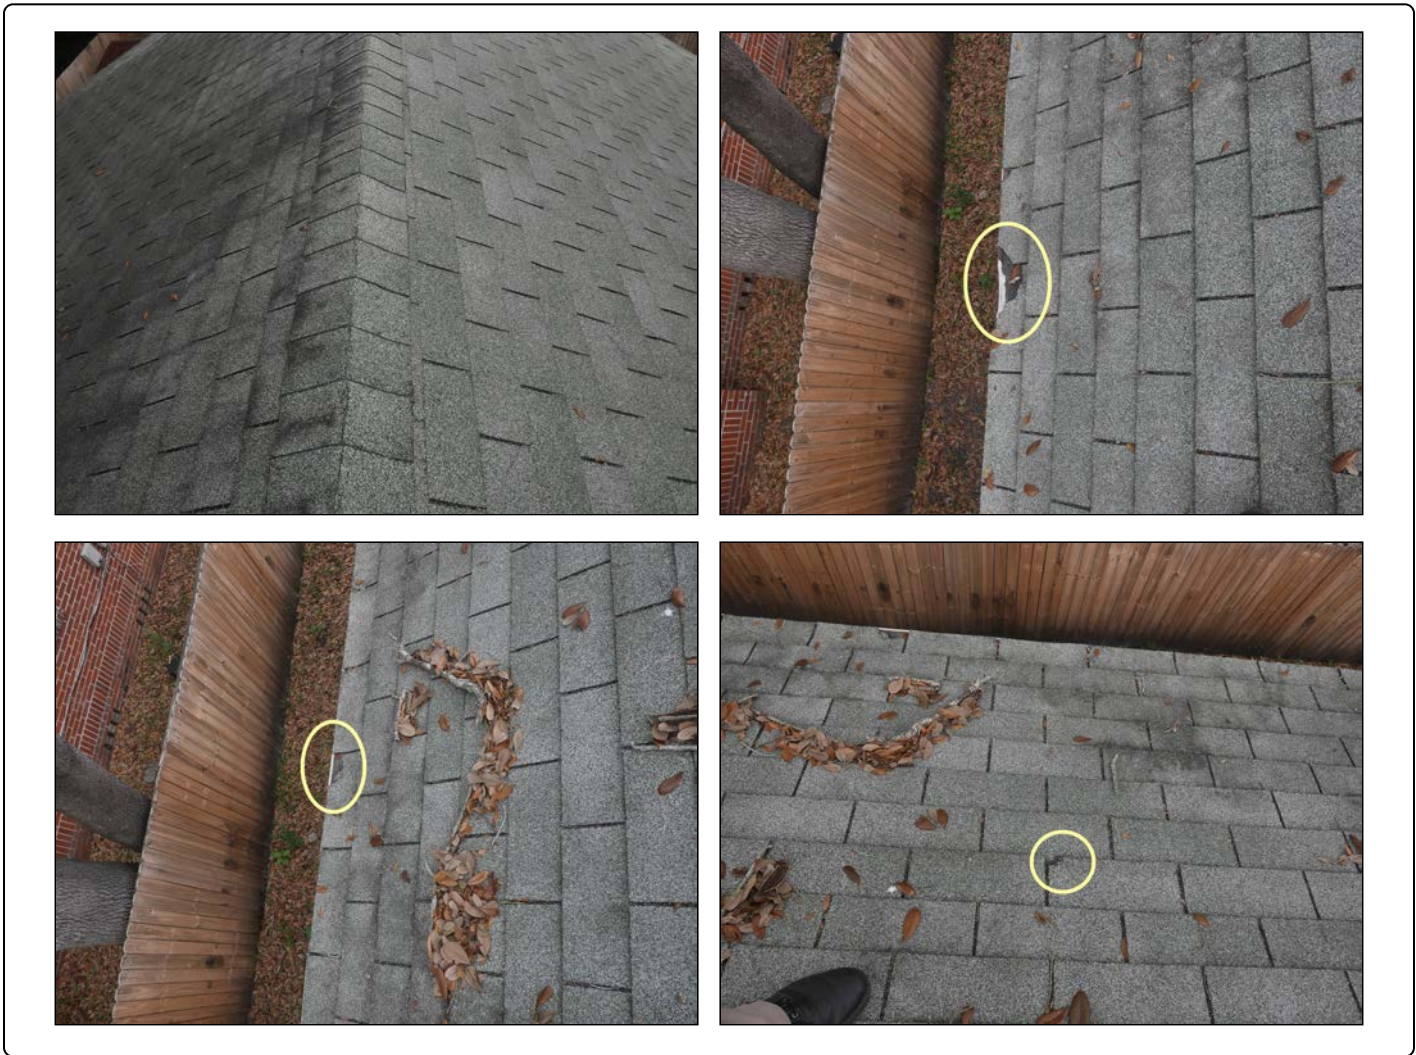
1.0 (2) Roof covering system exhibits signs of aging.

- Some surface texture material loss throughout roof exterior.
- Staining / discoloration at left side due to overhanging trees(s).
- Mechanical damage to shingles at localized areas. Recommend repair as appropriate.
- Should client have concerns regarding the remaining useful life of noted system(s), consultation with a licensed specialist is recommended.

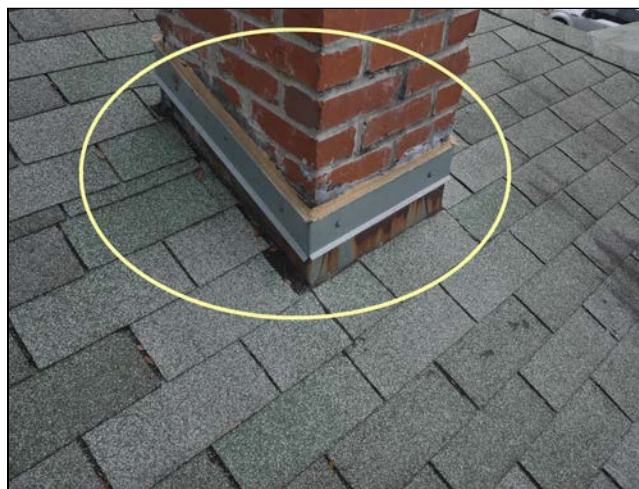
1.1 Rust / oxidation at flashings / vents.

- Continued oxidation may result in rust-through and subsequent leakage.
- Recommend repair and / or corrosion treatment as appropriate.

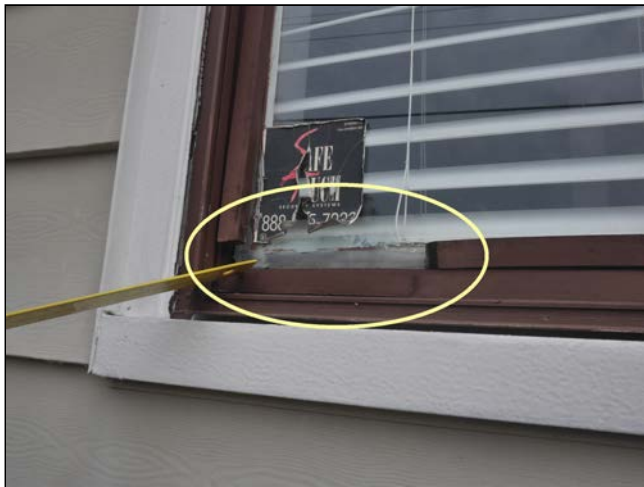
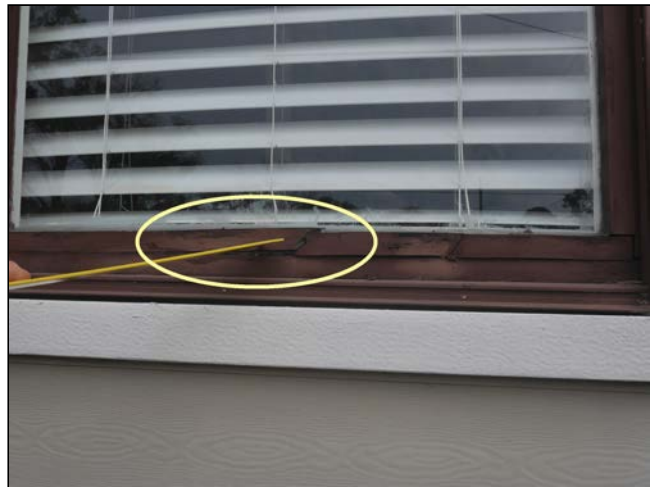
2.0 (2) Exterior window trim material damaged at some areas.

- Recommend repair as appropriate.

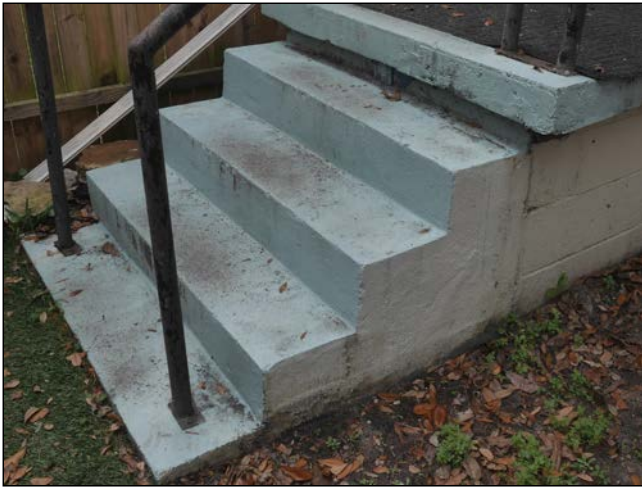
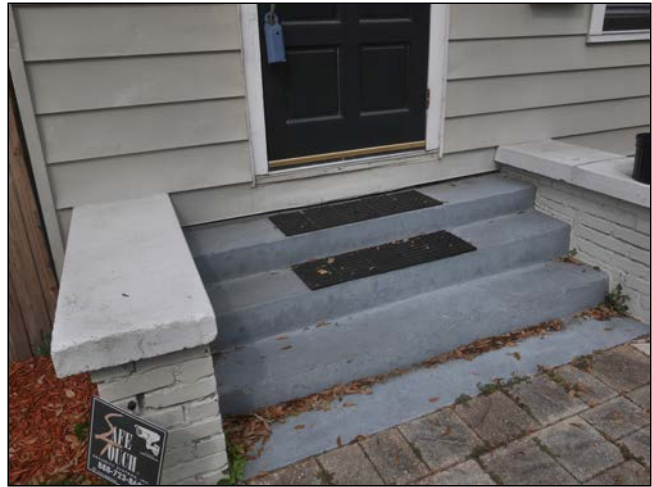
2.3 (1) Riser height variation exceeds 3/8 inch between the smallest riser and the greatest riser.

- Trip hazard.
- Recommend reconfigure / repair in accordance with current building practices and safety standards.

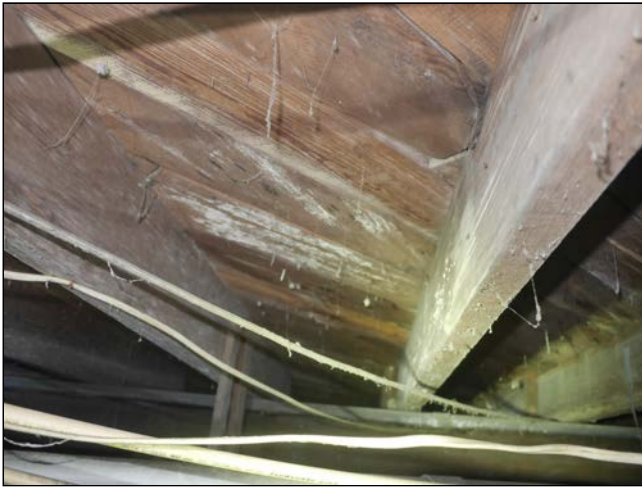
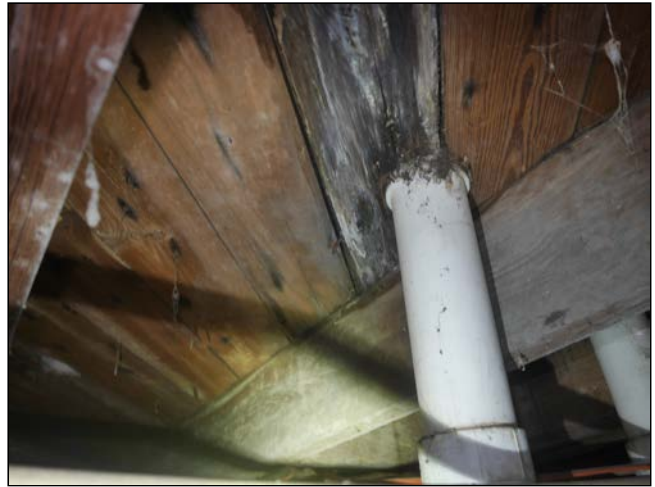
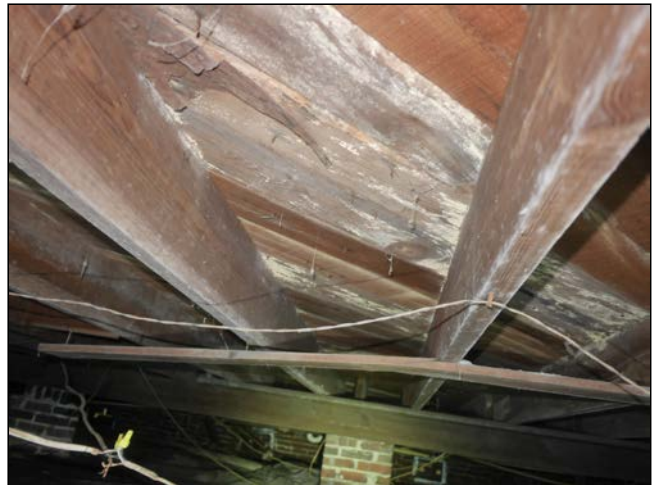
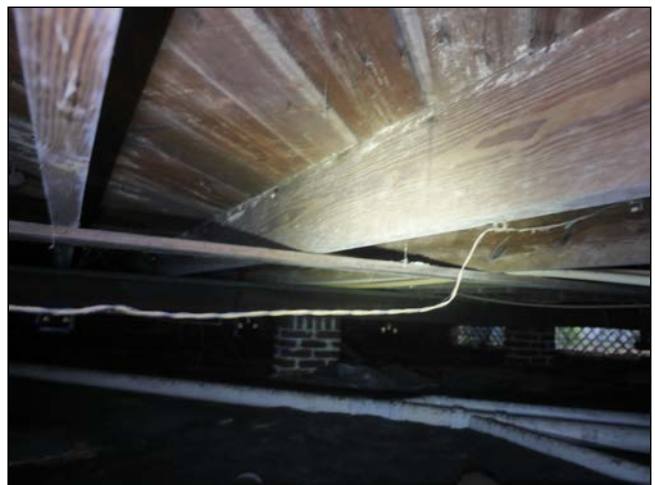
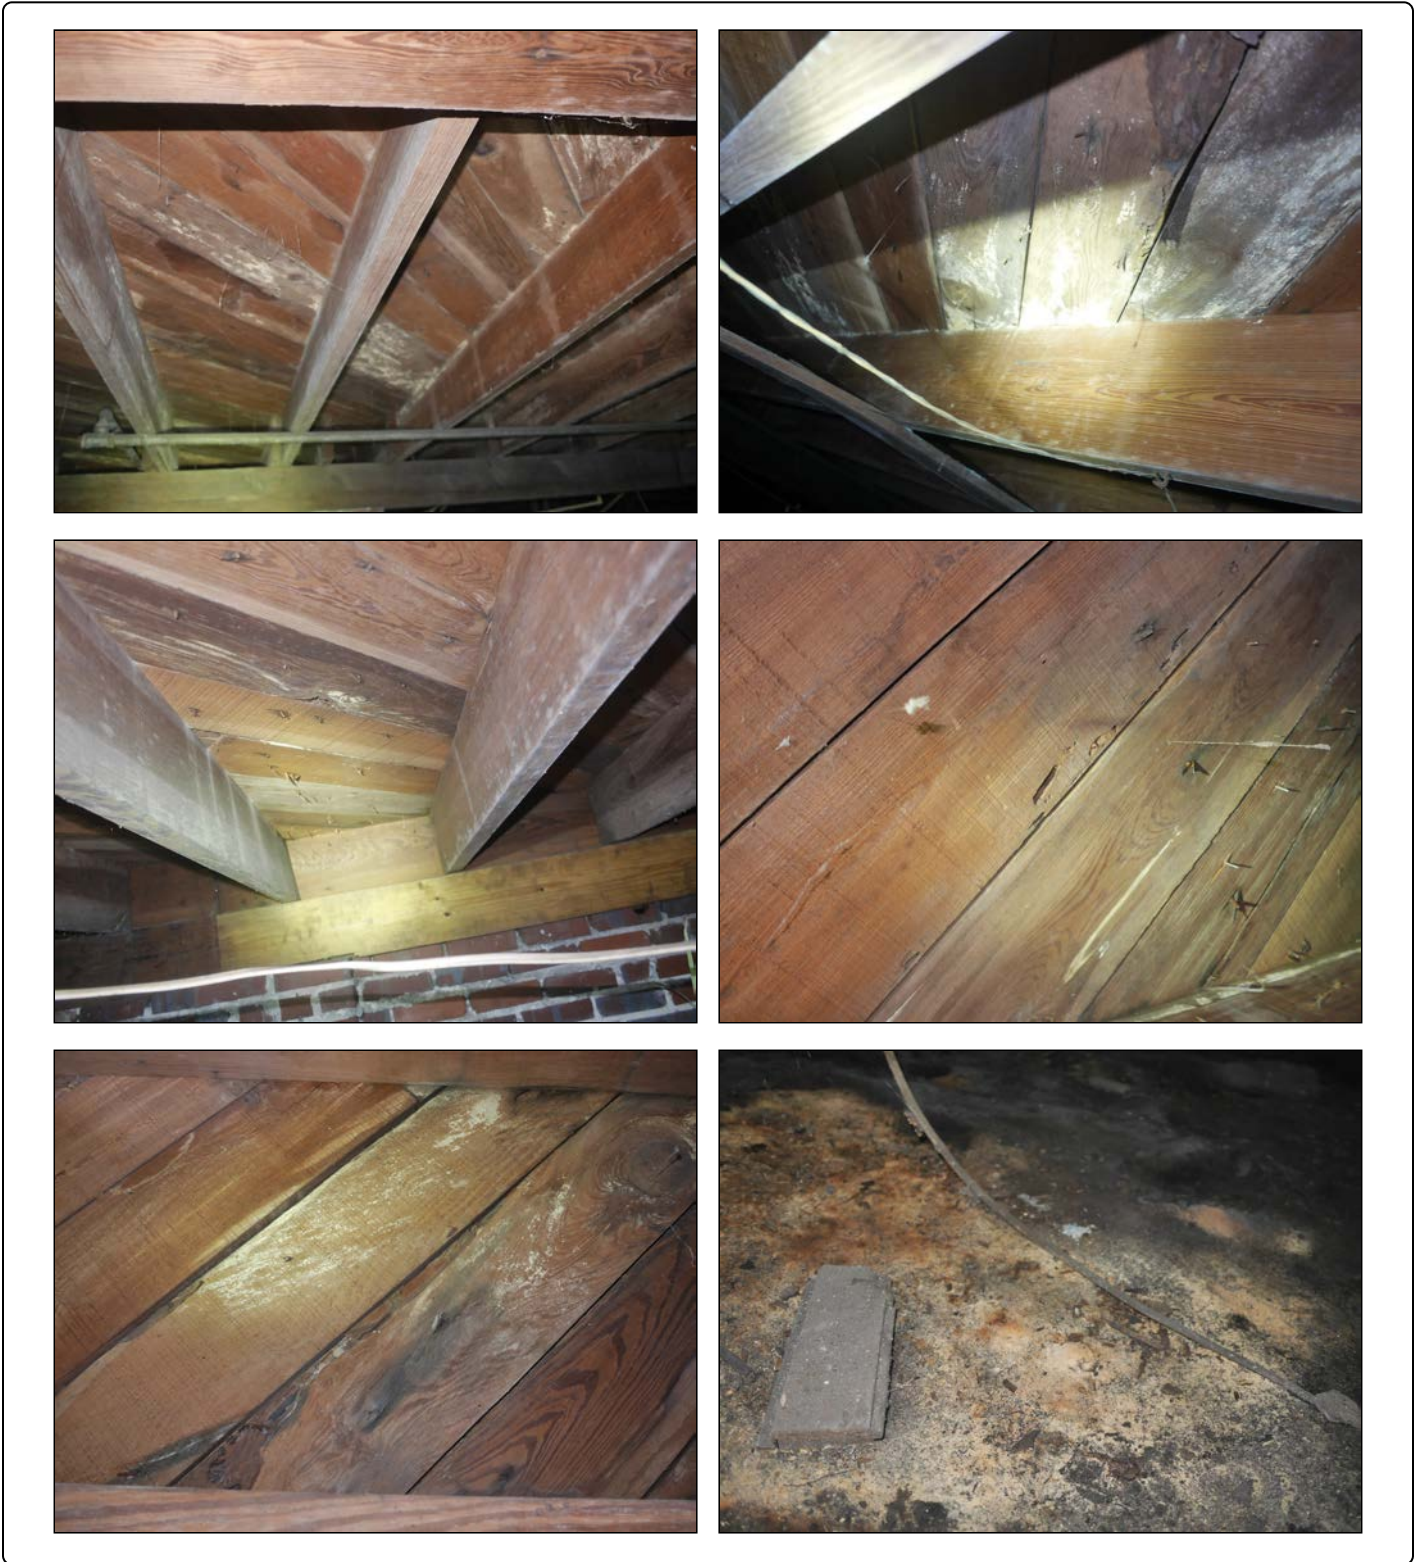
5.0 (2) Visible evidence of wood rot / wood-destroying pest activity at some areas throughout crawlspace. Multiple locations noted. This report is qualitative, not quantitative. Photo(s) representative of noted deficiency.

- Also see WDO report as applicable.
- Visible fungal / microbial growth at some noted areas.
- Recommend evaluate / repair as appropriate.

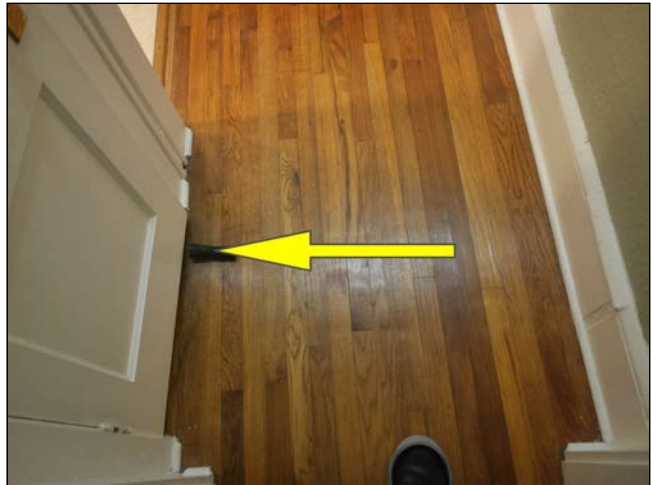
5.3 Floors out-of-level, likely the result of differential settlement and age.

- Should client have concerns regarding the floor structure, consultation with a licensed specialist is encouraged.

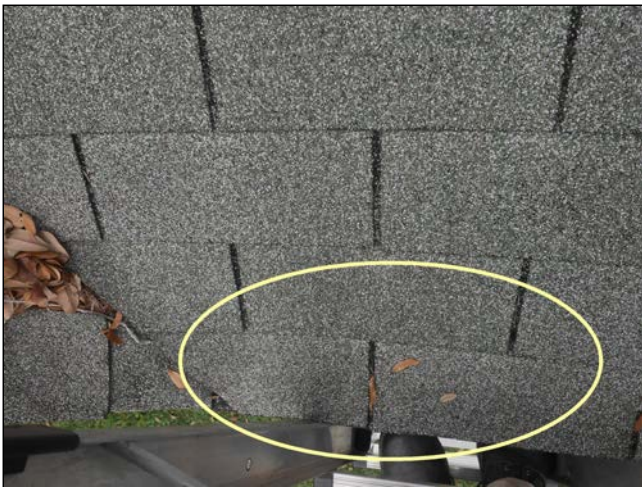
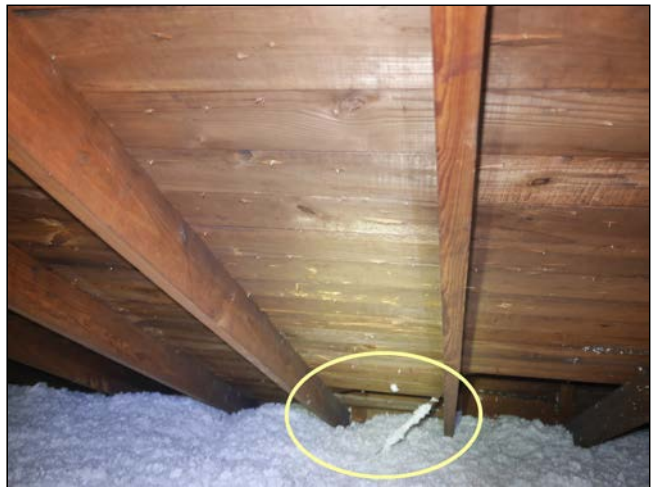
5.5 (1) Visible sag / dip at roof structure at right side of dwelling.

- Recommend repair as appropriate.

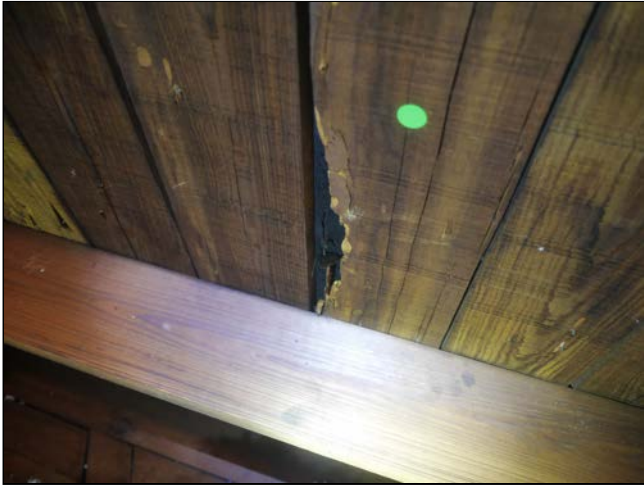
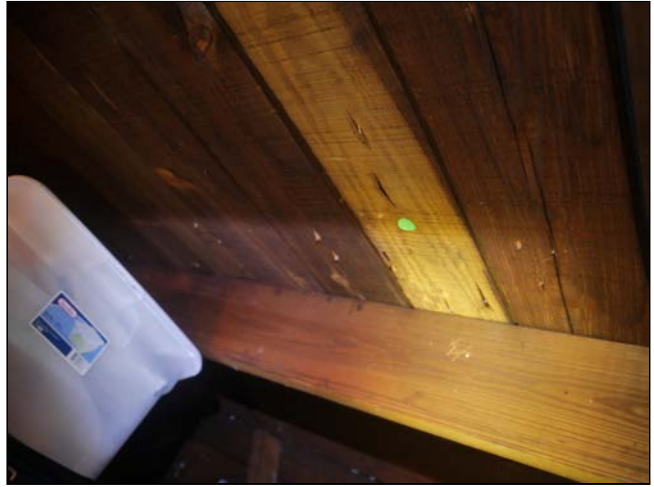
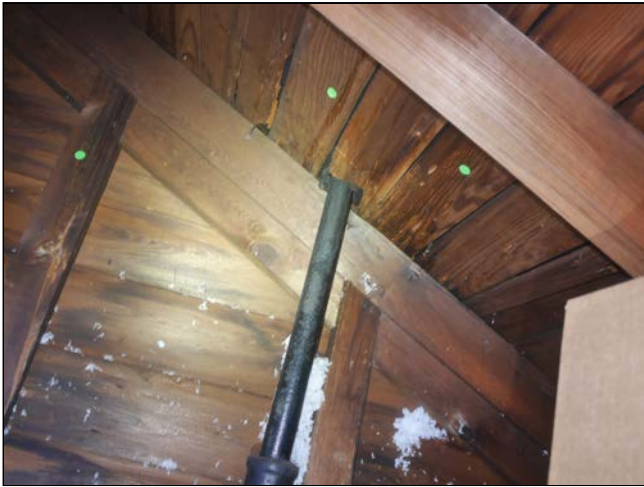
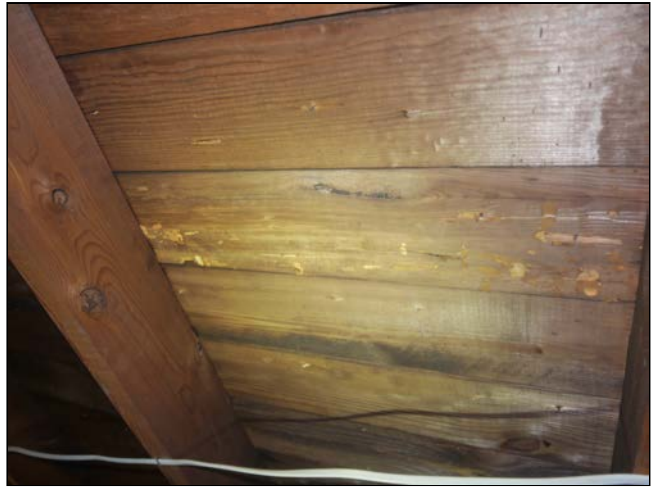
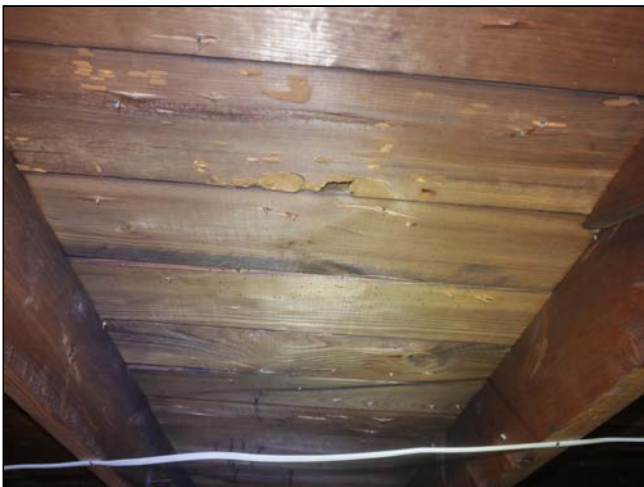
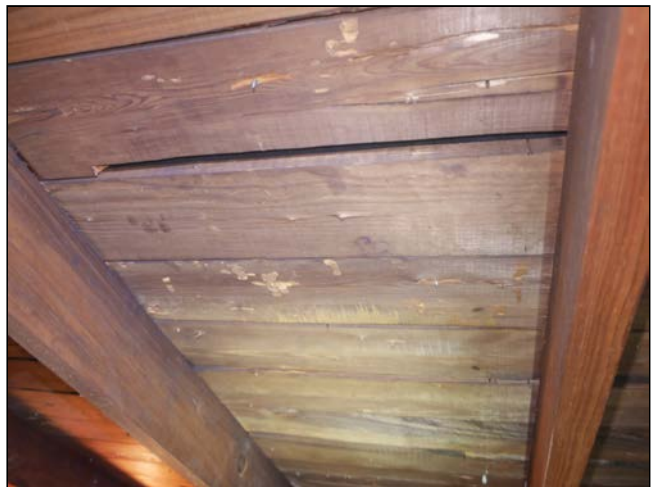
5.5 (2) Visible evidence of wood-destroying pest activity at attic. Multiple locations noted. This report is qualitative, not quantitative. Photo(s) representative of noted deficiency.

- Also see WDO report as applicable.
- Recommend repair as appropriate.

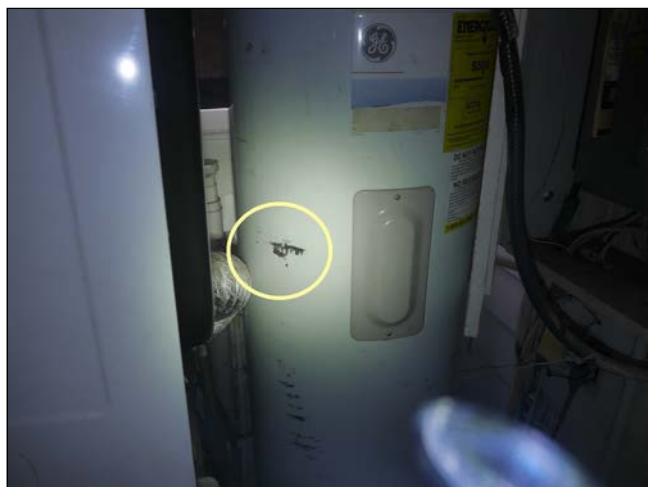
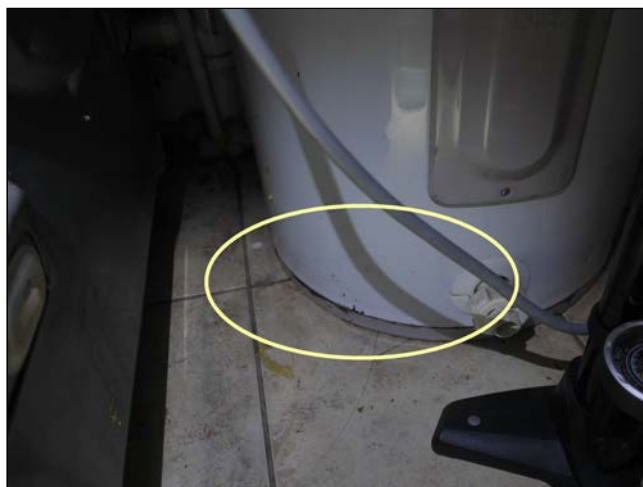
6.0 (2) MAJOR DEFICIENCY: Water heater is aged. Rust / oxidation / impact damage at tank.

- Replacement will likely be necessary in the near future. Recommend client budget as appropriate.
- **POTENTIAL INSURANCE QUALIFYING DEFICIENCY**

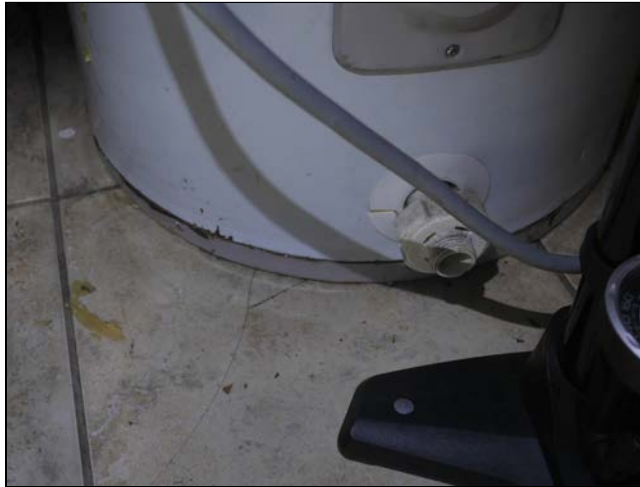
**6.0 (4) Drip / drain pan not installed at water heater.**

- Potential damage in the event of a failure of the water tank.
- Recommend reconfigure in accordance with current building practices and standards.
- **POTENTIAL INSURANCE QUALIFYING DEFICIENCY**

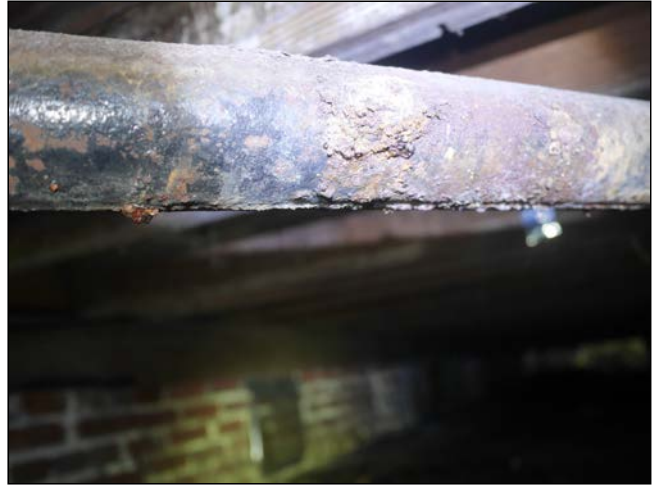
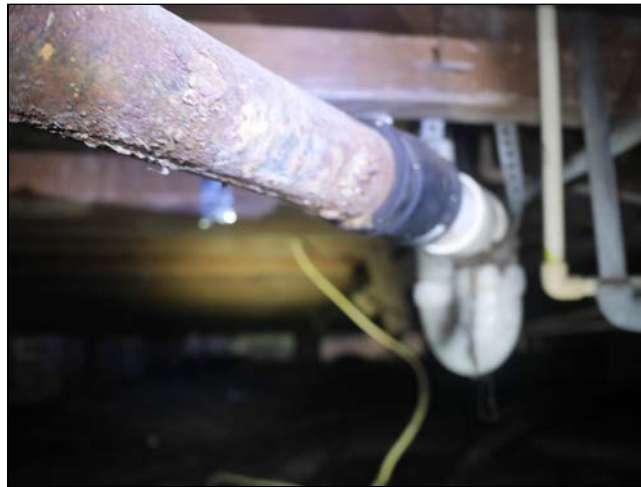
6.1 MAJOR DEFICIENCY - Rust / oxidation at cast iron drain line(s).

- Continued oxidation may result in rust-through, cracking, and failure of the waste / drainage system.
- Recommend consultation with a state licensed plumbing specialist.
- Recommend client budget for future upgrade / replacement as appropriate.
- Note: Some areas not visible at time of inspection. Should client have concerns regarding the waste / drainage system, recommend technically exhaustive plumbing system evaluation by a state licensed plumbing specialist.
- **POTENTIAL INSURANCE QUALIFYING DEFICIENCY**

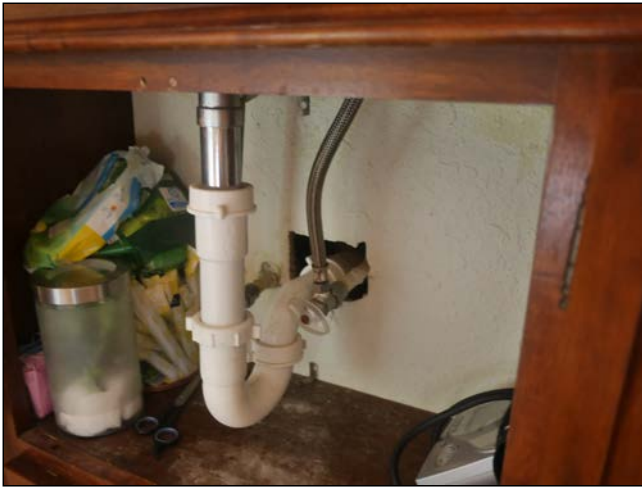
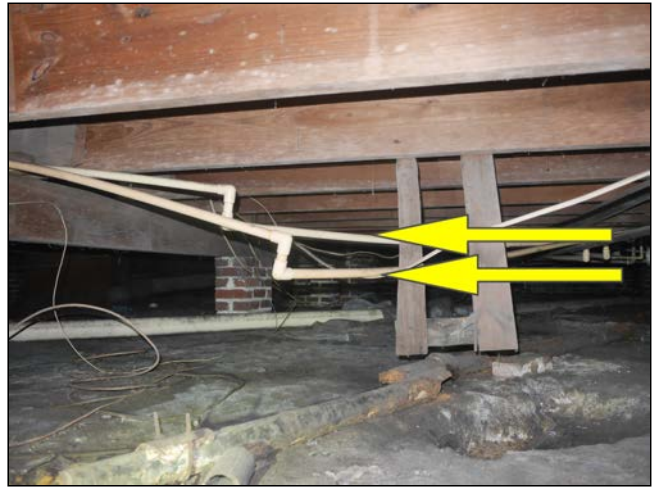
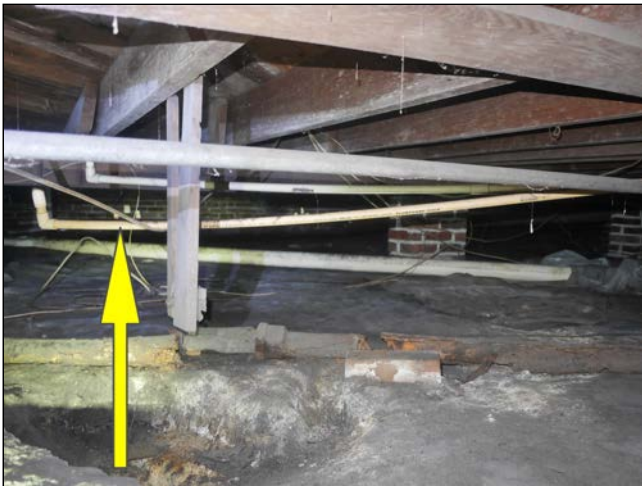
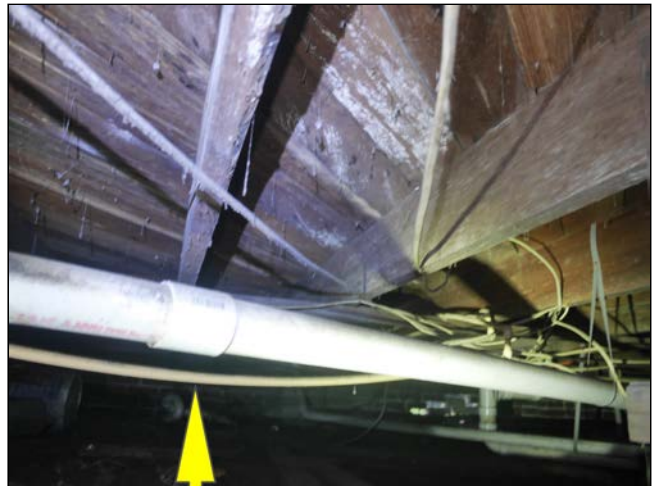
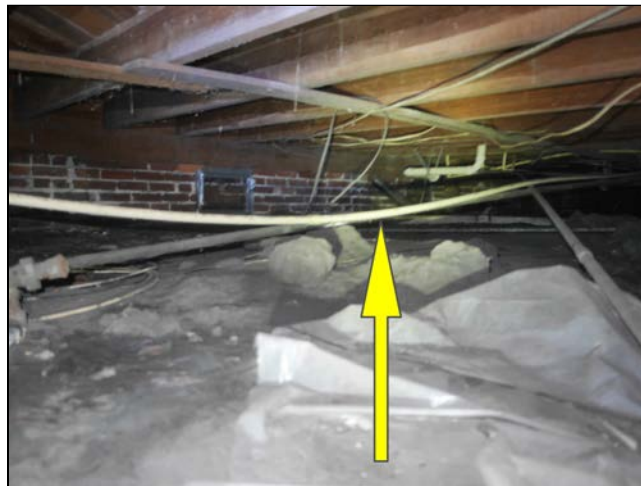
6.2 (4) MAJOR DEFICIENCY - Plumbing supply lines not secured to structure.

- Potential future point of failure.

- Recommend consultation with a state licensed plumbing specialist. Multiple locations noted. This report is qualitative, not quantitative. Photo(s) representative of noted deficiency.
- **POTENTIAL INSURANCE QUALIFYING DEFICIENCY**

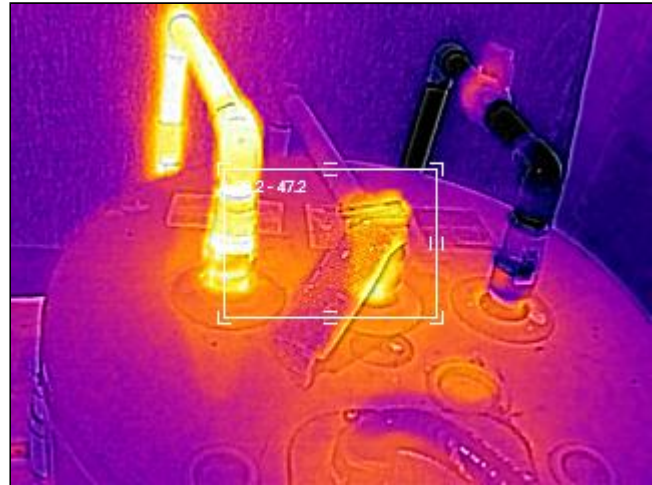
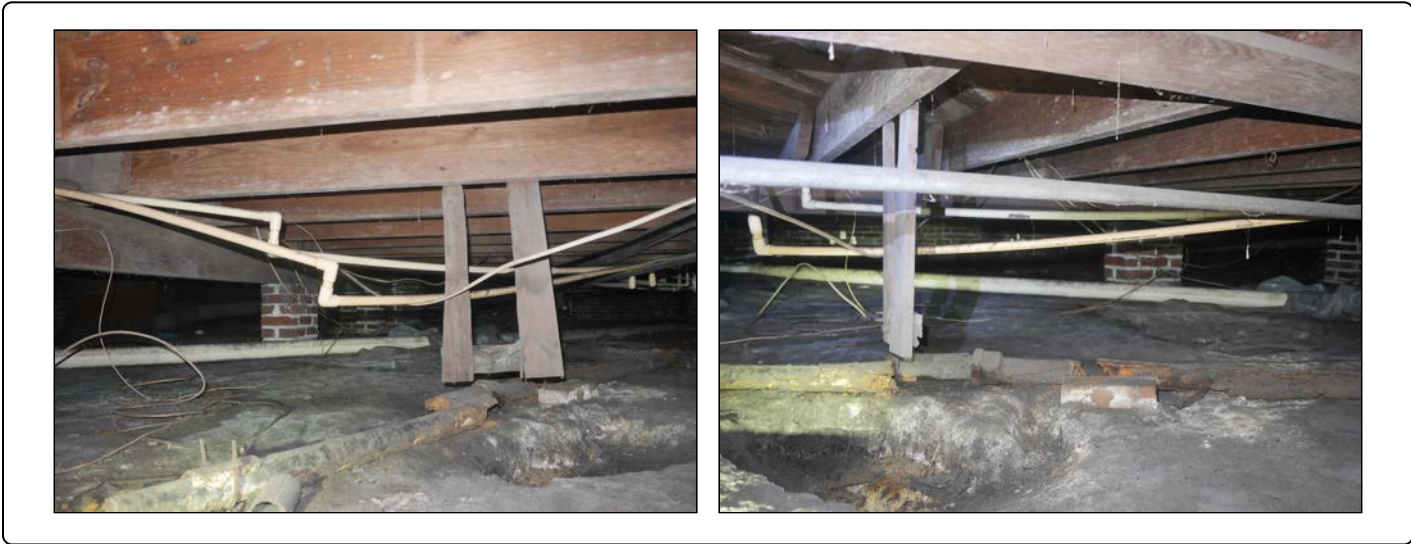
6.2 (10) Some plumbing distribution supply lines not insulated.

- Potential future point of failure in the event of frost / freeze.
 - Missing insulation may affect the efficiency of the hot water system.
 - Recommend repair in accordance with current building practices and standards. Multiple locations noted.
- This report is qualitative, not quantitative. Photo(s) representative of noted deficiency.

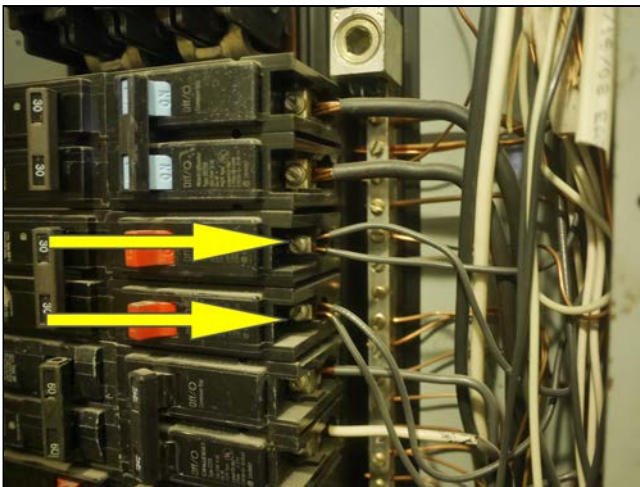
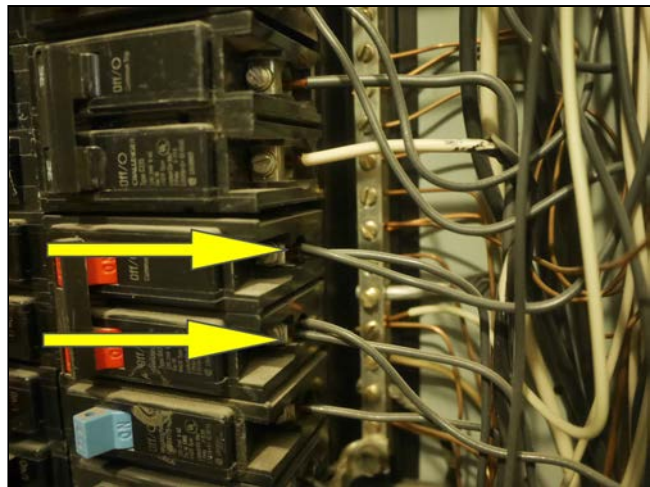
7.0 (5) Circuit breaker "Double-Lugged" (two circuit conductors installed into a single breaker lug). Potential overload hazard.

- Recommend consultation with a state licensed electrical specialist.
- **POTENTIAL INSURANCE QUALIFYING DEFICIENCY**

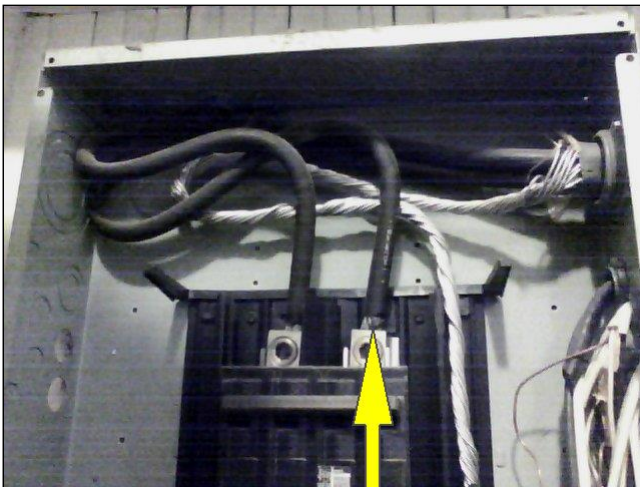
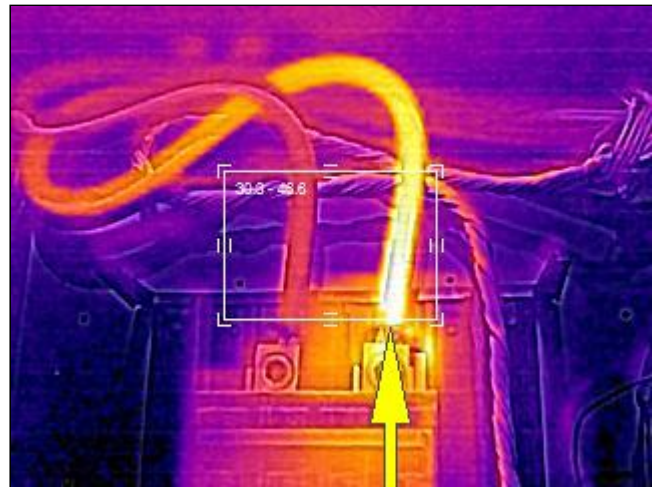
**7.0 (7)** Infrared evidence of temperature differential at main service entrance conductors at service panel.

- Temperature differential may be indicative of high electrical resistance resulting from improper termination, oxidation, excessive current draw, load imbalance, etc.
- Observed temperature delta: approximately 10 Fahrenheit degrees
- Recommend consultation with a state licensed electrical specialist.
- Note: Lighter areas of thermogram(s) indicate areas of higher surface temperature. Thermography performed using qualitative methods; direct temperature measurement not performed on energized equipment. Control photograph(s) presented at left of page, with corresponding thermogram(s) at right.

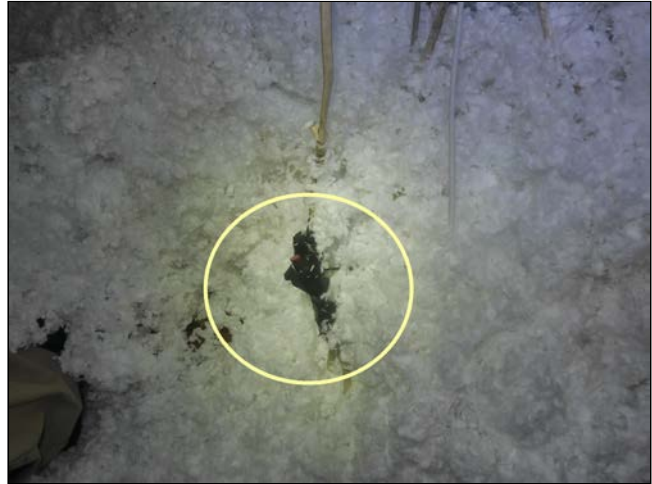
Crawl space

7.2 MAJOR DEFICIENCY - Wire splice not enclosed within junction box.

- Shock / fire hazard.
- Recommend repair / reconfigure in accordance with current building practices and standards.
- **POTENTIAL INSURANCE QUALIFYING DEFICIENCY**

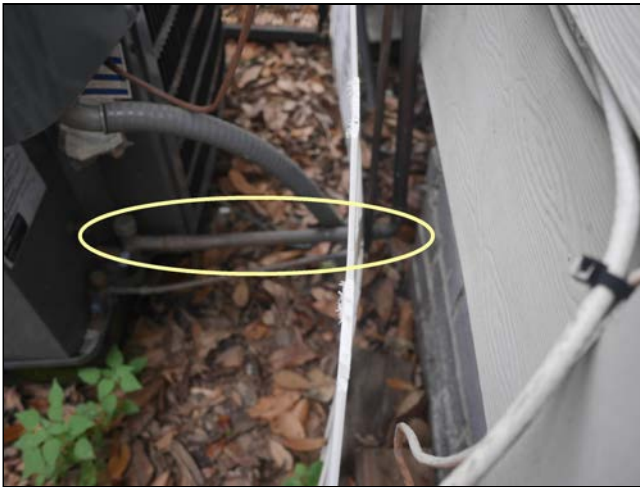
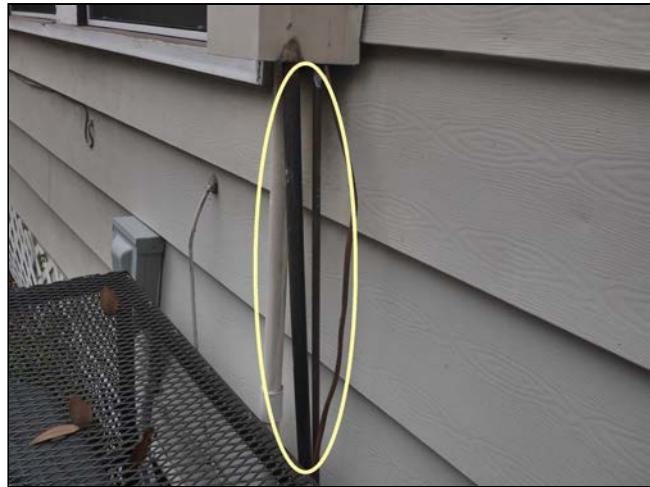
- 8.0 (3) Insulation deteriorated at HVAC suction line at outdoor coil.**
- Recommend repair by a state licensed HVAC specialist.

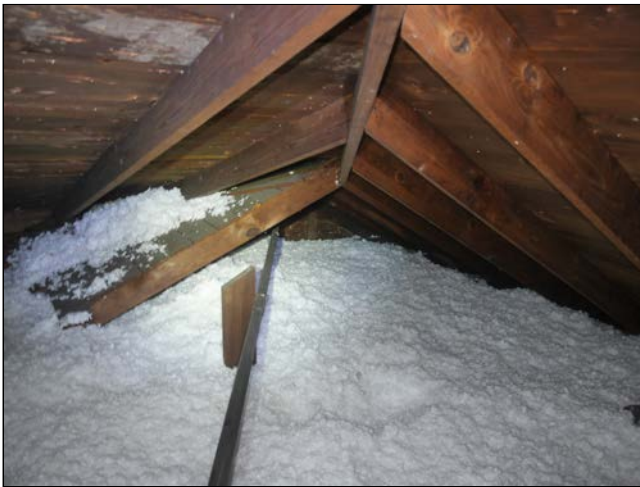
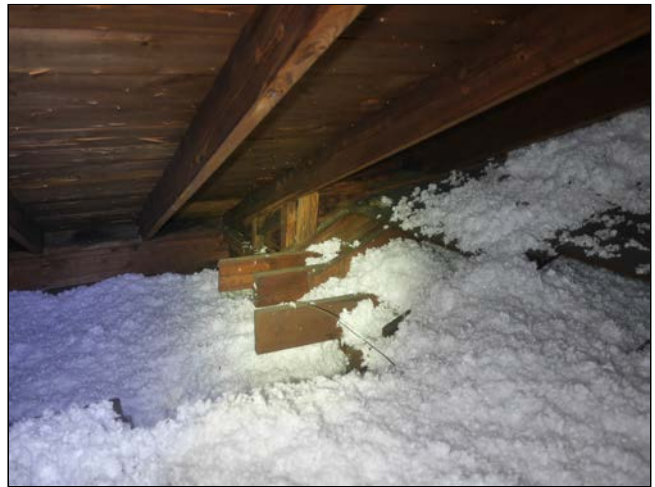
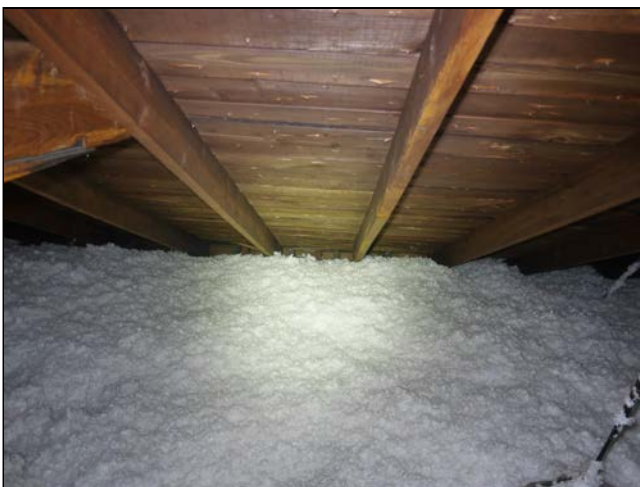
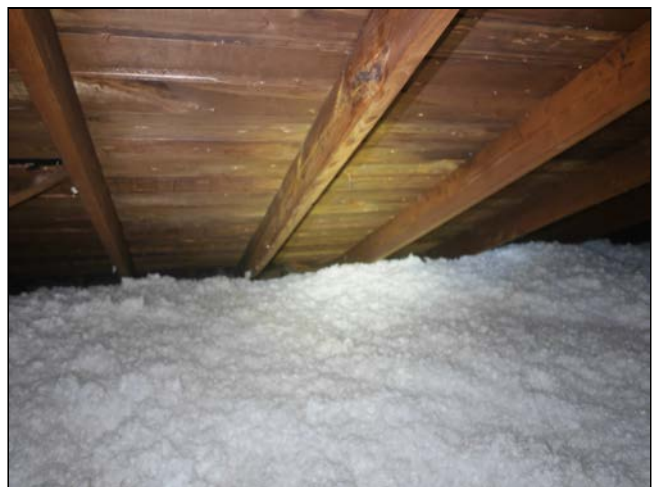
9.1 MAJOR DEFICIENCY - Roof system / attic appears to be improperly vented.

- Improper venting can result in excessive heat and premature aging of roof covering materials. Recommend consultation with a state licensed roofing specialist.
- Attic insulation appears to block soffit vents.
- **POTENTIAL INSURANCE QUALIFYING DEFICIENCY**
