# BIG STEAM NEWS

Web: [www.nmslrhs.org](http://www.nmslrhs.org) Email: [nmslrhs@nmslrhs.org](mailto:nmslrhs@nmslrhs.org) Tel: 505 246-2926  
 Restoration Site: 1833 8th St NW, Albuquerque, NM  
 Vol. XIV, No. 2 Apr.—May—Jun., 2015

## SUPERHEATER PIPE FABRICATION COMPLETE Pipes Are Ready For Hydrostatic Test And Reinstallation.

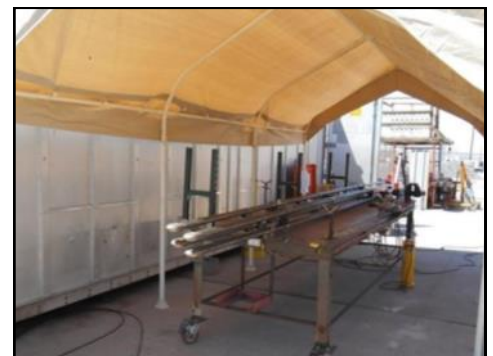
To assemble, two pipes are mounted in the jig on the work table. A return is slipped on the pair, tapped down, and then backed off 1/8th of an inch, and securely welded.

Shown in the photos at right are: 1) Two views of a new firebox end return; 2) An 'old and new' picture of a firebox end pipe pair showing a spacer clip and return in place on a new pair ready to be welded; and 3) A finished weld.

The other image, (4) is a reused smokebox end that has been welded into the swaged ends of new pipes.

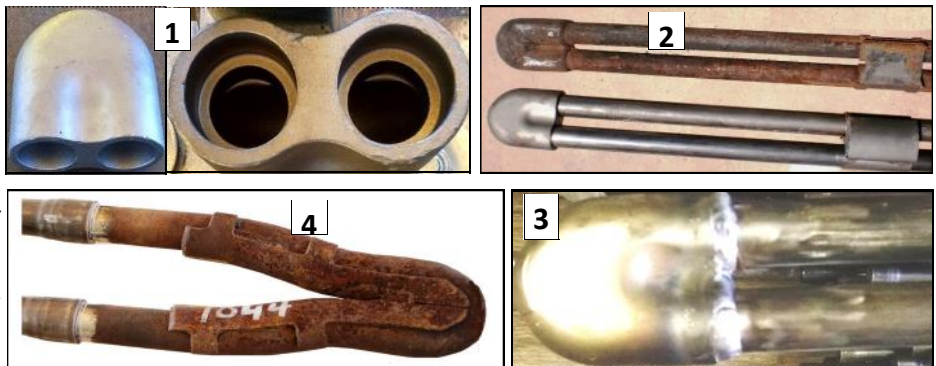
Due to extremely high heat, the returns for the firebox end are cast steel, machined to provide a snug fit for a pair of pipes.

The photos depict the difference between firebox and smokebox returns in the 2926 boiler..

The drawing depicts both ends as identical cast returns. The 2926 system to be replaced employed a pipe bend creating a hair-pin shaped pipe pair. That bend served as the smokebox return. The bend was protected from grit/sand by a saddle type shield inserted inside the bend. When the old pipes were pulled, those returns were cut off and stored for reuse. (See picture below).

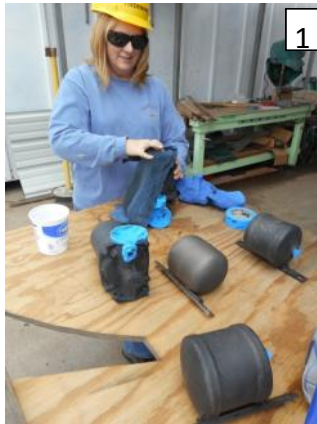
1. Julie completes painting the tiny air reservoirs for the 26L brake system. She had already completed painting of all the renovated lube distribution units.

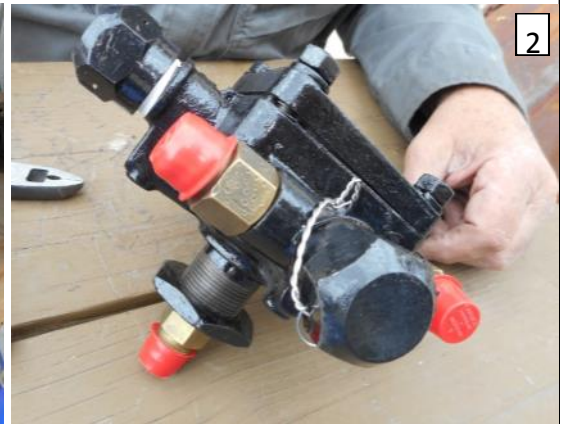
2. Lube distribution unit ready to be installed: The last step in this task was applying safety wiring to the distribution unit.

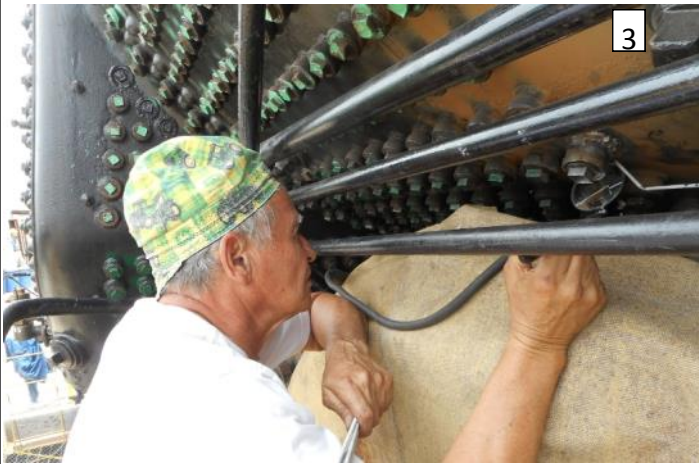
3. & 4. Two final steps on the long running flexible staybolt replacement task.

In image 3 Danny uses an inspection mirror to look at the weld on the back side of the last flexible staybolt sleeve repair.

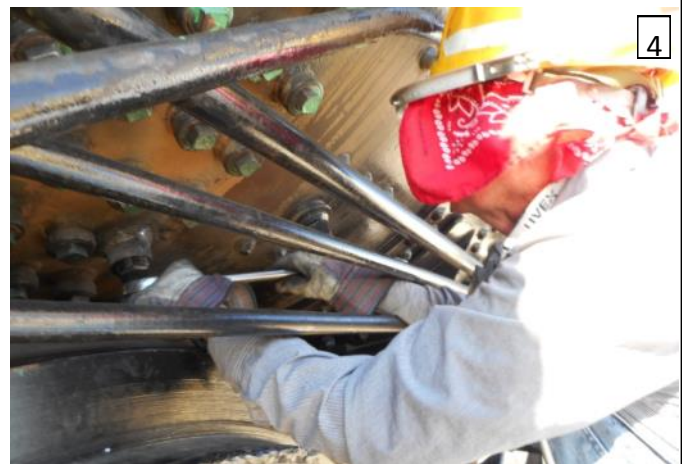
In image 4, reaching into cramped space, Tom torques the last flexible staybolt cap to complete a task that involved everything from fighting rust to parts manufacture.

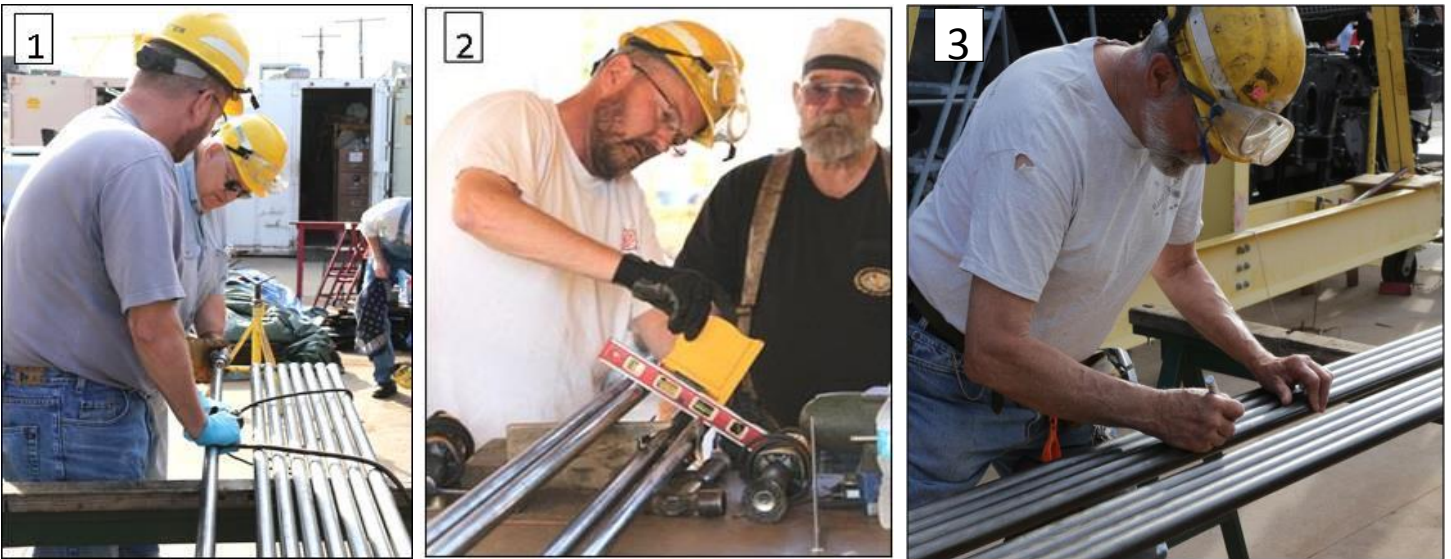
**Above Select, measure twice, cut once, and mark.**

1. Pipe sections are selected from stock, measured, cut to length as necessary, and placed in jigs on the work bench.
2. Welder Carlos Osuna watches as Chip Kizer sets up pipes for welding.
3. Team Member Ken Dusenberry measures and marks pipes for attaching the spacer clips.

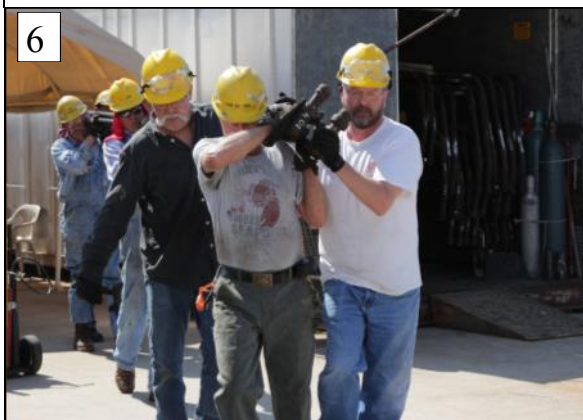
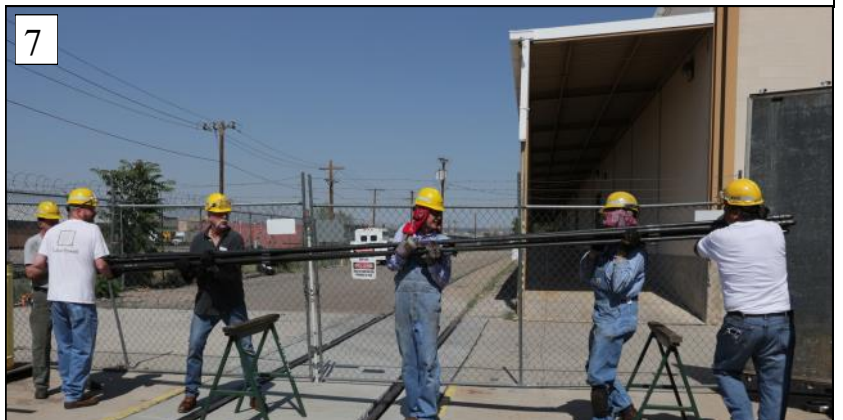
Photo No.6: After a call for help, some muscle shows up to carry the bundle from the work area to its storage niche. Photo No. 7: The last bundle is slid into its place in the storage container.

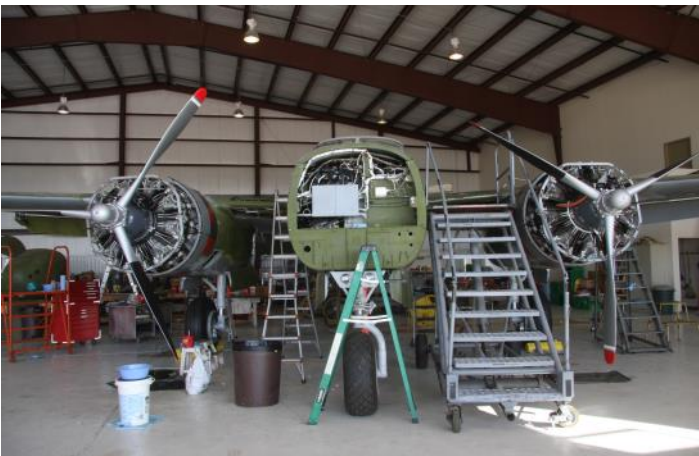
*Left: Lil' Twister Propellers Were Just Mounted*

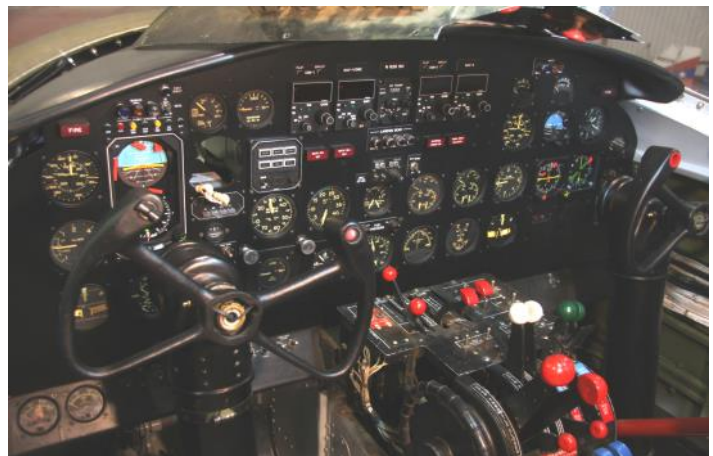
*Right: Restored instrument panel in the A-26 cockpit.*
