BIG STEAM NEWS

NEW MEXICO STEAM LOCOMOTIVE & RAILROAD HISTORICAL SOCIETY

Apr---May---Jun 2018

TRACK PROBLEM CAUSES DERAILMENT

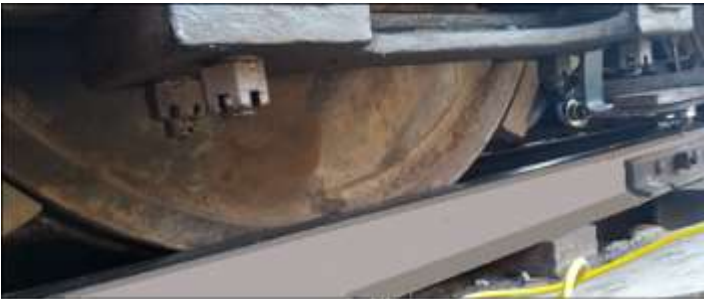
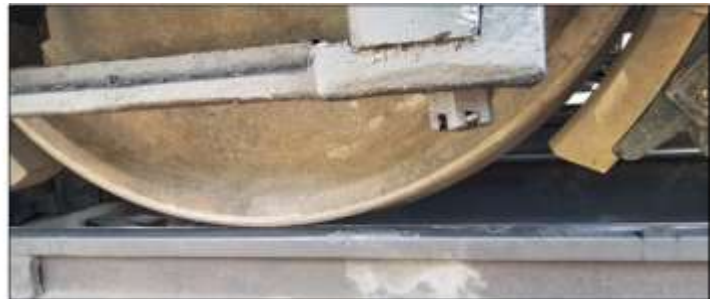
A quick look at the location of the noise revealed the problem. On the engineer's side, the rear wheel of the trailing truck had dropped inside the rail. The front wheel on the same truck was just a fraction of an inch from derailment. On the fireman's side, the supporting H-beam over the pit was bent, leaning out, and the rails were spread. With the derailment, the Saturday work session just got a lot longer. The location of the derailment so near the pit precluded conventional re-railing. A search for assistance resulted in a quick visit by re-railing specialists from Hulcher Services. The tender was disconnected and moved to the engine house.

Above Derail Photo: The photos above reveal the derail problem on the engineer's side of the locomotive's trailing truck. The photo at left shows the rear wheel off the rail. The photo at right shows the front wheel defining a fraction of an inch.

The volunteers finally left the site at 7:00PM. The Monday June 5 work session was still scheduled, but it was far different from a steam-up operation. Without the option of using a conventional re-railing method, it was determined that the locomotive would have to be **lifted and moved forward**. Santa Fe 2926 had not been lifted in many years. The huge locomotive's last lift was done more than 60 years ago by the 250 ton crane in the AT&SF backshops. That crane still exists, but 1) it is not mobile, 2) it has set idle for years in the backshops. The lift would require an innovative approach by some experts. It was Hulcher Services to the rescue with two large side boom equipped D8 Caterpillars.

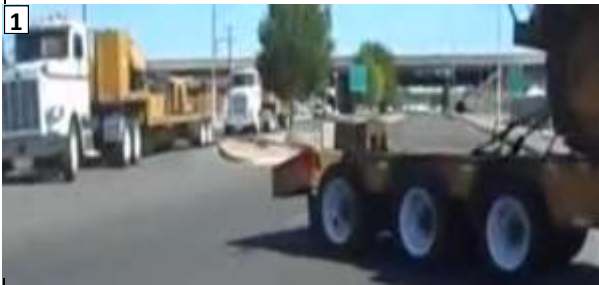
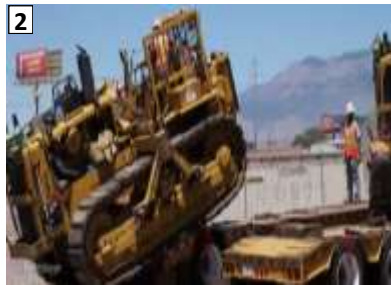
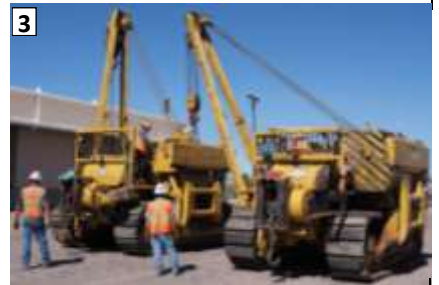
Arrival and Setup: 1) Hulcher team arrives with truckloads of equipment; 2) Caterpillars are quickly unloaded and lifting

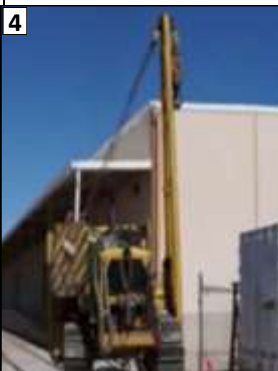
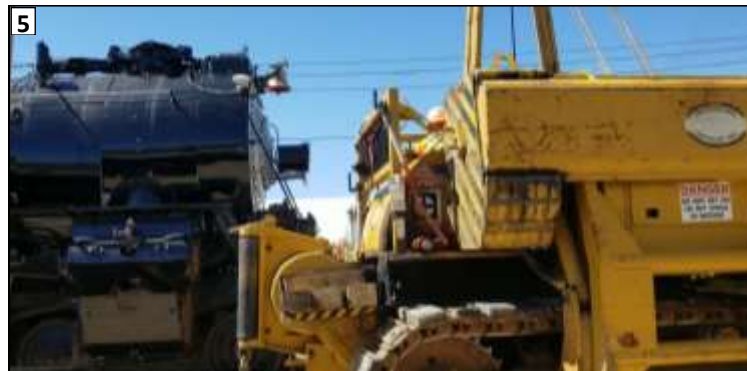
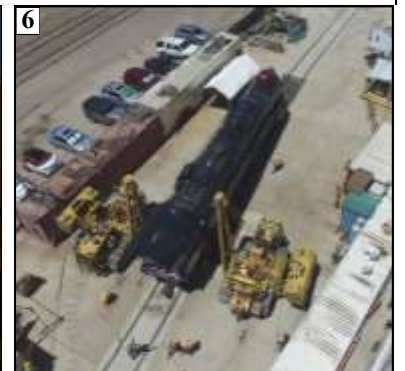
Getting Into position: 4) The first Cat enters the west entrance by the GSA building; 5) It proceeds by the engineer's side of 2926; 6) Both Cats are in position for the lift. Counterweights are extended, revealing very little clearance. The counterweight of the Cat on the right occupies the space that was once the Santa Fe 2926 Store. (The store will be replaced with a mobile unit.)

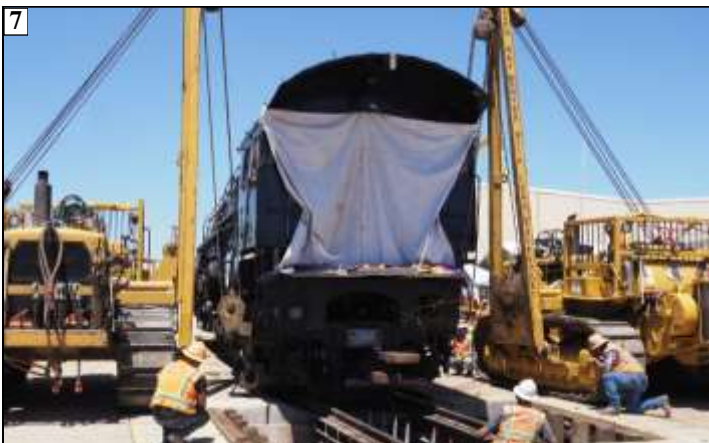
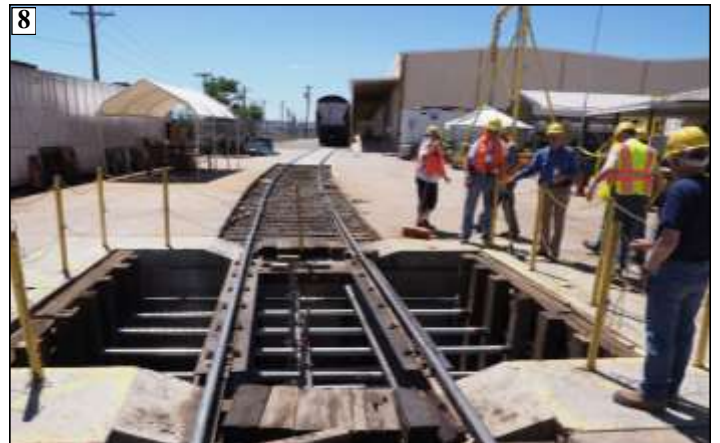
The Lift And Back On The Rails: 7) The lift was not as simple as it appears. When the engine was lifted and cleared the pit, the twisted rail and supporting beam snapped back into place. That derailed the firemen-side trailing wheel placing it outside the track. A little more lift, and forward move finally got all wheels back on track. 8) Back on track, the locomotive was moved forward by the GSA warehouse,, and crew members review the site. After snapping back, the track looks straight again. It was appearance only. There was still a lot of recovery and repair ahead.

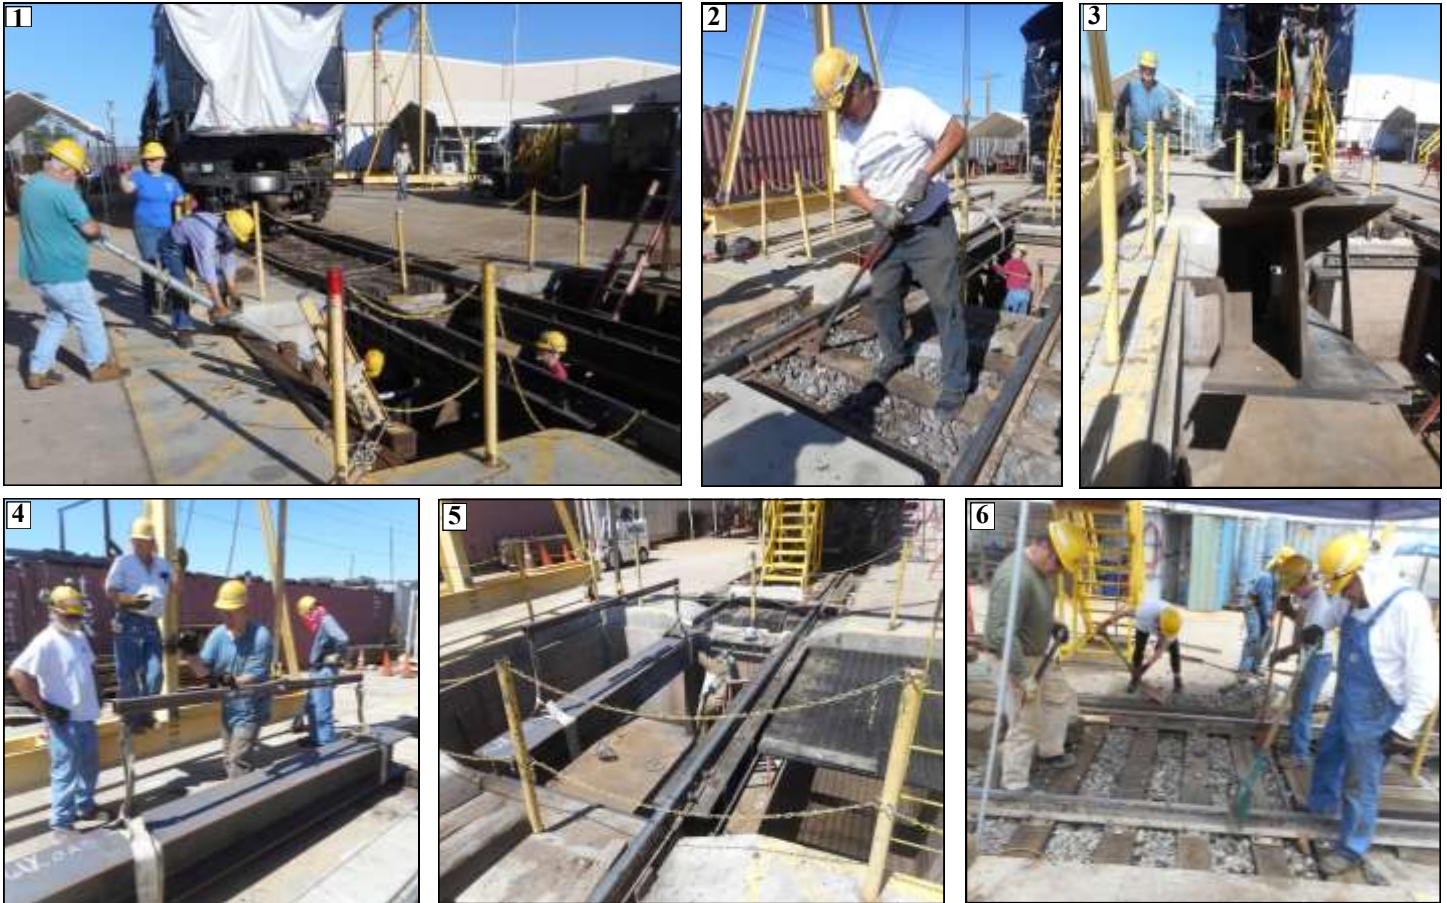
Recovery And Repair: With the locomotive back on rails and away from the pit, all of the cribbing and support was removed from the pit, (Photo 1). In Photo 2, Lewis gets some experience pulling spikes the way it was done before the advent of power tools. In Photo 3, the bent beam with a rail section still attached is lifted from the pit by the gantry crane, Big Bird. Removal of the pit structure elements also required a lot of 'in the pit' cutting and grinding before removal.

With the old pit structure removed, new larger beams were lifted in place by the crane, (Photo 4). Once the new beams were in place, the welding team, led by Danny and Rick spent several work sessions in the pit welding the new structure, (Photo 5). They did so in near 100° ambient heat. Even with a canopy and fan, it was a bit warmer in the pit. Finally, after getting additional help in properly installing the replacement rails from Gandy Dancers, the volunteers replaced and tamped the ballast, (Photo 6).

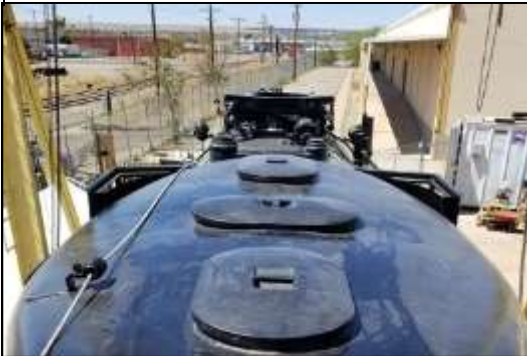
LOOKING FORWARD: The photo below looks over 2926's stack from behind the sand dome. It shows the end of a short siding that has been home to the historic locomotive during its restoration.

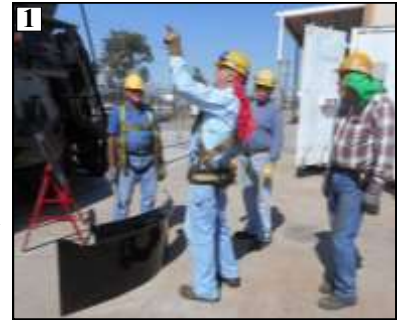
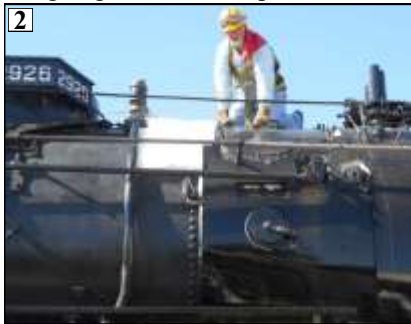
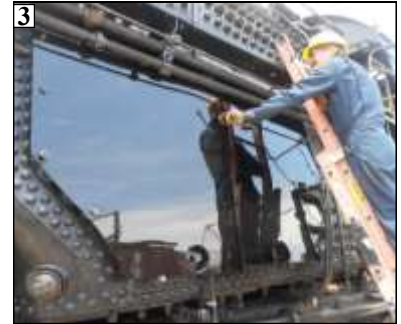
Once the shaped, fitted, and painted jacket parts are returned to the site, a number of them are installed upon delivery. Photos 1&2 show one with special bends and cutouts that is installed atop the smokebox.

The glossy black mirror-like finish is revealed in the large panel undergoing a fit check in photo 3.

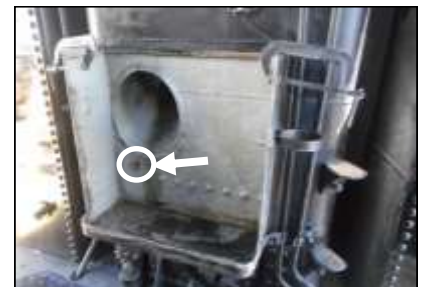
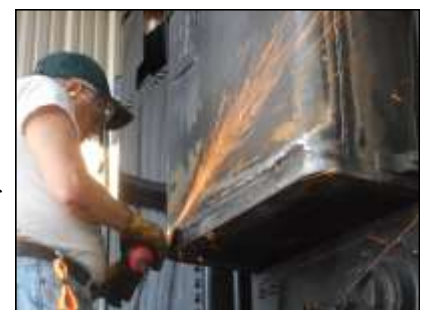
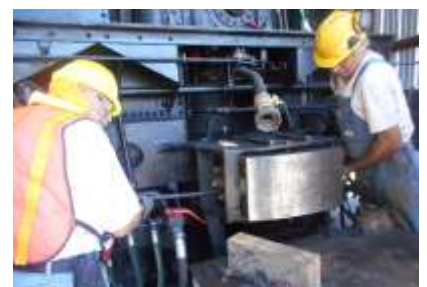
Above: More radial buffer work at the front of the tender.

For the replication, parts from 2912 in Pueblo, Co. were used as patterns. After producing new parts, the crew discovered that the 2912 and 2926 parts weren't quite the same. That meant disassembly, followed by cutting, machining, and welding to make the new ones fit.

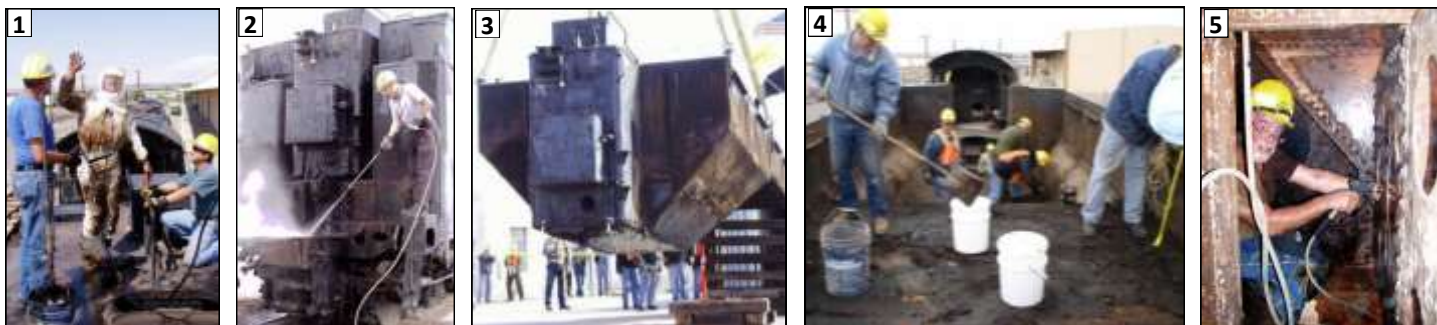
Bunker Cleaning And Preparation, Stage 1, 2003: The cleaning began in early 2003 by removing caked oil inside and out, (1 & 2). The fuel bunker was then lifted, (3) from the tender and placed on cribbing for more cleaning, Surprise!! More caked oil and assorted trash in the fuel bunker pocket, (4). Inside the water bunker, the crew scraped, scrubbed, and needle scaled hundred of pounds of scale, rust, and trash.

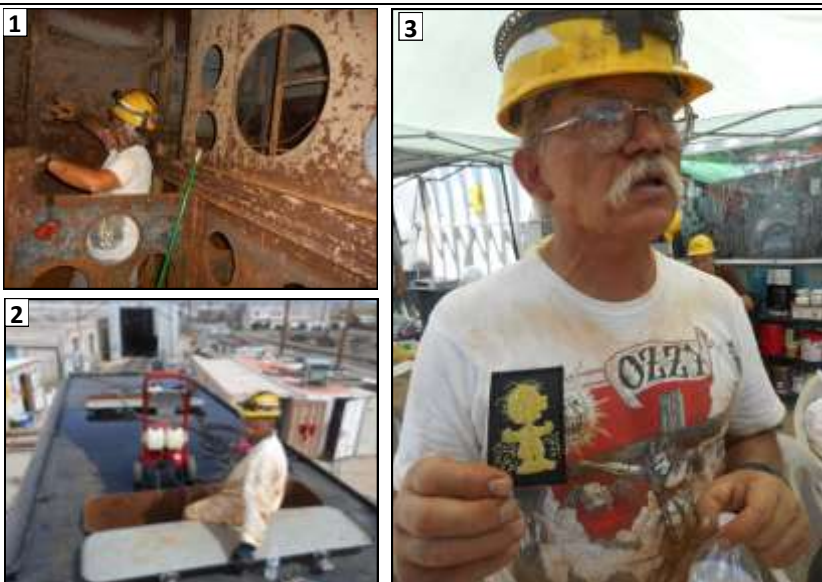
That task fell to Martin S. Though Martin had seen the 2003 photos, and heard some stories of the very dirty earlier tasks, he chose to forge ahead. The photos at right show what happened next. In the first, he is deep inside the water tank. In the second, he is seen emerging from the front hatch. From the appearance of his tyvex suit, it appears that he encountered some rust inside. Inside, he removed sediment and scale, checked internal fittings, and anything else that might interfere with the locomotive's water supply.

Martin's work inside the water tank provided him with an opportunity to earn a Pigpen Award. The award is presented to any volunteer who manages to get dirty enough to match the character "Pigpen" in the Peanuts comic strip. He shows his new "Pigpen" patch in the third photo.

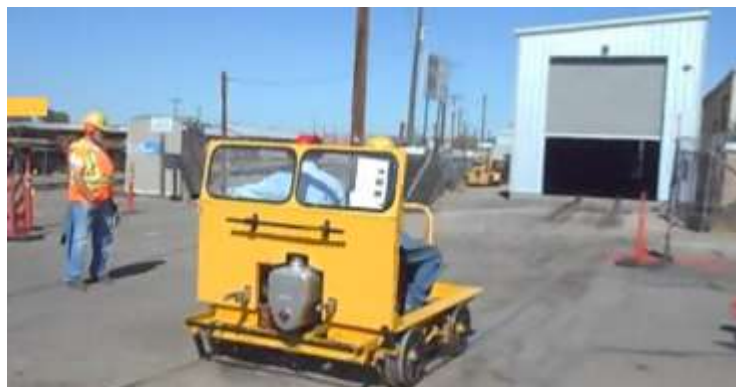
The speeder pictured at right once carried work crews along the railroad to keep tracks in good condition. After retirement, it rested for years in a yard in Albuquerque's north valley, slowly rusting away. Acquired a few years ago by Albert Leffler, it was hauled to Indianapolis, Indiana where Dick Downing and friends restored to operation. It was then returned to the 2926 restoration site where it can be seen on occasion putt-putting along rails near the site.

Putt-Putt: The recently restored railroad speeder crosses 8th St. as Ken D.. stands by to direct traffic.

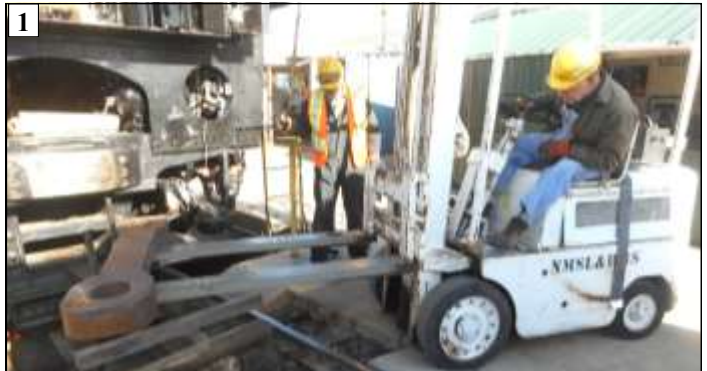
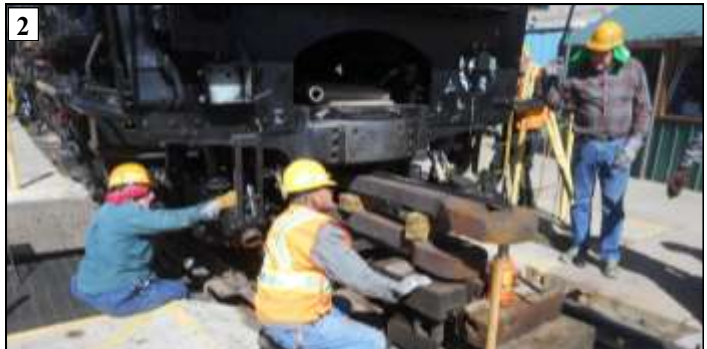
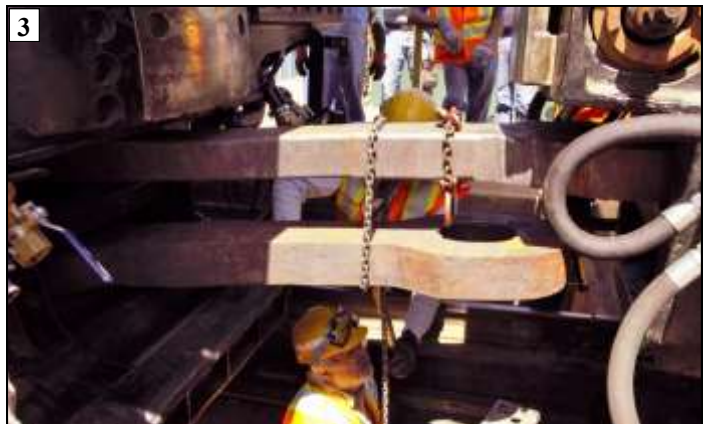
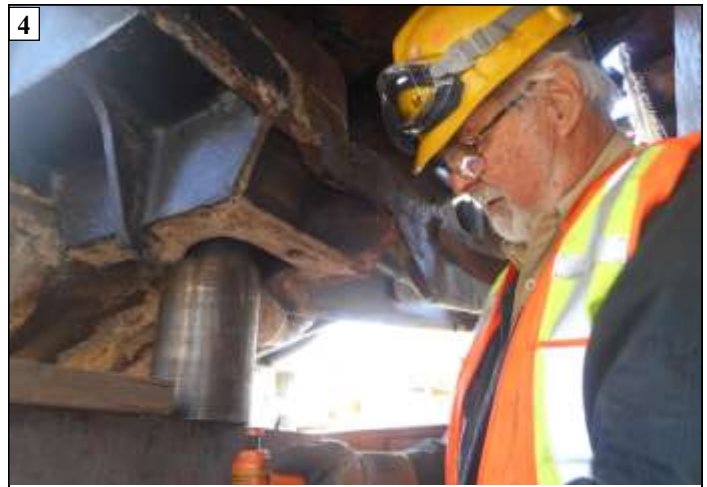
The drawbars fit into pockets on the rear of the locomotive and the front of the tender. There, they are held in place by huge pins that weigh up to 90 pounds each. They are the towing link between the locomotive and tender.

1 Drawbars are delivered to the rear of 2926 by forklift.

2 Are you sure this will work as well as original shop equipment?

3 Bill W. in the pit preparing to insert a big pin.

4 Bill hopes all the pins go in this easy.

The drawbars were removed at the start of the restoration. Since then, the tender and locomotive had been linked on occasion, but only with chains snugged tight between the two. Complete, proper connection was necessary for the first steam-up. That included those heavy drawbars—and some hard dirty work. In April, the drawbars were reinstalled for the first time in sixteen years.
