BIG STEAM NEWS

NEW MEXICO STEAM LOCOMOTIVE & RAILROAD HISTORICAL SOCIETY

Vol XVI No. 4

THREE BUSY MONTHS MEAN THE 2926 RESTORATION IS ALMOST FINISHED

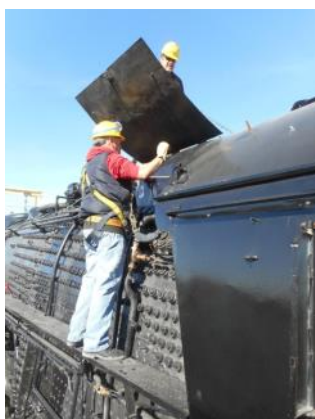
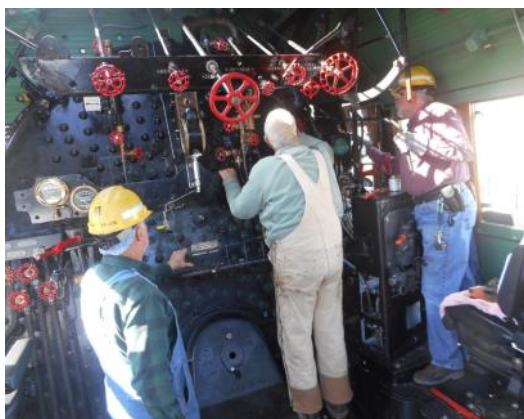
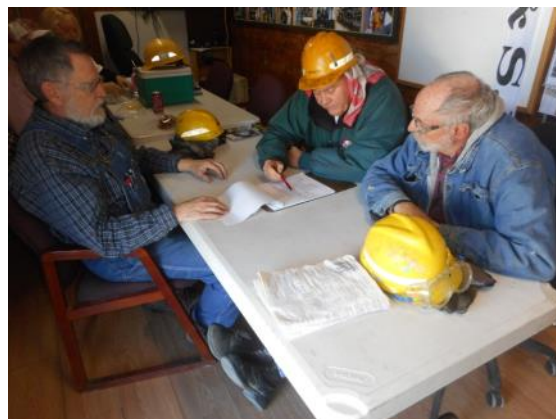
A Few Of The Final Tasks Leading To Completion Of The 2926 Restoration

Left: Volunteers are fitting some of the insulation and sheet metal jacketing that can be installed before steam up and testing. Jacketing around the boiler and other areas will not be installed until testing is complete.

Center: Dave V. watches as Scott A, and Rick K. focus on completion of one of the many small tasks involved in restoration of all the controls and instruments on the backhead.

Right: Firing up a big steam locomotive is not a simple task, especially for the first time after a complete rebuild. A detailed step by step plan is being developed. Here John T. goes line by line through the plan with Larry L. and Ken D. Having served as a nuclear engineer on the U.S. nuclear submarine Nautilus, John thus has steam experience, but with a different source of heat.

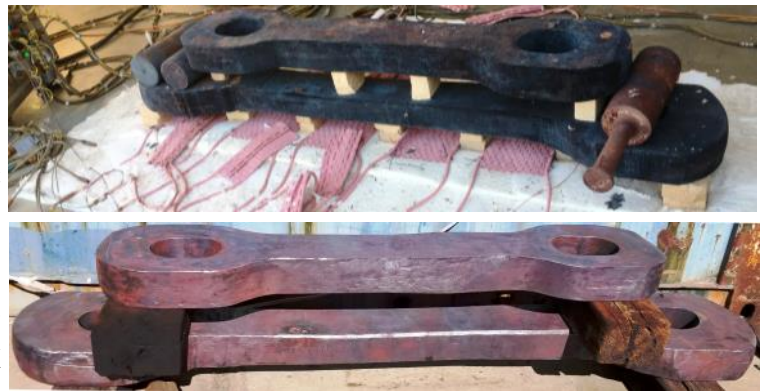
DRAWBAR RESTORATION

The 2926 drawbars were certainly due an inspection more than sixty years after the locomotive’s retirement to the park. Other than some descaling and rust removal, this was an off-site task. The drawbars were loaded into Rick’s Ford truck and hauled to Team Industries, Inc. in Farmington where Kyle Riley and his crew annealed them. The photos at right show the process, and the drawbars back at the restoration site.

Title 49 CFR Sec. 230.90, Draw gear between steam locomotive and tender: *The pins and drawbar shall be removed and tested for defects using an appropriate NDE method at every annual inspection. Where visual inspection does not disclose any defects, an additional NDE testing method shall be employed.*

This task has drawn more discussion than actual work. The regulation cited above does not specifically require that the drawbar and pins be annealed—but the Folio for the AT&SF steam locomotives does.

The subject of regular drawbar annealing has been discussed for decades. Some organizations required periodic annealing. As early as June 19, 1920 Railway Review noted that fact with the following. “Drawbars in service shall be thoroughly annealed at least every six months.”

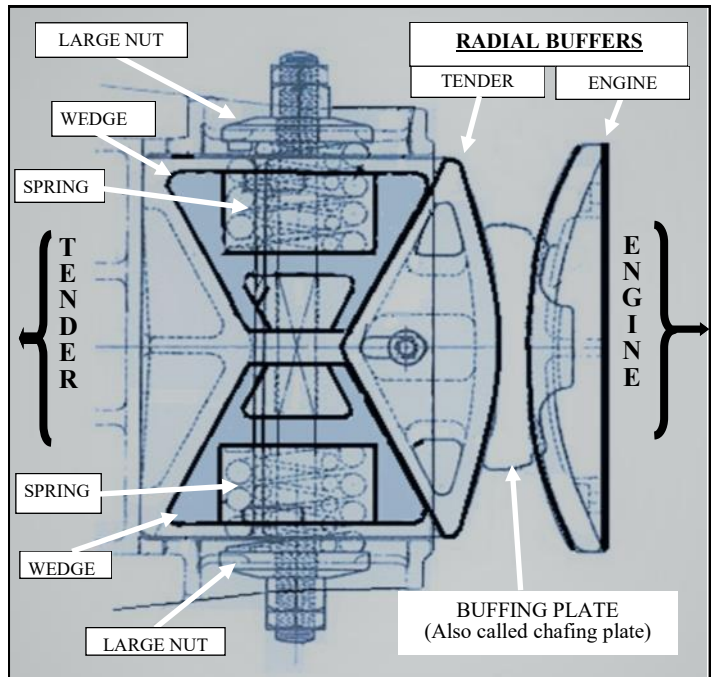
RADIAL BUFFER:

There are many types of radial buffers. The above drawing resembles the Franklin design used after the early 1900s. AT&SF used a similar Franklin design.

The radial buffer assembly is mounted above the drawbars on the tender. It employs spring tension to maintain a snug connection between the tender and engine while allowing flexibility.

At the front of the assembly is a large convex steel element—the tender side buffer. It faces a similar buffer on the engine. Sandwiched between the convex buffers when connected is an expendable concave brass buffering plate, also called a chafing plate or wear plate. Behind the tender side buffer is an assembly of springs and wedges that maintain tension on the buffer. At right is a sketch of a buffer assembly similar to the one on 2926. The purpose of the radial buffer is to control slack in the engine-tender connection, while allowing flexibility for curves.

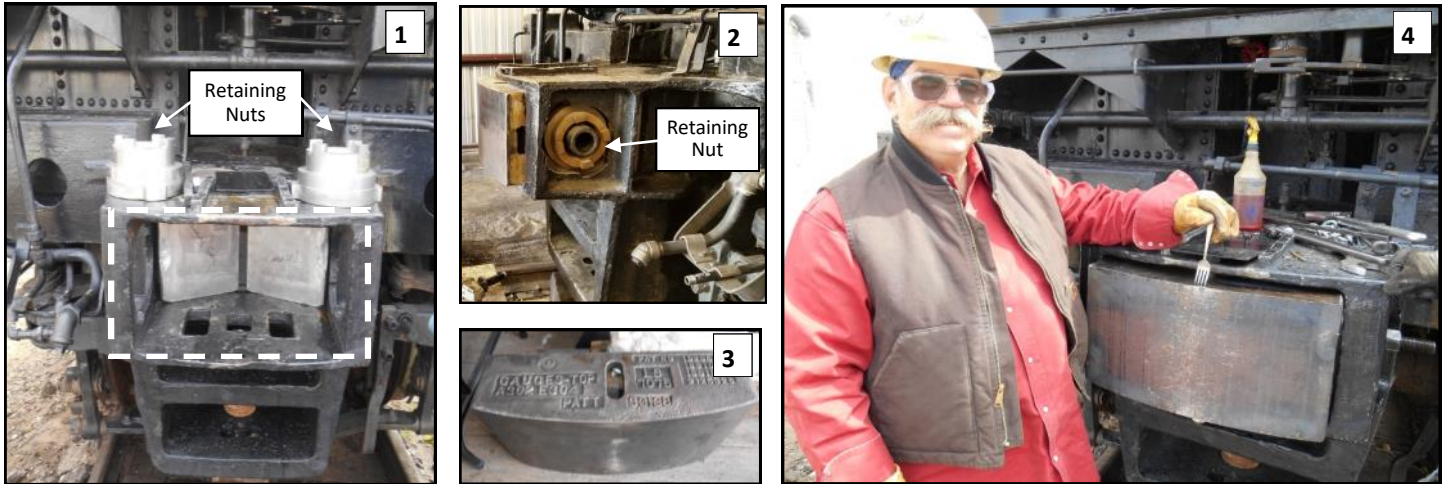
Tender Portion Of The Radial Buffer

The pictures above show parts of the radial buffer assembly on the tender. Several of those parts were stolen and had to be replicated. Located directly above the tender's two drawbar pockets, the buffer housing is defined by the dashed line in Photo 1. It contains a set of wedges and a large spring. The spring is mounted on a horizontal shaft passing through the assembly housing. The tender side buffer element is mounted on the front of the assembly. It is shaped to fit against wedges inside the assembly and on the spring. The shaft carrying the wedge enclosed spring is threaded on both ends, and secured by two large nuts that retain all the parts. The large odd shaped nuts were produced by Eric R. from solid blocks of steel. They are shown resting on top of the housing in Photo 1, and one is shown mounted in place on the shaft in Photo 2.

The purpose of this assembly is to keep the curved buffer units between the tender and locomotive snugged tight on the buffer plate as lateral movement occurs.. The lateral movement allows the engine-tender combination to flex. Photo 3 is a picture of the borrowed AT&SF 2912 tender side buffer. It was used as a pattern for making a new buffer to replace the one that was stolen. In Photo 4, after reassembly, Carlos points to the new tender side buffer that was built on site, .

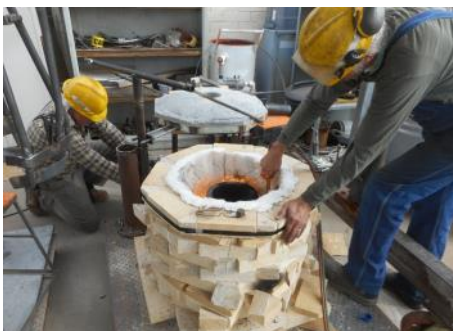
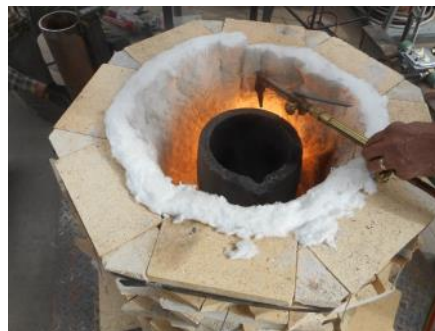
The first photo below shows the furnace building process—using firebrick to build it. The second photo shows some of the initial testing of the new on site capability. Actual production work and photos of the final product will be placed on our web site, Facebook, and the next newsletter.

Work began to build a furnace for creating a buffer plate and future casting needs. When finished, it will be tested and practice pours will be made. The crew will then cast a new brass buffering plate to provide the bearing surface that will complete the radial buffer engine-tender connection.

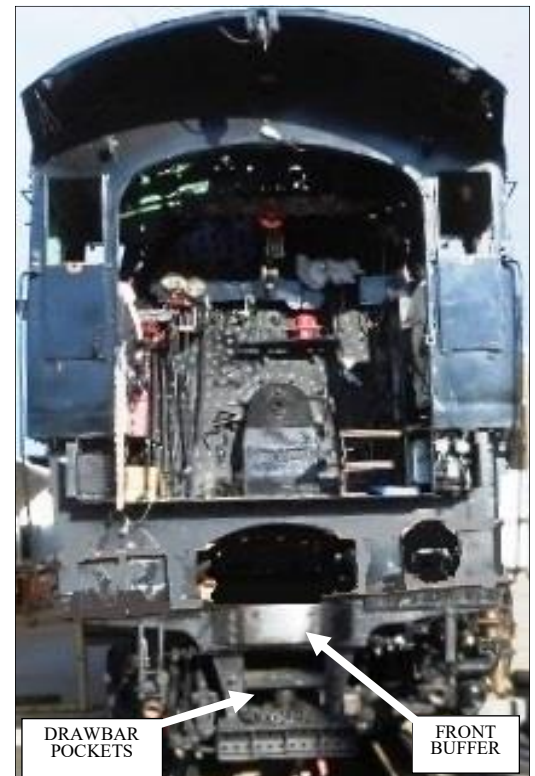
Engine Side Of Radial Buffer

The photo at right was taken after the burglary when work in and under the cab was just getting underway. The front buffer is the only part of the overall buffer assembly mounted on the engine. The fact that it was still mounted in place is all that probably allowed it to avoid the theft.

Once the tender side stolen parts were replicated and reassembled, and the engine side buffer cleaned, the only part still needing attention was the brass buffer plate that fits between the buffers. The original plate was not stolen, but due to poor condition, a decision was made to replace it.

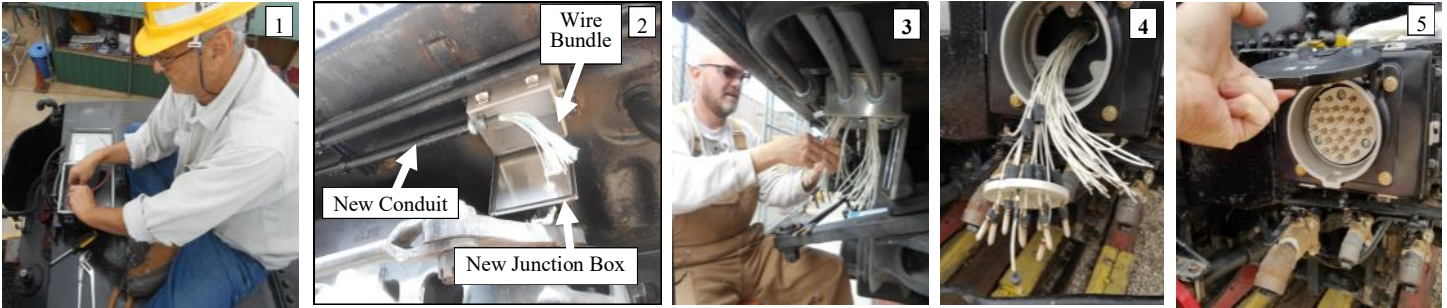
This series of photos show some of the many tasks involved in creating and installing a Multiple Unit System between the cab of 2926 and the rear of the tender. This is just a few steps in the portion of the system on the tender. Designing and installing the interface with controls in the cab is also a complicated task. To see many additional pictures of the design, building, and installation of the MU System, check the NMSLRHS web site <http://www.nmslrhs.org/> Progress on the MU project, with photos will be included in the next quarterly newsletter.

Photo 1: Bill R. is building a junction box for the MU System.

Photo 2: A junction box has been installed on the tender bottom, connected to conduit, and the wire has been pulled through.

Photos 3 and 4: Chip K. sorting wires, preparing junctions, and connectors.

Photo 5: A completed connection.

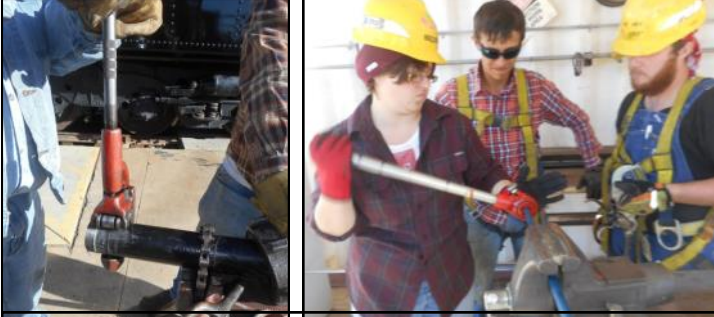
As previously mentioned 2926 is heavily populated with pipes of all sizes, shapes and types. The photo at right provides a look at many of the pipes atop the locomotive. A large number of the original pipes had to be replaced.

Among the most tedious and time consuming tasks of the entire restoration are those involving the fabrication, installation, insulating and painting of many yards of pipes.

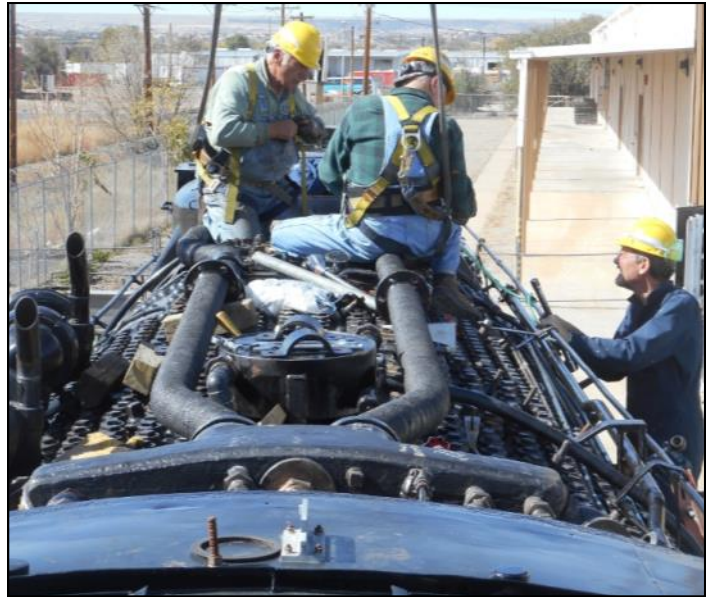
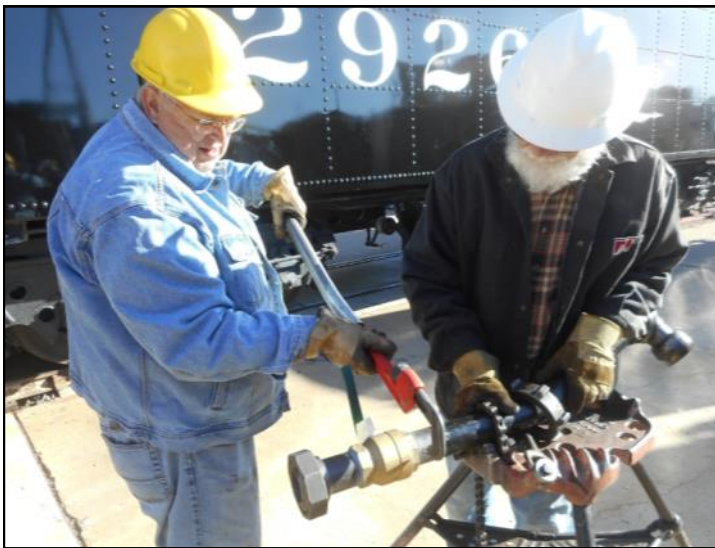
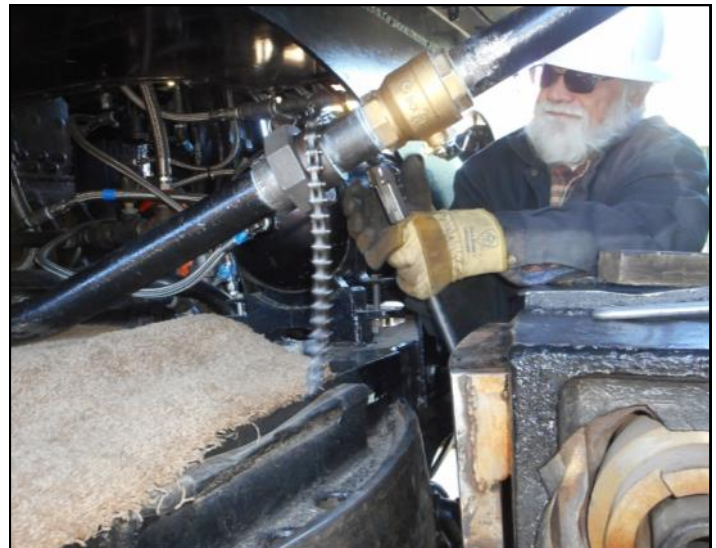
Above and Below: Just threading and connecting the pipes occupied many hours of volunteer time, **Below Right:** Nate finds pipefitting workspace underneath the cab a bit cramped.

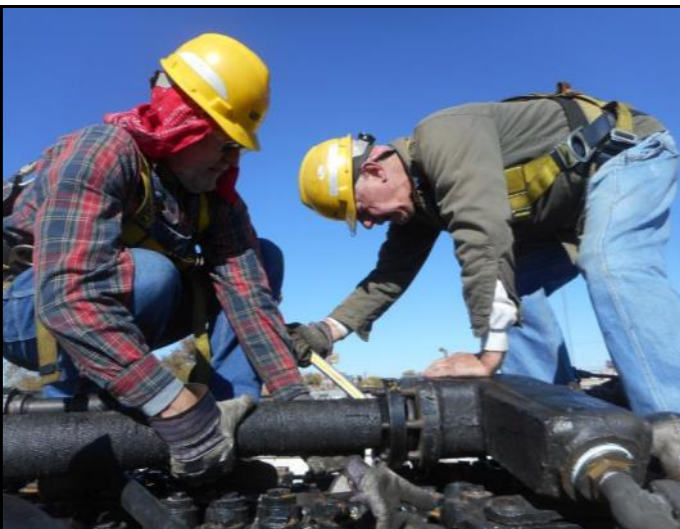
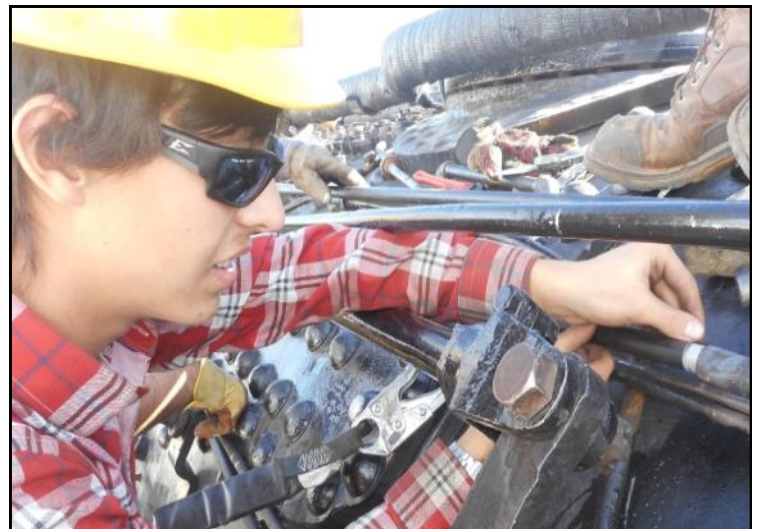
Below Left, Larry L. and Dave V. work on some larger pipes on top of the locomotive. They may appear to have a lot of room to work, but like Nate's situation below the cab, the pipes are so close together that completing the connections requires painstaking labor. Below right, Scotty A. works on a very small pipe behind other pipes. He is applying Teflon tape to the threads. Having been developed just a few years before 2926 was built, there is little chance Teflon tape was used when the locomotive was operating. It takes more time to apply, but is much less messy than pipe compound. Both Teflon and 'pipe dope' were used in the 2926 project.

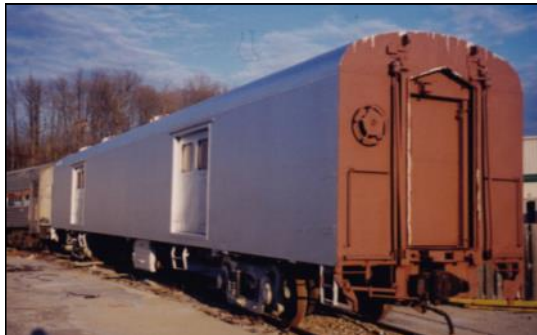
Pictured above is RPCX 3939 baggage car donated to NMSLRHS by Curt Potter. It is currently located in Bellevue, Ohio. Under the care of Mark Magers, the first stage of its transformation into a tool car for 2926 is underway.

That first stage includes removal, (Photo below) and disassembly of both trucks for inspection and any needed repairs. It should be ready to roll by summer. It will then be moved to Albuquerque for the second stage of the transformation at the restoration site.

Other tasks will include some door repair, painting, and seating for the road crew.

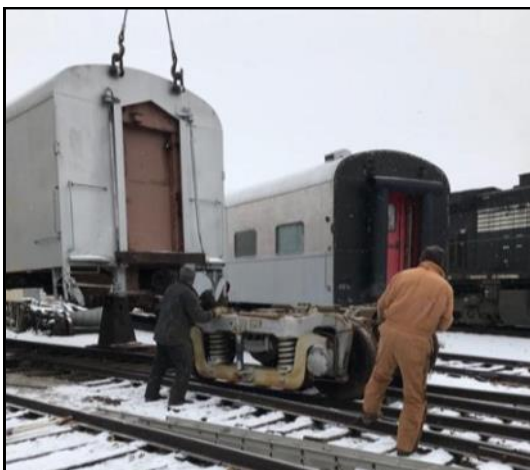
Above: Workers in Ohio ignore snow and cold to remove the baggage car trucks. And the 2926 crew thought working outside in NM was a challenge

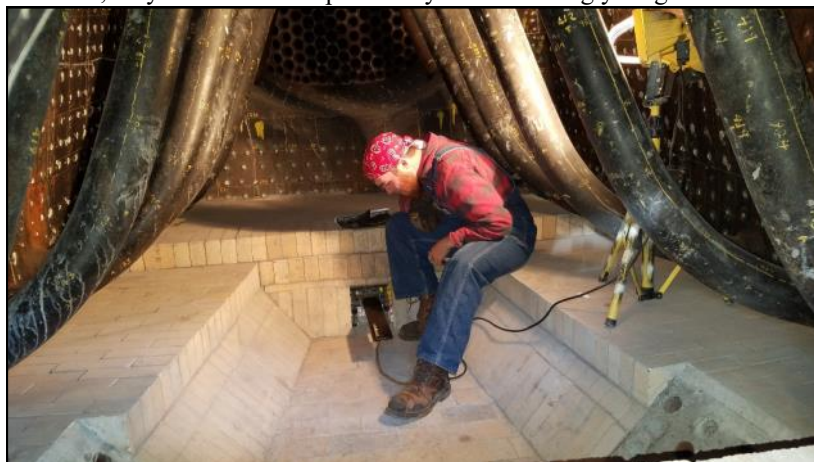
Above: Henry checks the key fire point. Fuel oil is delivered to an atomizer at the front of the firebox next to Henry's right foot. With someone on the other end of the fuel line applying pressure, he is checking to make sure the line is clear and can deliver oil to the atomizer.

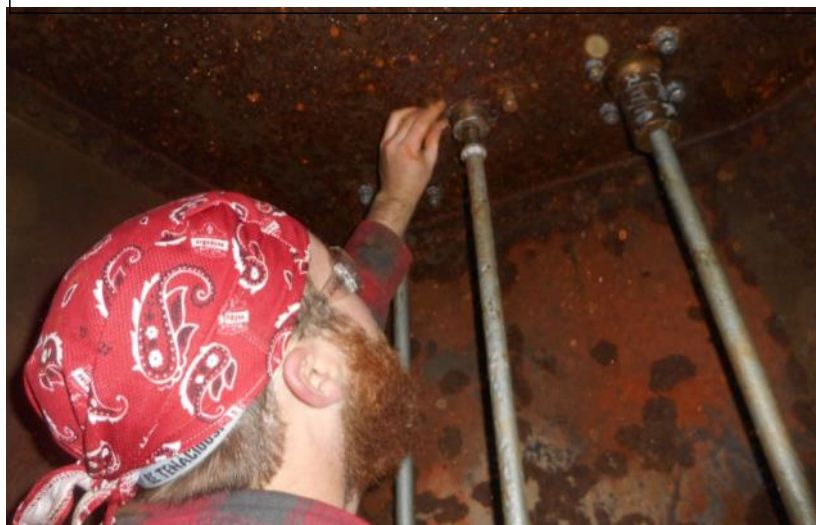
Below: Deep inside the front of the water tender, Henry checks a leak on the telltale water level valve. The leak was caused by some grit on a hard rubber seal when the valve was rebuilt.
