WaterFurnace E7 Condensate Overflow Remedy

WHAT IS THE E7 ERROR?

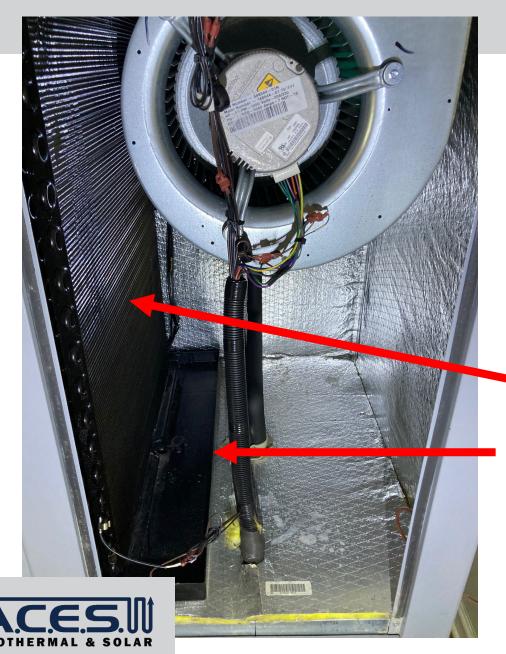
When your geothermal heat pump is run in cooling mode, moisture from the air condenses on the cold air coil inside the unit. This moisture is collected in a pan beneath the air coil and drains through a flexible vinyl hose in the bottom of the cabinet. The drain hose creates a trap that remains filled with water. Without this trap, the negative pressure in the cabinet would prevent the moisture from draining. Microbe colonies can grow in the standing water of the trap and form a blockage, causing water to back up into the pan. To prevent water damage to the equipment, this condition will trigger an **E7: Condensate Overflow** fault and the heat pump will shut itself off. Follow the instructions in the following slides to correct this fault.

AIR COIL

CONDENSATE PAN

CONDENSATE TRAP W/ BLOCKAGE

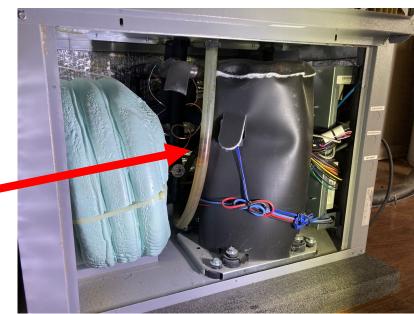
DISCONNECT

STEP 1: TURN OFF POWER TO THE UNIT

Your heat pump may have a dedicated sub panel, or pull-out disconnects near or on the unit.

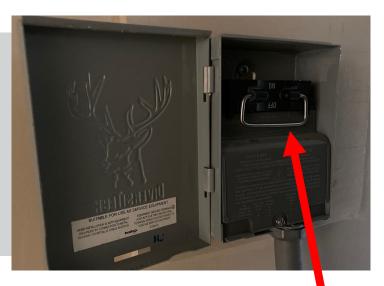
IF YOU HAVE DISCONNECTS:

- Locate the disconnect boxes either on or near the geothermal equipment.
- 2. Open the covers. Some open up, some open to the side.
- 3. Pull on the handles to remove the disconnects from their enclosure. Appearance may vary. There may be 2 or 3 disconnects depending on equipment installed be sure to remove all of them. Note the "on" and "off" labels for proper orientation when reinstalling.

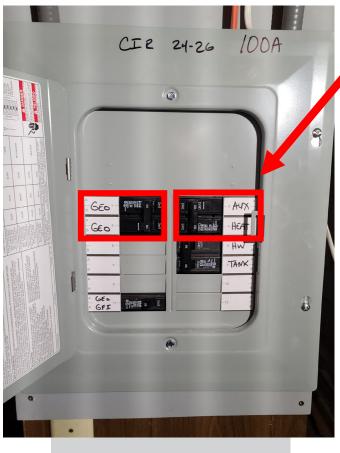
SUB PANEL

IF YOU HAVE A SUBPANEL:

- Locate the double-pole circuit breakers labeled GEO and AUX HEAT in the sub panel near the geothermal equipment. There may be one or two double breakers for AUX HEAT depending on equipment installed
- Turn all of these breakers off, and proceed the next page

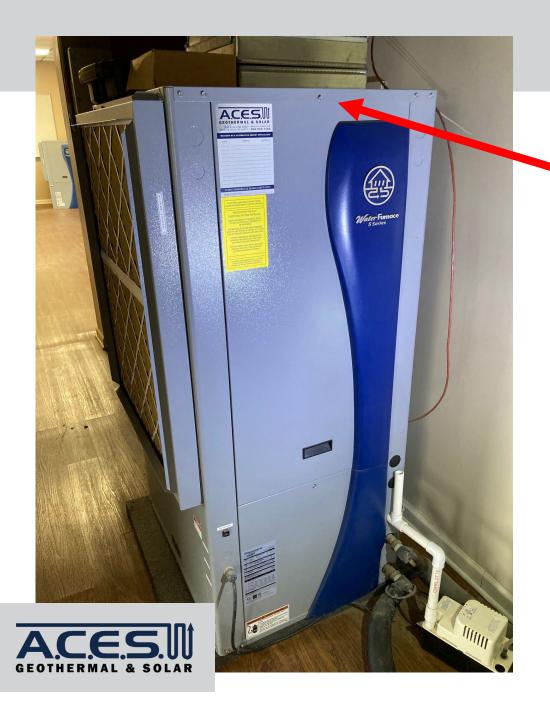
STEP 2: OPEN THE UNIT

- 1. Ensure the unit is completely shut off before opening the cabinet
- 2. Remove the 5/16" hex-head screw at the top of the upper panel on the heat pump cabinet using a socket, nut driver or flat-head screwdriver.
- 3. Lift the cover from the handle, then pull outwards to remove

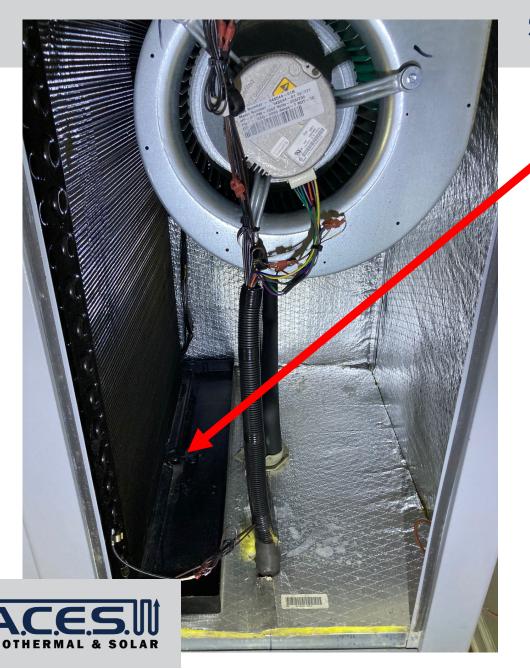
STEP 3: REMOVE DEBRIS

- 1. Locate the condensate drain in the center of the black pan underneath the air coil
- 2. Use a shop-vac to suck out the blockage from the drain. A wet rag can help to create a seal around the vacuum hose. Be careful not to damage the fins on the air coil.
- 3. Pour clean water into the pan to refill the trap and test the drain. If the pan drains quickly, replace the cover on the unit, restore power and resume normal operation.

Always reinstall the cover on the heat pump cabinet before turning the power back on

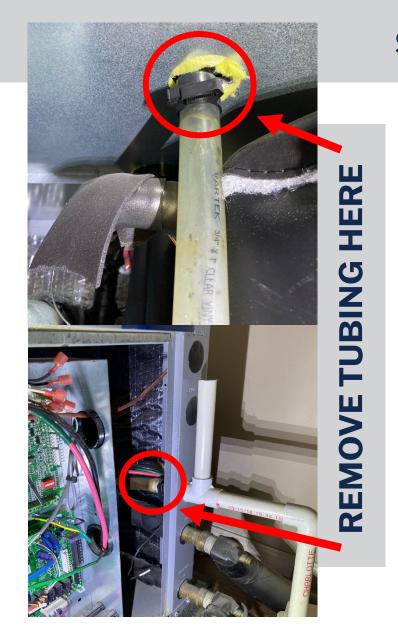
STEP 3: REMOVE DEBRIS

- If the clog is severe, a shop vac may not be able to remove the blockage.
- If this is the case, the clear vinyl trap must be removed from the bottom compartment of the heat pump and cleaned manually. This can be accessed by removing the lower covers. The trap is fastened at either end with reusable plastic clamps as shown. Once removed, the tube can be cleaned with water pressure or a tubing brush (click here for Amazon link).

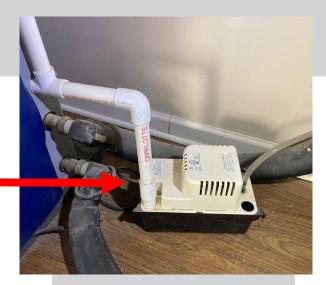
CONDENSATE PUMP

- If your system includes a condensate pump, it is also a good idea to check and clean the pump reservoir as needed during cooling season.
- Condensate treatment products are available that slow the growth of microbes in the trap. These are available at your local hardware store or online, and can be added to the condensate pan periodically as a preventative measure.

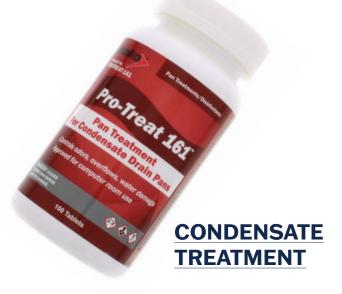
STEP 4: CHECK CONDENSATE PUMP (IF APPLICABLE)
