# BIG STEAM NEWS

NEW MEXICO STEAM LOCOMOTIVE & RAILROAD HISTORICAL SOCIETY

Vol XVI No. 3

Jul—Aug—Sep 2017

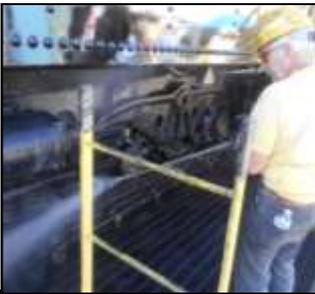
High pressure wash for the star of the annual Open House.

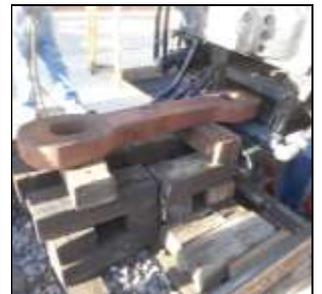
Installing a drawbar at the rear of AT&SF 2926.

The last photo, showing reinsertion of one of the two drawbars connecting the water/fuel tender to the locomotive. This the first time a drawbar has been reinstalled in fifteen years. Previous moves about the site with the tender and locomotive connected have been done by chaining the tender and locomotive at the radial buffer.

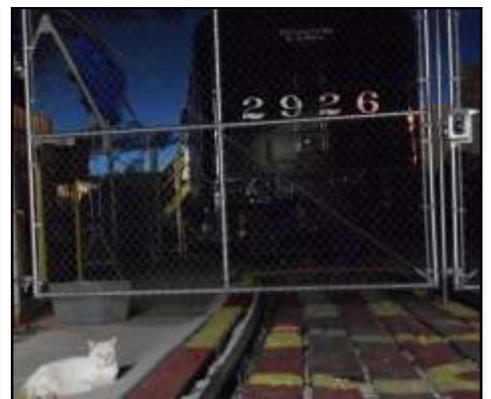
**BELOW: Ready for visitors:** In the first picture, Open House preparation is near completion. The image reflected in the highly polished side of the water/fuel tender is a group of drop-in visitors being shown around the site by 2926 volunteers.

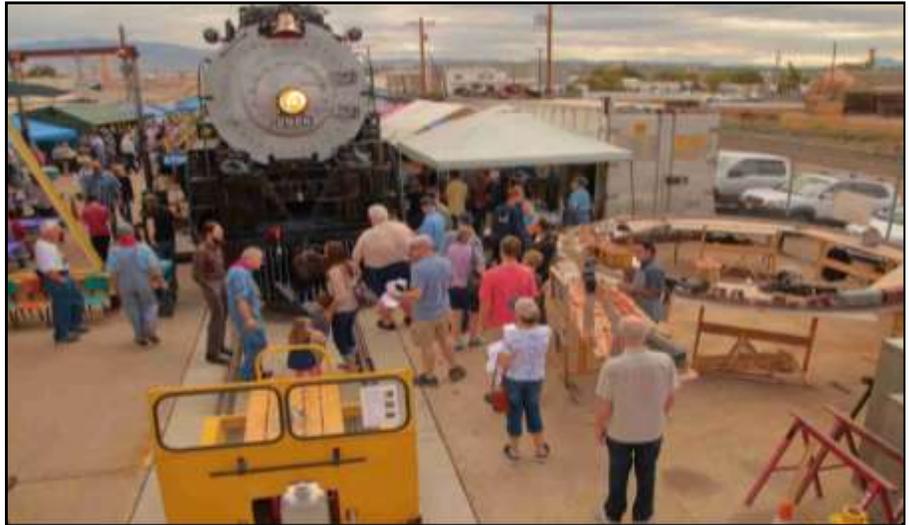
**West Entrance:** This photo by Ron Taylor shows the 2926 site as viewed visitors entering from the GSA parking lot. In the foreground is the Society's fully restored rail maintenance crew 'speeder'. On the right is one of the model layouts.

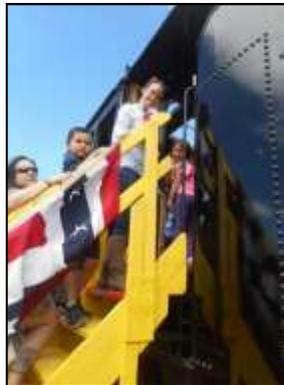
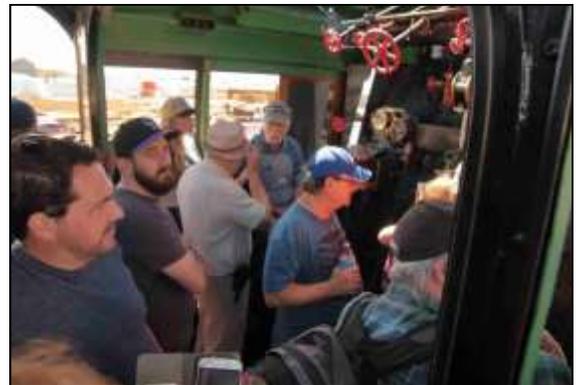
**Cab Tour:** An early, and very popular stop for visitors entering from the east gate was the locomotive cab (two pictures above). In the small picture, visitors are lined up for entry to the cab. In the second picture, visitors crowd the cab for a briefing on the controls, instruments, and duties of the crew members.

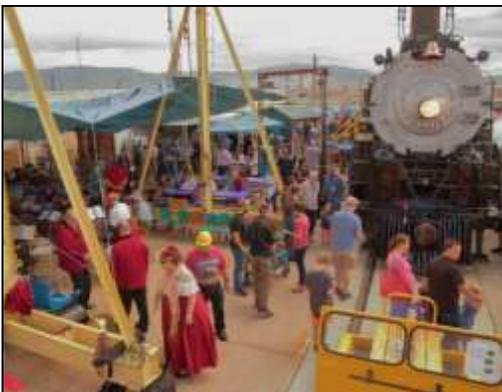
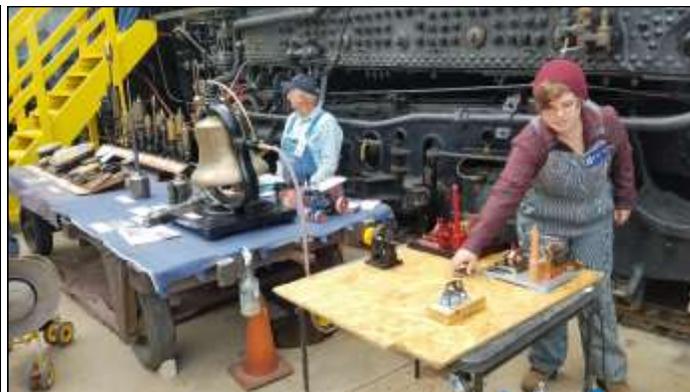
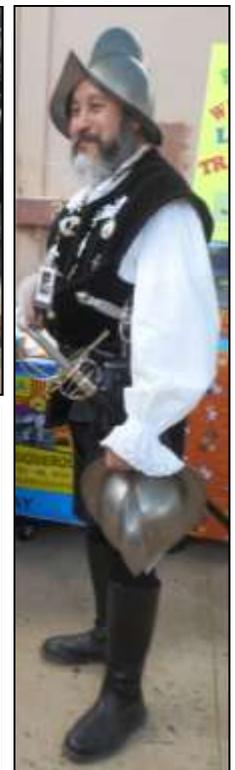
**Around The Site:** There was a variety of things to do and see. There was something for everyone. During the day, four different musical groups performed under the blue canopy at the extreme right of the first picture. Beyond that were tables and chairs, the food line, and the AT&SF 2926 country store with a variety of rail memorabilia.

No rail affair would be complete without whistles and bells. The blue covered table is really not a table. It is a very heavy 4 wheel steel wagon that once hauled locomotive parts at the Santa Fe Backshops. Atop that is a collection of whistles, gauges, and a large bell similar to the one on 2926.

Even the Duke of Albuquerque showed up in the person of NMSLRHS member Martin Andazola who depicts the Duke in local events and movies. Finally, in the picture at right, a young rail fan sits at "restored for display" original 2926 brake stand, bringing this Open House report to a stop.

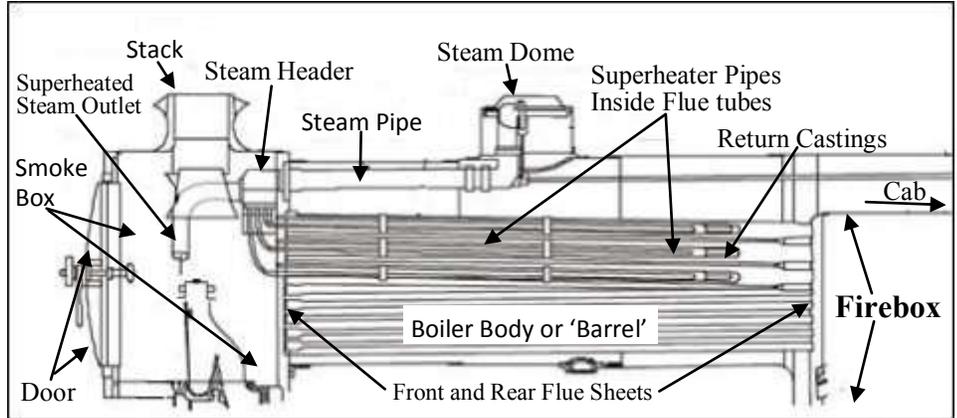
Most rail fans—surely most AT&SF 2926 friends—are aware of the purpose and function of superheater pipes. For those not so well versed in boilers and superheaters, the sketch at right depicting the firebox, barrel, and smokebox, may be helpful.

The firebox, directly in front of the cab is surrounded by water. Steam is produced there, and is collected at the steam dome as 400° 'saturated steam'. The superheater raises the temperature to 700° 'dry steam' to power the locomotive. This is done with small pipes exposing the saturated steam to the hot exhaust gases in the flue tubes.

There are 272 flue tubes in the barrel of AT&SF 2926. Of those, 220 are 3.5 inches diameter. The remainder are 2.5 inches. All 21 feet long, and are attached to 'flue sheets' at the ends of the barrel. Passing through the water filled boiler body, they carry hot fire gases from the firebox to the smoke box. Each 3.5" flue tube contains a 20 foot long pipe assembly consisting of four small diameter pipes. "U" shaped return castings are welded to the pipes to create a total length of 80 feet of superheater pipe in each flue tube.

Wet steam is fed from the steam dome to the pipes at the steam header in the smokebox. As the steam passes down and back through the 80 feet of superheater pipe in each flue tube, it is exposed to the high heat of the exhaust gasses. The steam temperature is thus raised to 700° dry steam. The dry steam is then fed into the steam header for use by the locomotive.

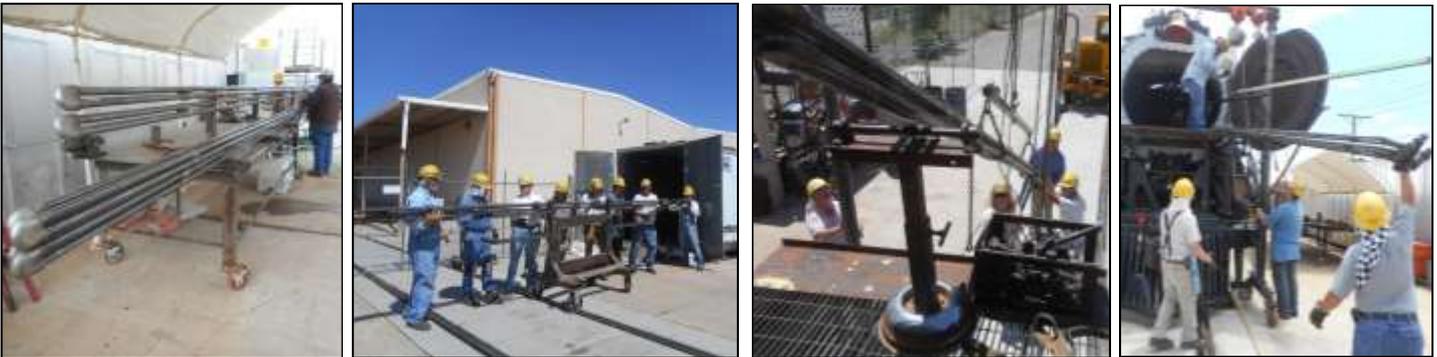
**Above:** The first photo shows Carlos working on one bundle of superheater pipes earlier in the year. The second photo shows the amount of muscle necessary to tote the pipe bundles. Picture three reveals some of the innovation required. A chain hoist on a built-on-site gantry crane is used to lift each bundle. The end of the bundle is then placed on the metal stand with a roller on a platform in front of the smokebox. The chain hoist is then used to bring the bundle to a horizontal position, level with the front of the firebox. All flue tubes and header fittings were numbered at removal to ensure a proper match at reinstallation.

At completion of Carlos' long running task of welding and pressure testing, the 'ready to install' pipes were stored. The installation task, toting, hoisting, and shoving the long 4-pipe bundles into the flues, was a new challenge, requiring innovation and muscle. It meant pulling the bundles from storage, carrying them to the front of 2926, lifting them to the level of the smokebox, inserting them into the flue tubes, and connecting them to the steam header. The following pictures show some of that activity.

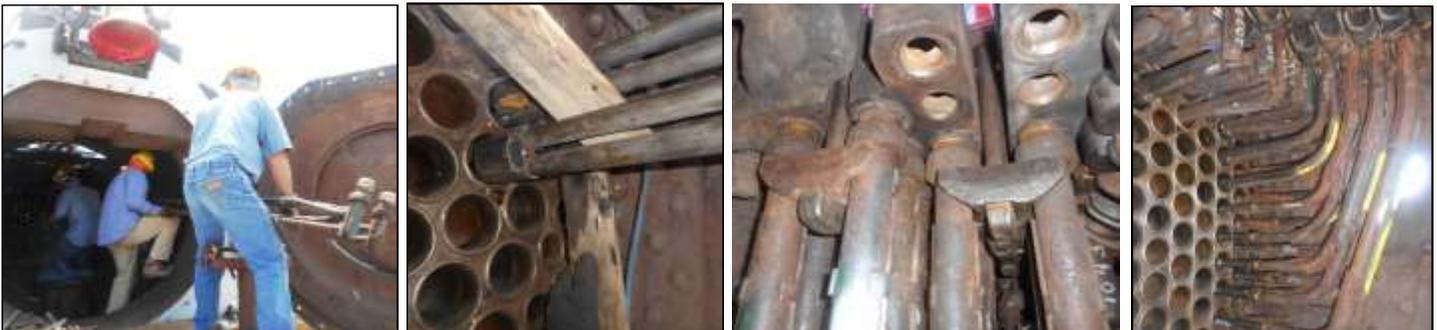
**Below:** Once a bundle is level with its insertion point, several crew members are still required and on the platform outside to finish the installation. A lot of jiggling and sometimes a 2x4 are necessary to get it started. The final two photos depict the header pipe fittings and their connection to the steam header. The final photo shows pipes inserted and connected to steam header.

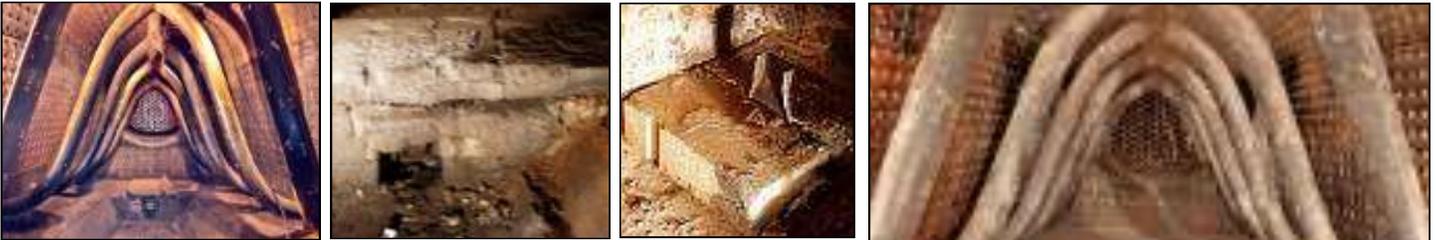
**Before and After:** The first photo is a shot of the firebox taken in 2007 after it was cleaned, but before removal of old firebrick. It was cleaned and firebrick removed allowing workers to carry out the 7000 ultrasound measurements on the walls of the boiler and firebox. The next two are close-up photos of the deteriorated condition of the firebrick before removal and cleanup.

The photo at right is a panoramic firebox view after completion of the firebrick installation. It and the first photo are before and after views by Ron Taylor. They were taken at the firebox door looking toward the front of the locomotive.

The large wishbone shaped images are safety circulators that provide enhanced water circulation in the boiler. The small rectangle at bottom center is the site of the fuel spray nozzle. Above, at the center of the photo, a small portion of the rear flue sheet is visible. The 272 flue tubes between the rear and front flue sheets carry the combustion exhaust through the barrel of the boiler to the stack. The flue tubes transfer more heat to water in the barrel. Those exhaust gases also provide increased heat to the steam via the superheater pipes. A number of the myriad stay-bolts suspending the firebox in the boiler are seen on the walls of the firebox.

The variety of talents among the AT&SF 2926 volunteers does not include masonry—especially the expertise necessary to perform the installation of the firebrick in the locomotive’s huge firebox. That task was done by a team from Winter Masonry. Located in Glyndon Minnesota, Winter does expert masonry work throughout the U.S. Arriving in mid-August, the professional crew went to work. The 2926 crew went into what CMO Rick called a “surge work” to keep the site open and provide support for them.

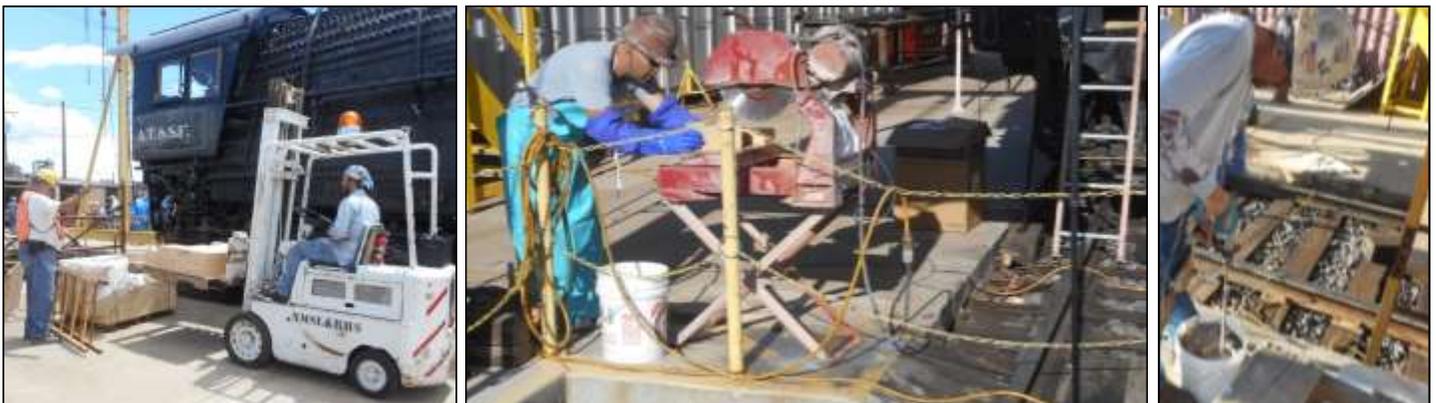
**Above:** In the first photo, Safety Officer Jon spots firebrick that Henry is delivering to work area below the locomotive’s cab. Many of the firebrick had to be cut and shaped to fit. Precision cutting equipment, (second photo) was set up on a platform directly behind the cab. A member of the firebrick team prepares mortar.

**Firebrick Installation:** The 2926 volunteers are accustomed to spending two days per week working at the restoration site. Spending six days per week to support the professionals from Winter Masonry was challenging. But the result was an excellent job of reinstalling firebrick. Though the locomotive firebox is almost large enough to seat six for dinner, the small entry hole at the firebox door might present a problem. The photos below capture some of the action inside and outside the firebox.

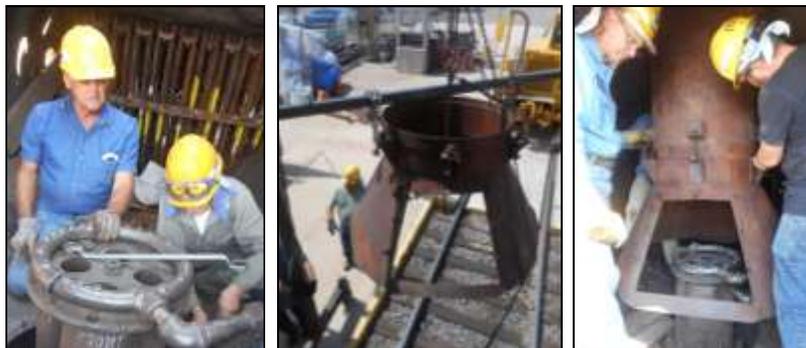
**Above:** In the first photo, the blast pipe is being set into place at the bottom of the firebox. Next (Photos 2 and 3) the petticoat that shrouds the blast pipe is lifted and set in place to receive the stack.

The following photos show just a few of the stack reinstallation steps including related components, two of which are shown below.

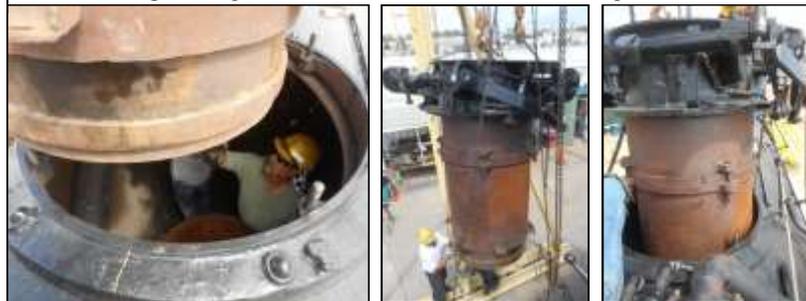
**Below:** The reassembled and tested stack is hoisted above the locomotive, lowered through the top of the smokebox and inserted into the petticoat.

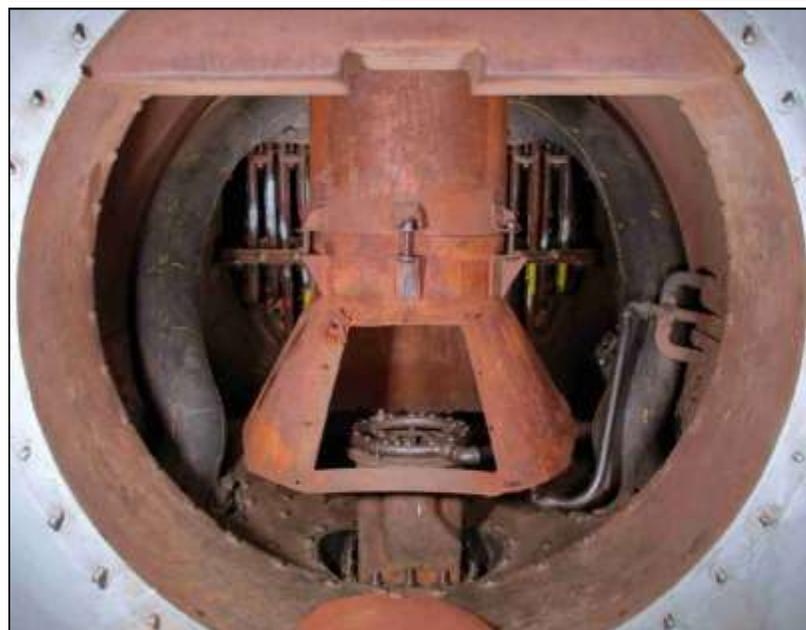
**One Last Look Inside:** From now on, the top of the stack will be easily seen whether extended or not, but this is a last peek inside the smokebox. Ron Taylor shot this picture before the front door was closed and bolted shut.
