# BIG STEAM NEWS

NEW MEXICO STEAM LOCOMOTIVE & RAILROAD HISTORICAL SOCIETY

Vol XV, No.4

## A BUSY END TO A GOOD YEAR AT THE RESTORATION SITE

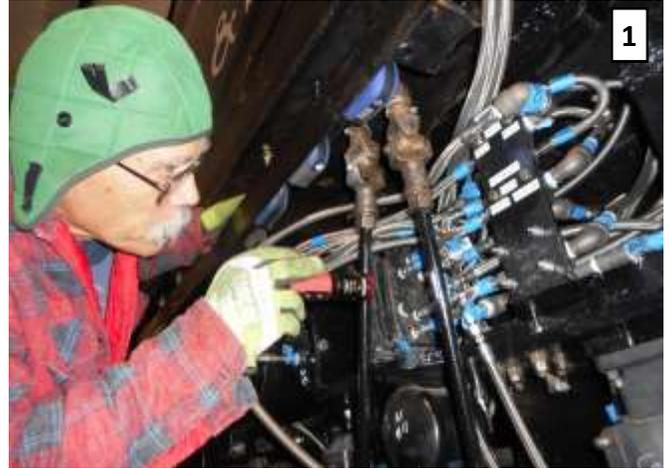
Upgrade of the brake system to current requirements was nearing completion as the year ended. Most mechanical parts and piping hidden beneath the cab were in place. Specialized breakers and other electrical components arrived, and were linked to the installed components. Final connections were labeled as such. In **Photo 1**, Martin Sanchez labels each completed connection with blue labels.

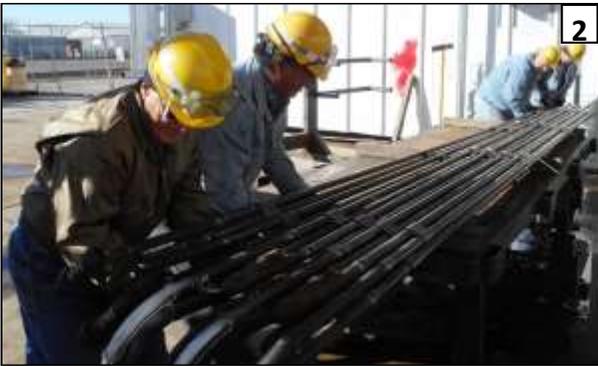
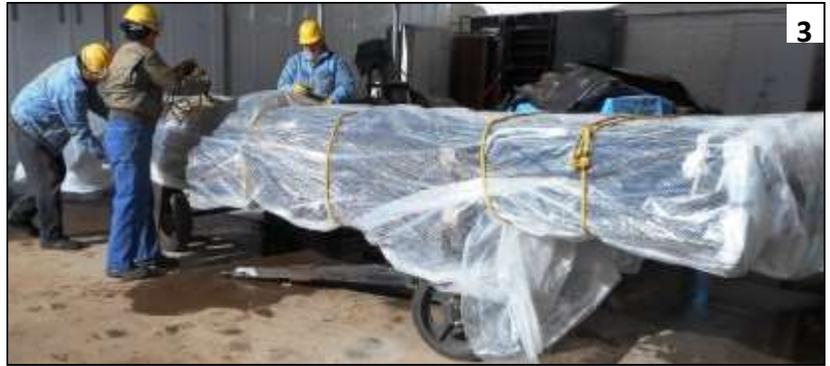
### Superheater Bundle Work (Photos 2,3)

Pressure testing of the superheater pipe bundles is another long running task that is finally nearing completion. This task involved some heavy lifting that provided a lot of exercise—and possibly a few strained muscles and joints—for the volunteers. The routine is: 1) call for volunteers to bring the bundles from storage to the pressure test station; 2) pressure test each, and if necessary repair any leaks, then call for volunteers again; 3) move to a point for temporary storage; and 4) wrap them in plastic for weather protection.

*Note: Carlos and crew did an outstanding job on welding the new superheater pipes to the original headers. The only leak found during testing to date was a weld on one of the headers. That leak dated back to an original weld in the old Santa Fe Shops.*

The wrapped bundles are now resting on a vehicle that is also a piece of rail history. A heavy wagon with a metal bed, it was used to haul parts about the Santa Fe Shops. Lacking the infrastructure—traveling cranes, lifts, etc.—that once existed in the shops, the 2926 restoration team has made use of it on the site. It has served as a parts transport, work bench, and now temporary storage.

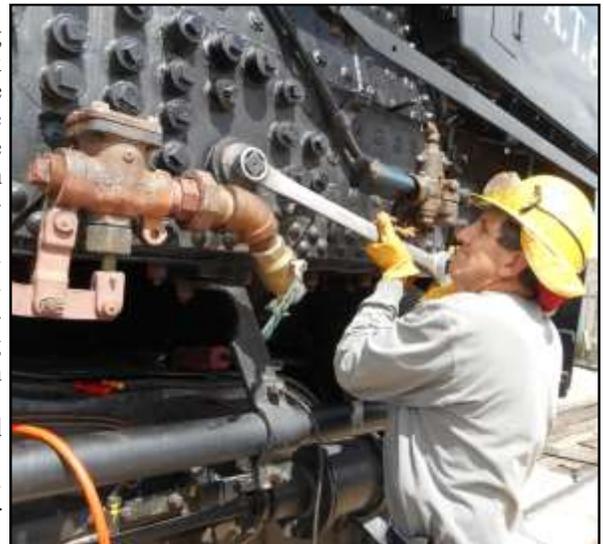
By November, work on the troublesome staybolts and washout plug leaks was coming to an end. While reviewing that overall task, the firebox ultrasound measurements were also reviewed. The review revealed that there were two areas in the firebox that could use further attention. Though above minimum thickness, they were a bit below other ultrasound readings. The team members working on that problem decided to perform build-up welds in those two locations. That work may delay further pressure testing by a couple of weeks, but will contribute to longer boiler life.

On November 8, two trips by a water truck delivered a total of 8000 gallons of water for a non-pressurized leak test. There were not many leaky staybolts and washout plugs, but some of them were in not-so-easy-to-reach places. Others, such as the washout plugs required extreme attention to fitting and torquing. In the picture at right, Pecos Bill applies all the torque he can muster on one of the problem washout plugs.

The water test did reveal one more leak. The water was being transferred to the tender when a small flood occurred underneath the front of the tender. As expected, the source was difficult to reach. Seems a pipe connection behind the radial buffer, and below other components was not connected. After an initial wasted water panic, the pipe was connected—problem solved.

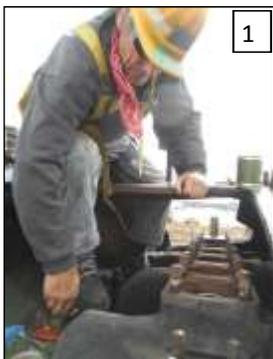
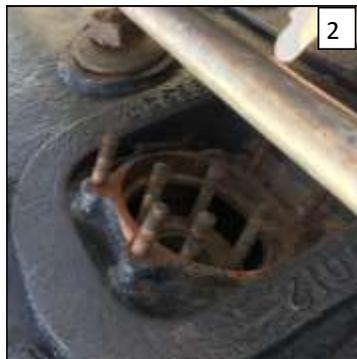
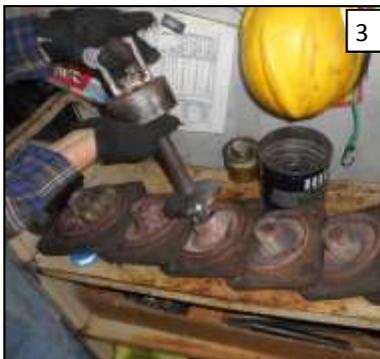
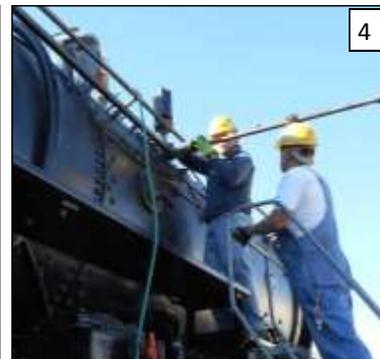
Santa Fe 2926 has a large variety of valves. They range from large drifting “spool” valves and throttle valves pictured below to numerous small valves associated with various functions. All needed careful attention in order to function efficiently and safely when the locomotive begins operation. There were multiple checks and measurements to ensure accuracy. Photos 1,2,3 below are three different views of the throttle valve system atop the front of the locomotive. The rust and corrosion is typical of virtually all the valves on 2926. With the throttle valve system, some of the smaller parts could be taken to a workbench for removal of surface corrosion, but cleaning the throttle manifold, and bolts, as well as lapping the seats had to be done in place. In the fourth picture, the throttle valve control rod also needed work and is being checked for proper fit.

Lapping the valve seats required additional tasks. The lapping also called for design and fabrication of special tools to hold the valves steady and maintain alignment while lapping. Picture 5 shows the lapping guide being built in the machine shop. In picture 6, the guide is being placed on the studs to begin lapping that seat.

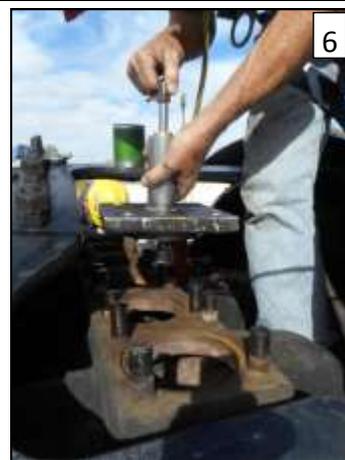
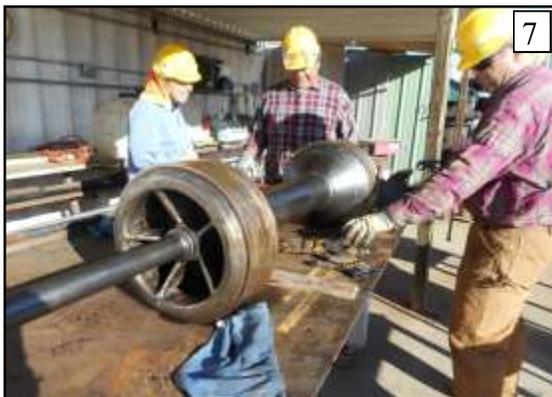
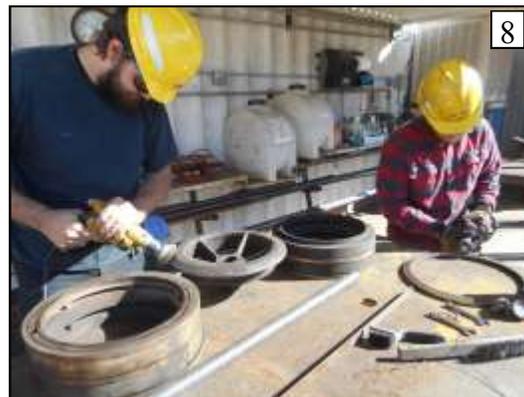
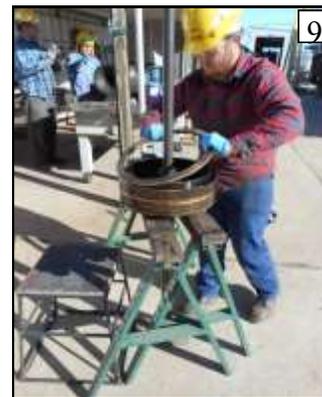
The throttle and drifting valves were quite probably the most difficult tasks. In the case of the drifting valves, the work included heavy lifting, disassembly, lots of scraping and buffing, and reassembly. The photos below (7,8,9) give a brief look at the process involved with one drifting valve.

With a bit of grunt work, the spool is placed on a work table, (Photo 7). Volunteers are clean, buff and inspect all parts (Photo 8) before reassembly, (Photo 9). With a bit more heavy lifting,—the ready-to-install spools are wrapped in plastic and placed in storage, (Photo 10).

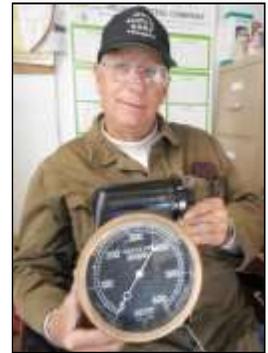
One gauge task involved the much traveled dual sided boiler pressure gauge that was described in this newsletter a year ago. It was finally fully assembled, calibrated, and ready to mount in its place in the cab.

In rebuilding the gauge, assistance came from individuals and organizations in several states. But back at the restoration site, brackets still had to be fabricated to mount it in the cab. In the picture at right, Rick Kirby is all smiles as he holds the fully assembled, ready-to-mount dual sided gauge.

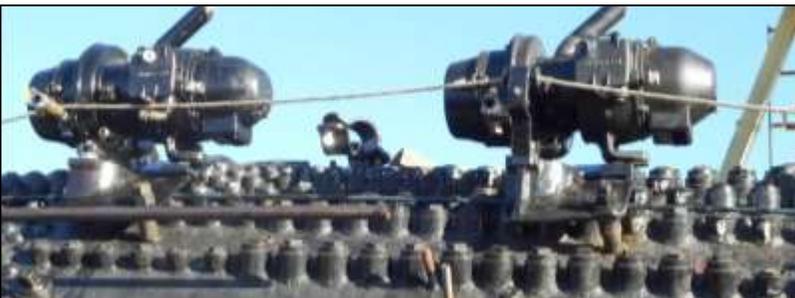
As the year drew to an end, two fully restored dynamos were hoisted to the top of the locomotive. The photo of the dynamos in place leads into another task that is just getting underway. That is the sheet metal jacking that will certainly change the appearance of the locomotive. The jacking will cover the all of the staybolts pictured beneath the dynamos, as well as a lot of piping and related fixtures. Most of the original jacking is severely rusted and not useable, but it has been kept for patterns, and a sheet metal fabricator is producing new jacking.

Above are the two dynamos that will provide electrical power when operating. At right is a photo of recently fabricated jacking. Some trimming and tailoring was necessary to fit the new jacking over the steam chest.

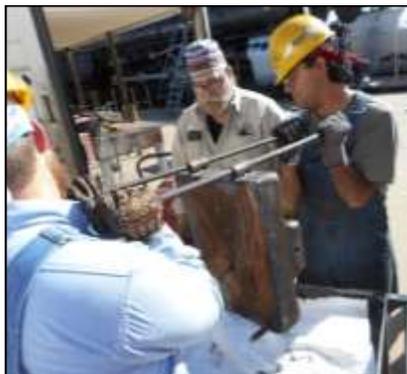
The previously mentioned radial buffer task involved a bit of innovation to facilitate lifting. The innovation is pictured in the first photo at right. Metal loops were welded to the edge of the buffer plate to make it easier to move. In the photo, Anthony and Henry lift the plate as Carlos watches.

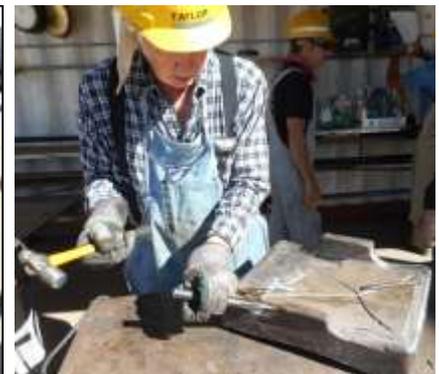
Then was hammer and chisel work to remove the old brass facing on the buffer plate. In the second photo, Ron removes the old worn and scarred face plate. The new brass face was then replaced.

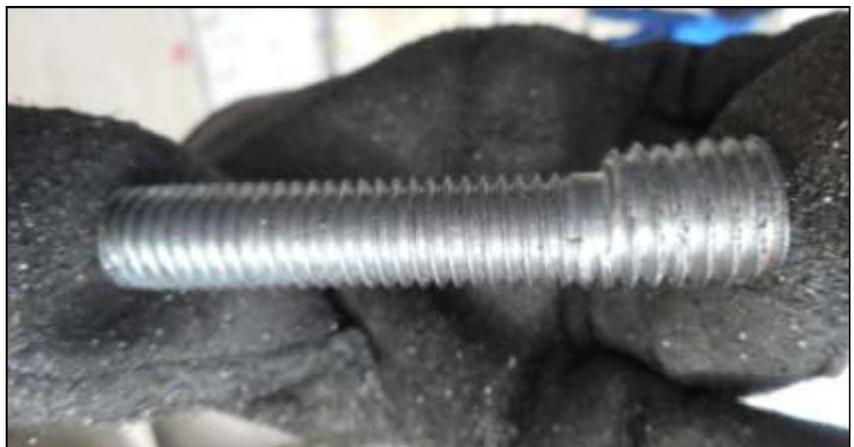
One other task, the result of which is pictured at right, demonstrates two things. One: Restoration of last century equipment that has experienced exposure and decay will mean that problems encountered cannot be solved by calling the parts room. Two: The all volunteer Santa Fe 2926 restoration crew is quite capable of solving such problems, often without having to call for outside help.

The doubled threaded stud shown was the response to such a problem. Bolt threads on the steam chest slide valve were in very bad shape. The workers drilled and re-tapped the hole for a larger bolt.

Then machinist John M. went to work and fabricated bolts with two diameters to match the original holes in the cylinder head.
