# **Inspection Report**

**Property Address:**  
1234 W Paradise Lane  
Chandler AZ 11111

**John Owens InterNACHI Certified Master Inspector, AZ License #62984**  
4939 W Ray Rd Ste 4  
PO Box #362

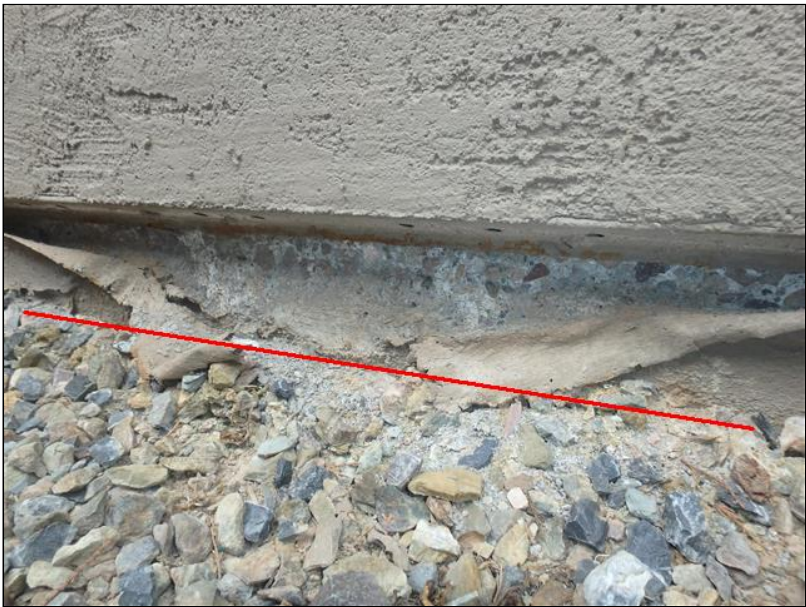
1.0 Item 1(Picture)

There is evidence of water penetration into the foundation on the left side of the house. This is likely due to too much irrigation water in the adjacent planter beds. The excess water wicks into the concrete and through hydrostatic pressure pushes to the surface. As the water evaporates it pushes the paint off the concrete and leaves a mineral residue which will eventually de-grade the concrete. You can remedy this condition by reducing the irrigation to the adjacent planter beds, let the concrete dry, scrape off the loose material and re-paint.

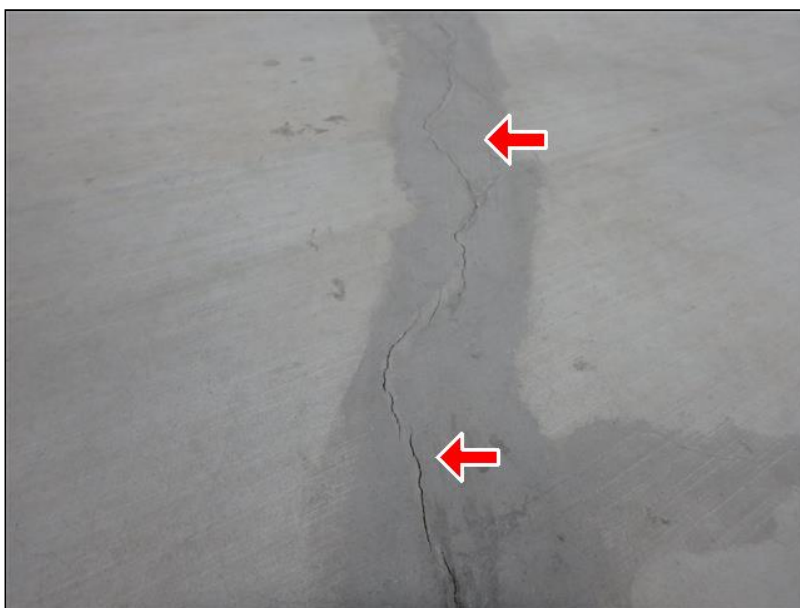
1.1 Item 1(Picture)

There is evidence of movement in the left rear of the garage. I recommend sealing of the crack by a licensed contractor and monitoring it for further movement with further repair as necessary.

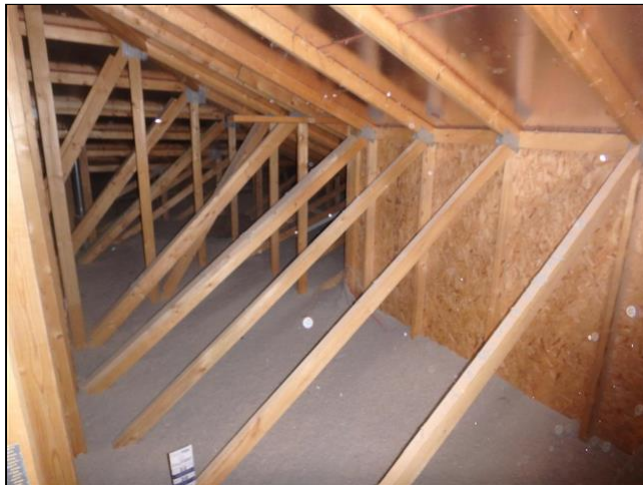
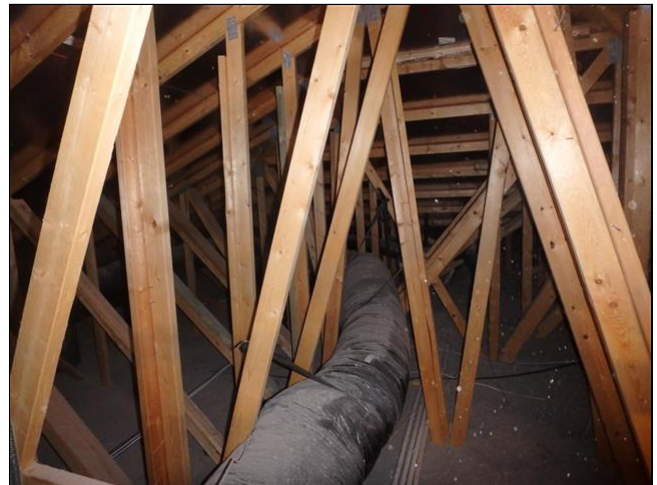
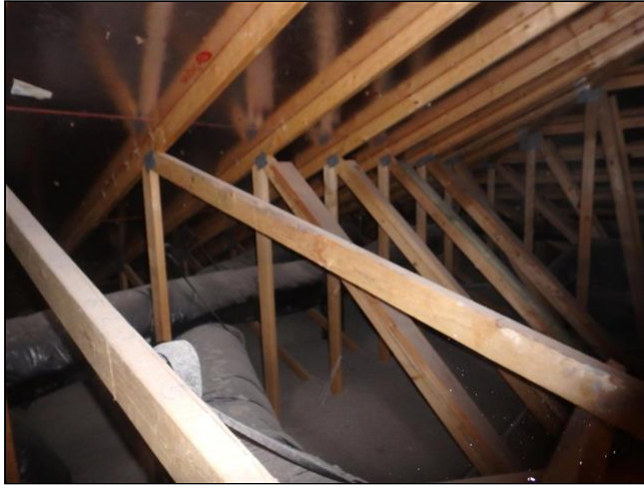
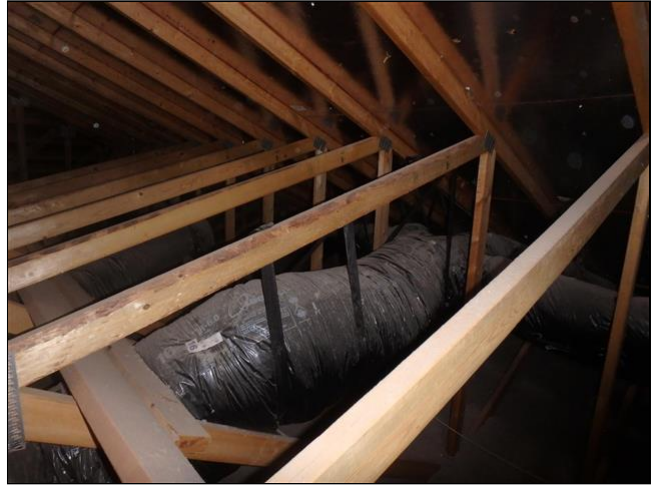
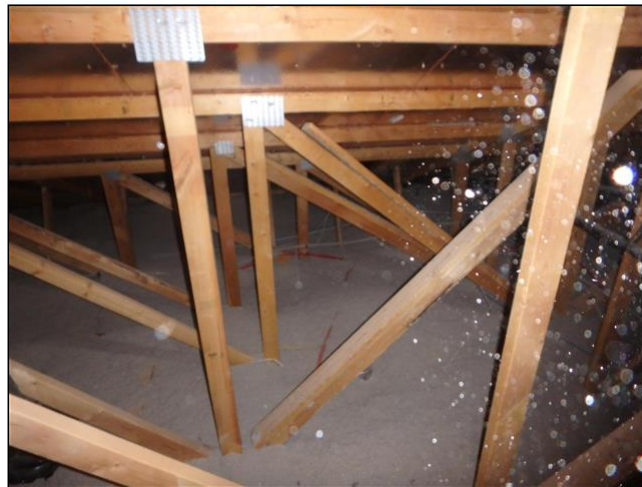
The visible portions of the roof and ceiling structure are in satisfactory condition.

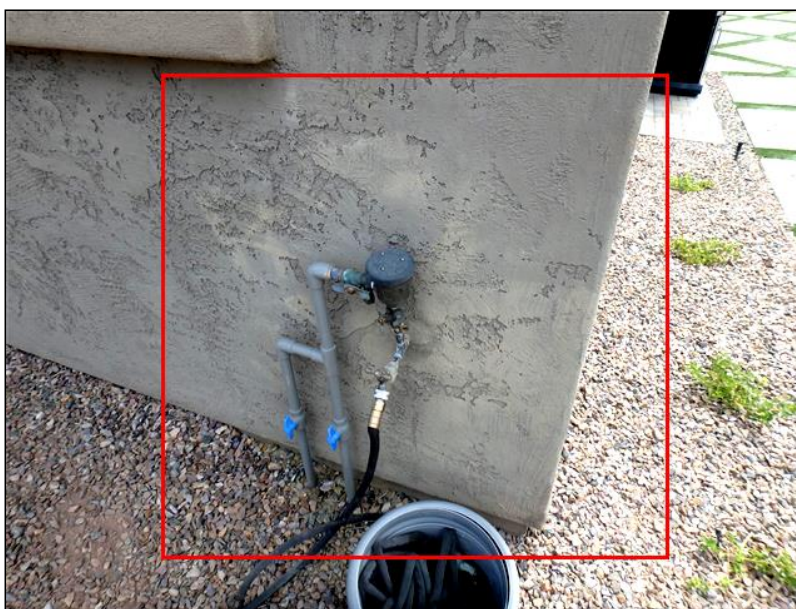
2.0 Item 1(Picture)

(1) The exterior paint is beginning to fade on the rear, budget for exterior re-paint in the future.

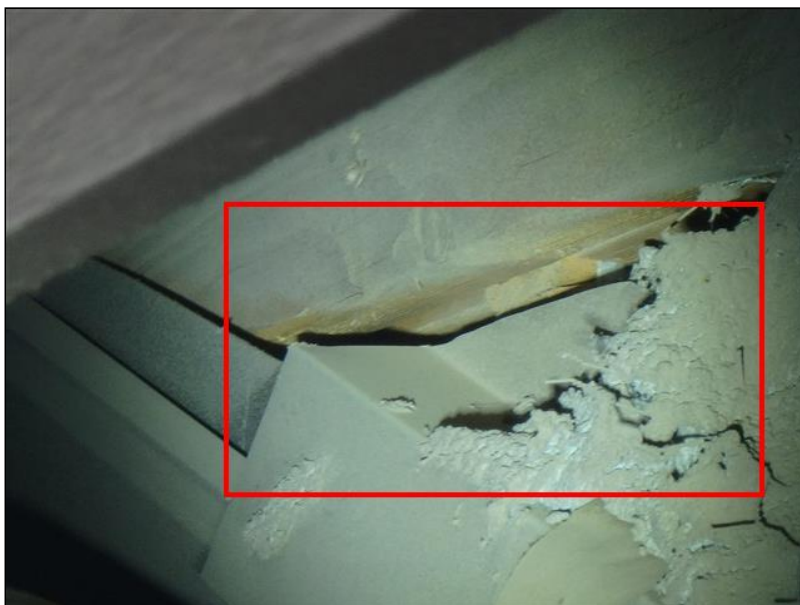
2.0 Item 2(Picture)

(2) The stucco is unfinished at the left and right side of the dining room roof. I recommend professional sealing to prevent pest intrusion.

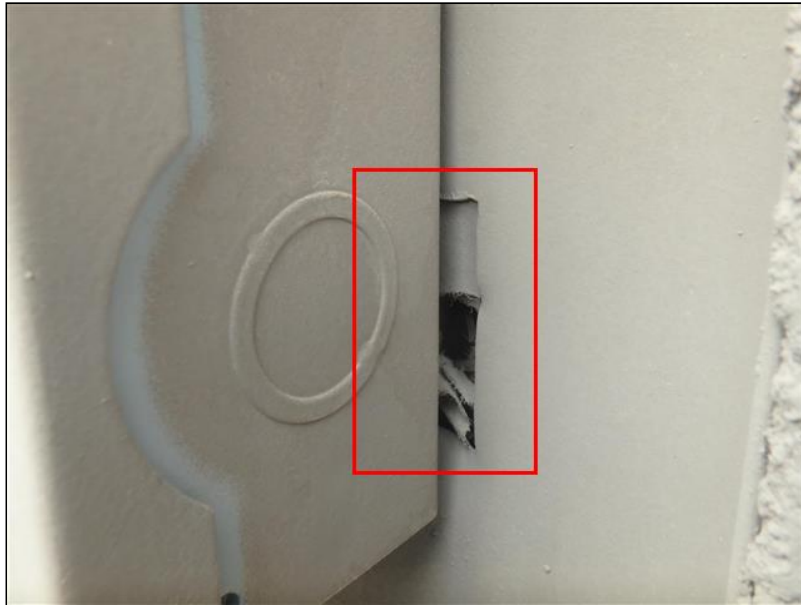
(3) Seal all exterior penetrations to prevent water and pest intrusion.

2.0 Item 6(Picture) Left side condenser disconnect

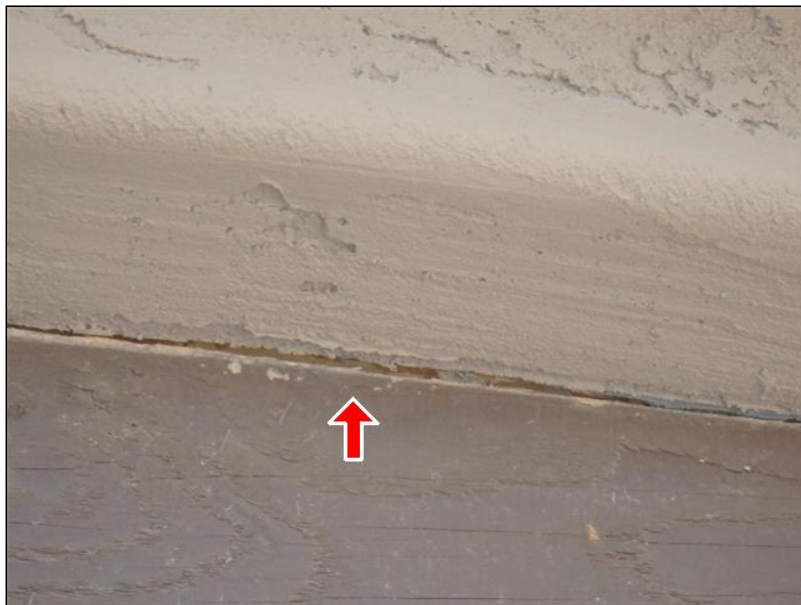
2.0 Item 7(Picture) Front garage

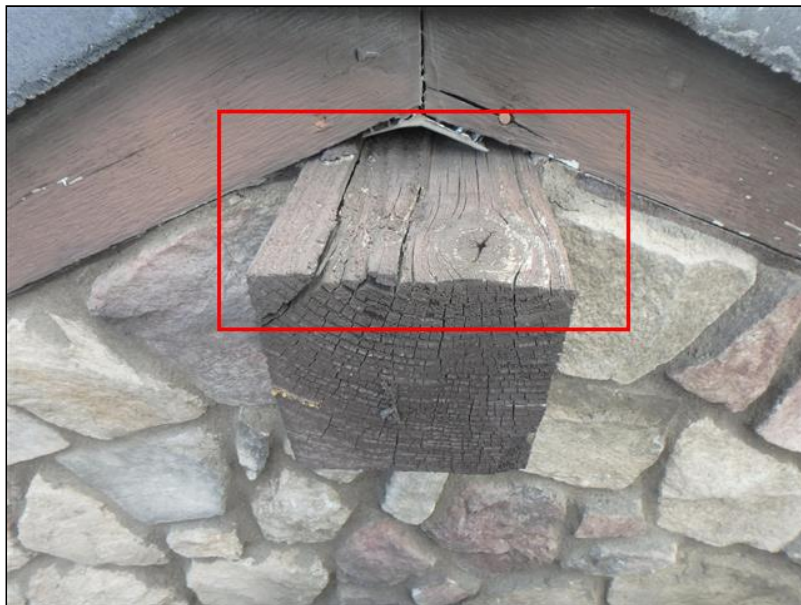
2.1 Item 1(Picture)

- (1) Overall, the visible portions of the flashing and trim are in satisfactory condition.
- (2) The tops of the faux beams are exposed, Consider the installation of full width cap flashing to prevent weathering.

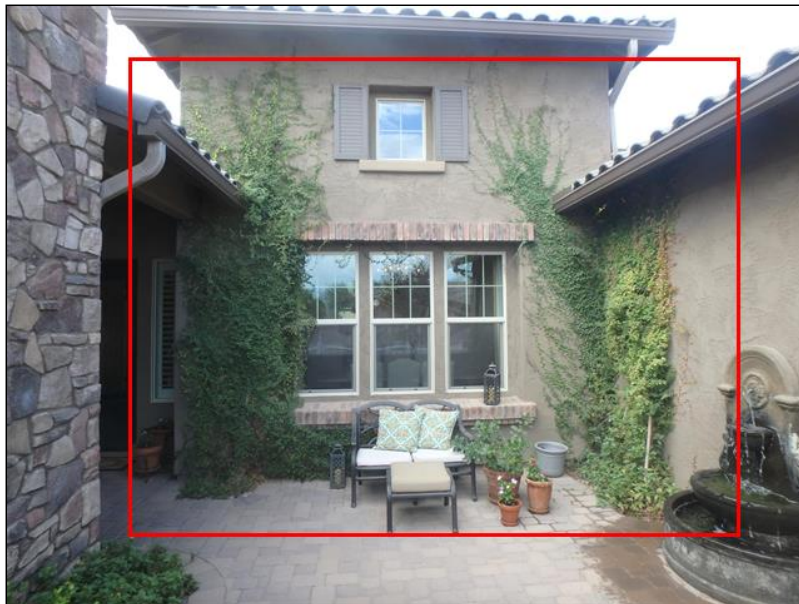
2.8 Item 1(Picture)

Tree limbs/vegetation in contact with the exterior and roof can cause damage and provide access for rodents. Trim as needed to prevent damage.

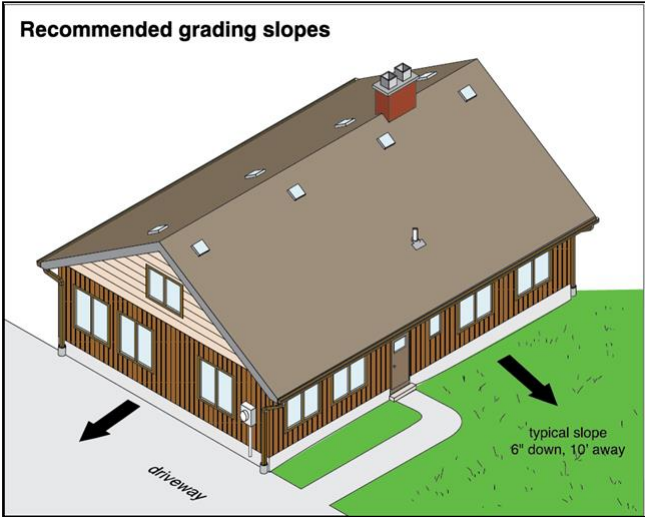
2.9 Item 1(Picture)

(1) The grade is sloped toward the house on the right rear. This will direct surface water into the soil adjacent to the foundation and cause water damage to the foundation concrete. Adjust the grade to direct surface water away from the foundation to prevent water damage.

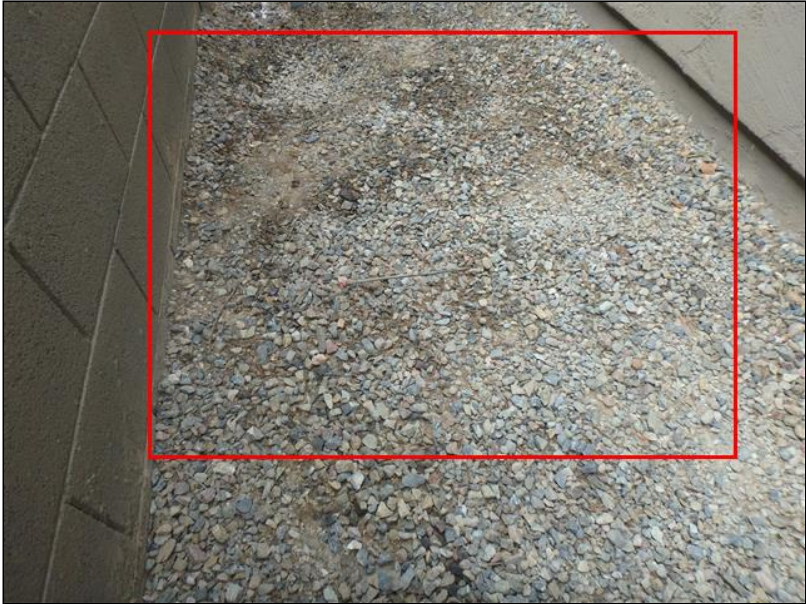
2.9 Item 3(Picture)

(2) There is excessive moisture in the soil on the left side. This is condition is conducive to water damage and encourages termite activity. Reduce the irrigation to the affected areas and adjust the grade as needed to direct water away from the foundation to prevent water damage.

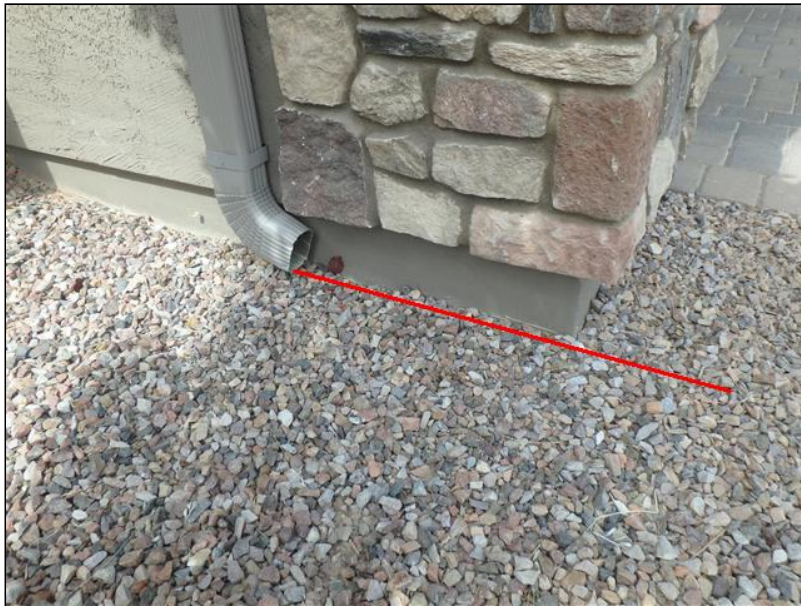
2.9 Item 4(Picture)

(3) I recommend extending the gutter downspouts so that they drain away from the foundation.

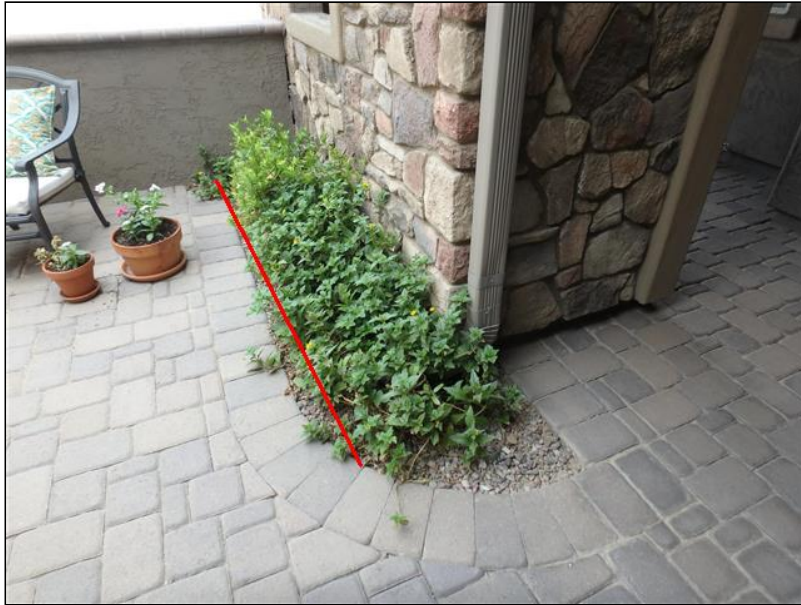
2.9 Item 6(Picture)

(4) Planters hold moisture in the soil adjacent to the foundation. This condition is conducive to water damage to the foundation concrete and encourages termite activity. Keep the planters as dry as possible, provide drainage, or remove them to prevent water damage.

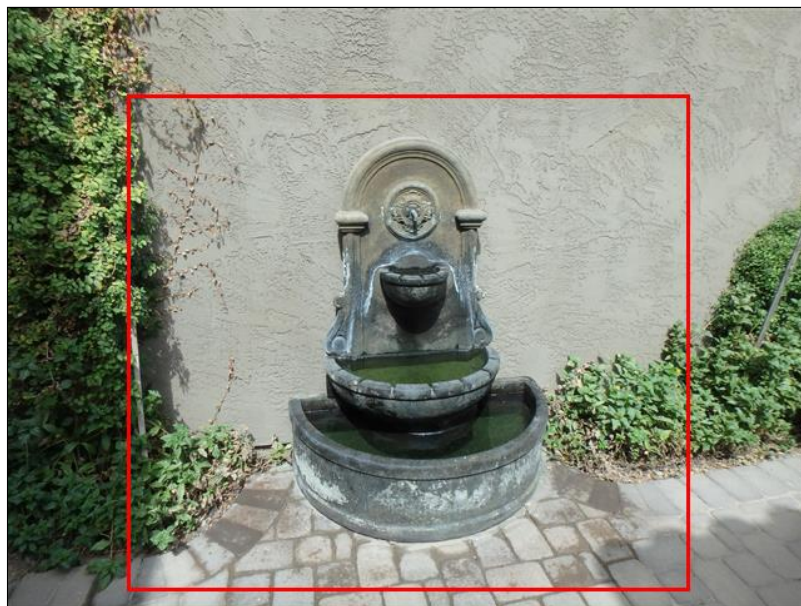
2.12 Item 1(Picture)

(1) I recommend moving the fountain to a more suitable location to prevent water from splashing on the stucco and foundation.

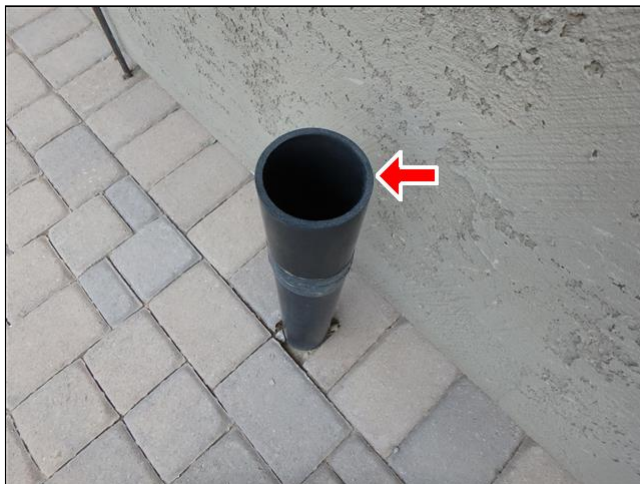
2.12 Item 2(Picture)

(2) There is an exposed ABS pipe on the right side of the garage, I recommend further evaluation to identify if this is part of the french drain system or a drain line hook up for an RV. I recommend capping the line to prevent water and pest intrusion.

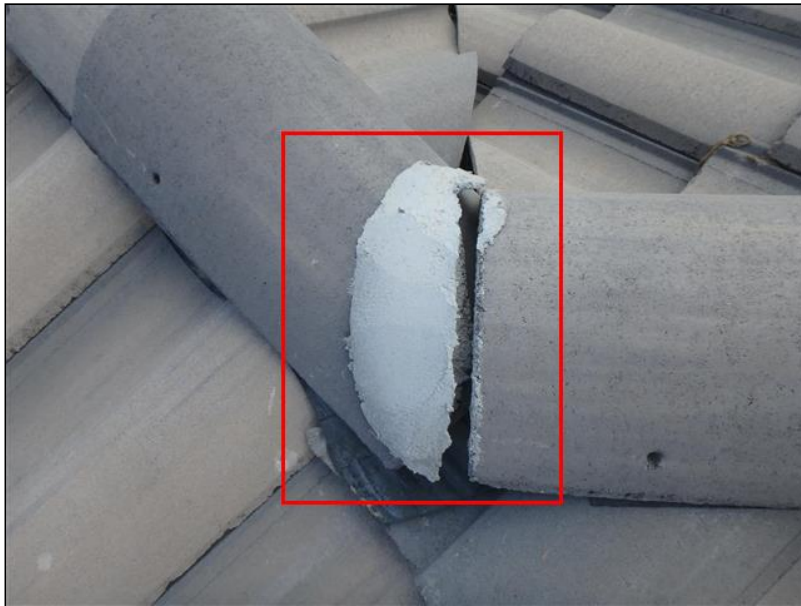
3.0 Item 17(Picture)

(2) Routine maintenance required to repair cracked tiles, secure slipped tiles, and repair cracked mudballs.

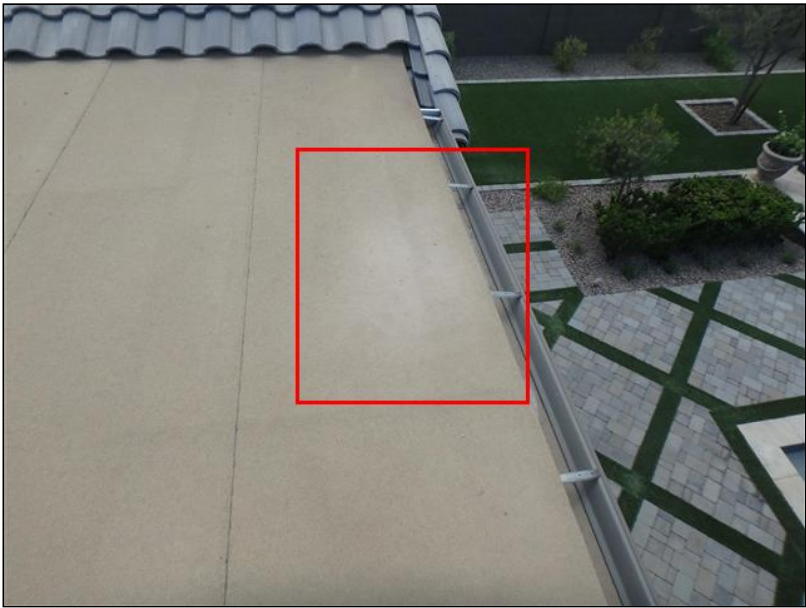
3.1 Item 1(Picture)

(2) There is evidence of ponding water on the rear patio roof, adjust as needed to prevent damage to the finish and leakage.

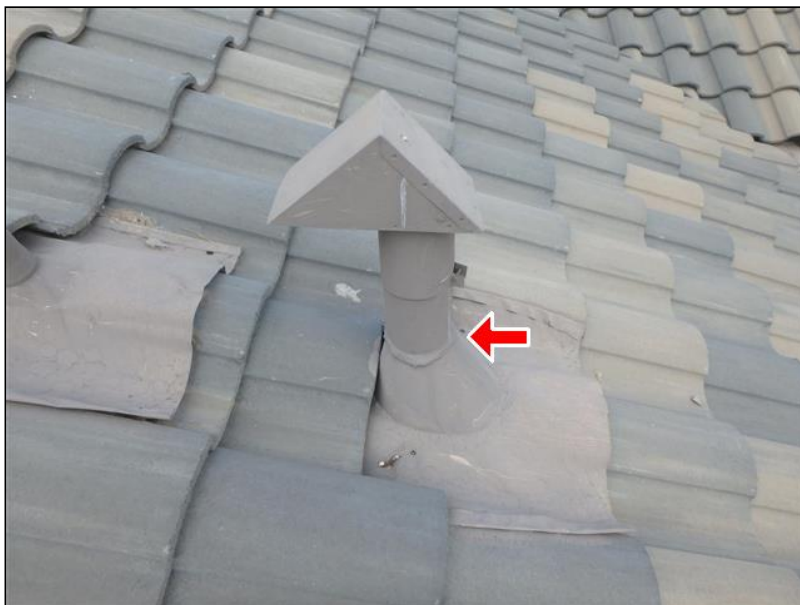
3.2 Item 3(Picture)

**Comments:** Inspected  
Add a storm collar to the two piece water heater and dryer vents to prevent leakage between the vent and primary flashing.

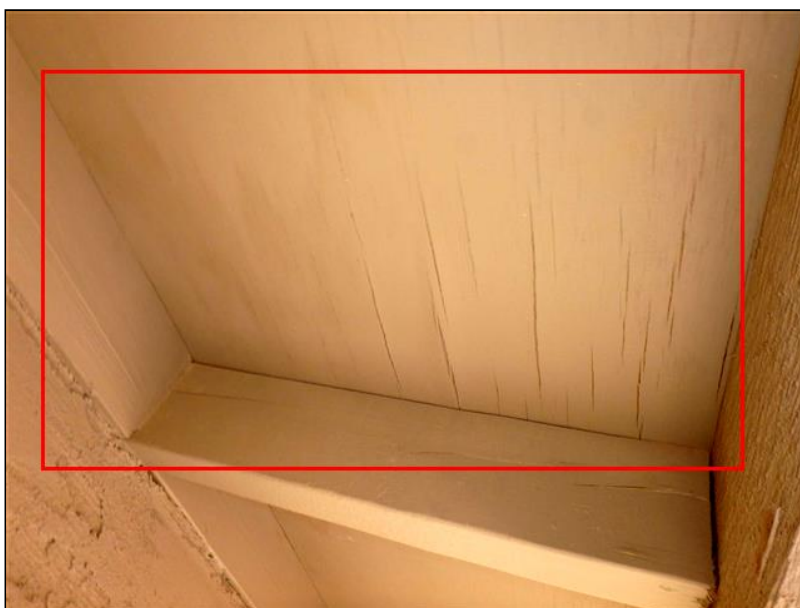
3.3 Item 1(Picture)

There are signs of leakage (water stains) at the eaves on all sides and minor water damage at the left rear eave over the condensers (Item 1). I recommend professional evaluation and repair as necessary.

I recommend further professional evaluation of the roof by a licensed roofer with repair as necessary.

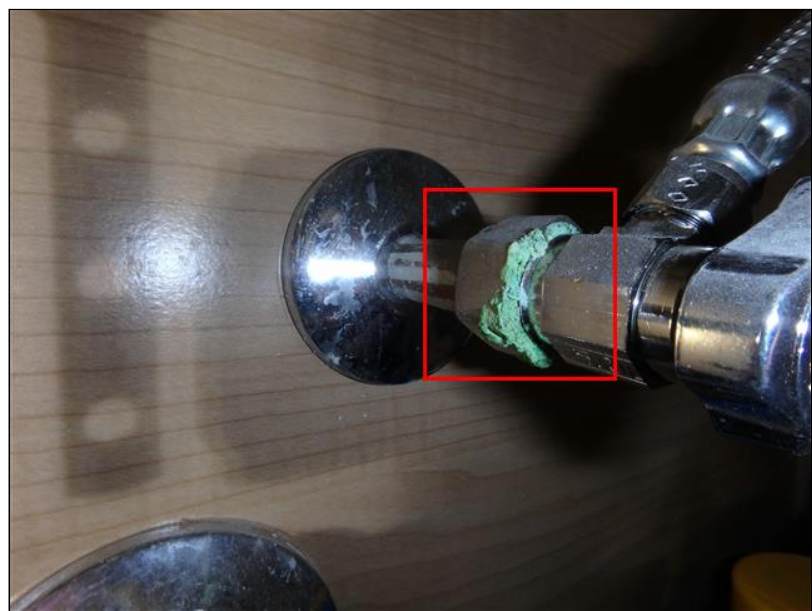
4.3 Item 1(Picture)

**Comments:** Inspected  
(1) Overall, the fixtures and faucets are in satisfactory condition and operational.  
(2) There is evidence of leakage at the front left guest suite and master bathroom sink supply valves. I recommend professional repair/replacement to prevent further leakage.

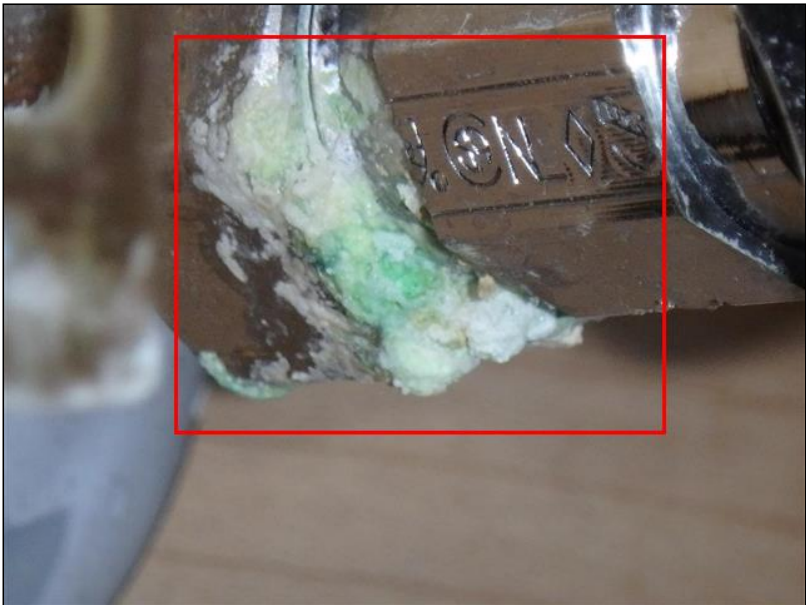
4.3 Item 3(Picture)

(3) The front left guest suite bathroom sink stop is inoperable. Repair or replace as needed.

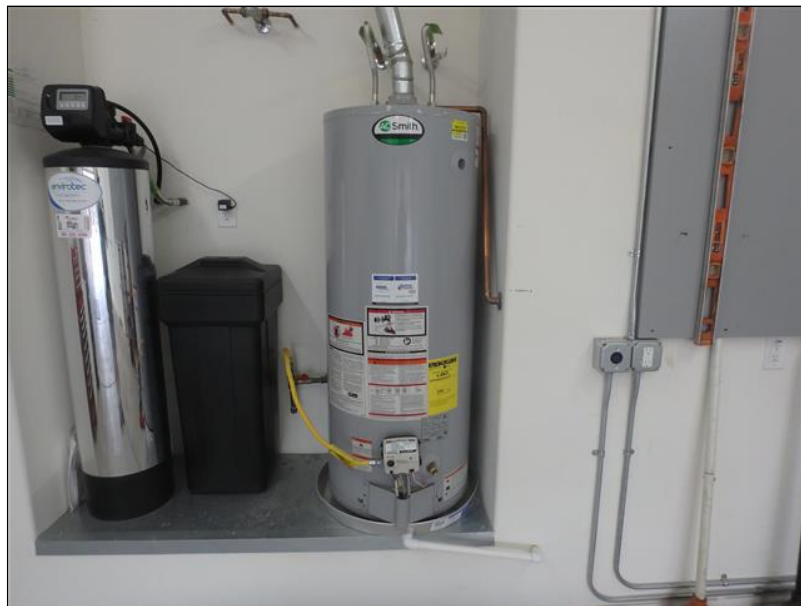
4.10 Item 1(Picture) 2015 model 50 gal

- (1) Overall, the water heater is in satisfactory condition and operational.

(2) There are leaks in the cold water supply valve body. I recommend replacement with a ball valve by a licensed plumber.

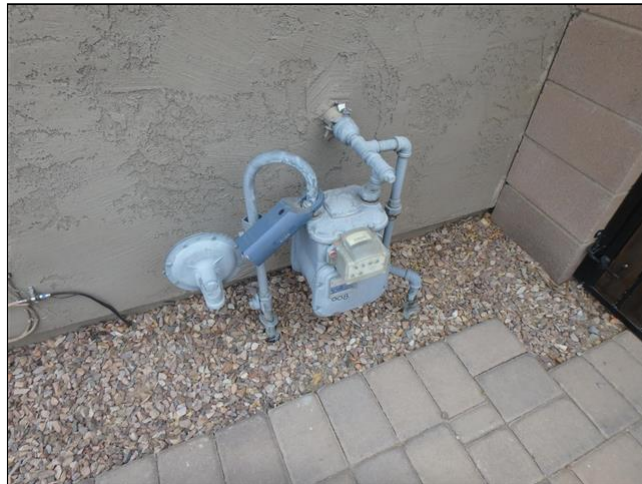
4.17 Item 1(Picture)

Located on the right side of the house.

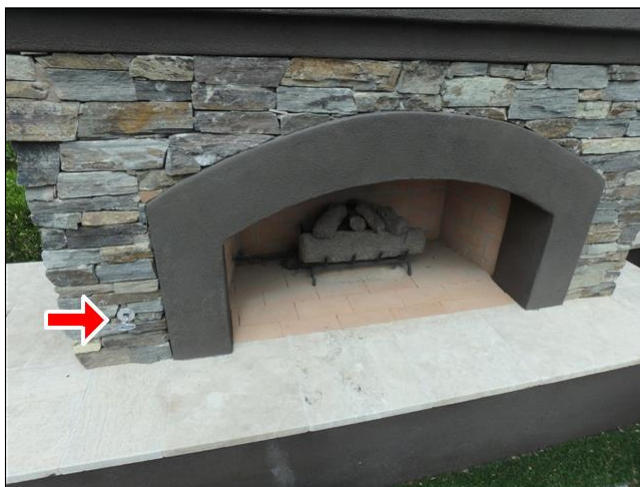
4.18 Item 1(Picture)

(1) All gas appliance valves were located.

(2) The exterior gas fireplace was not tested (requires open flame). Ask the current owner to demonstrate operation to your satisfaction.

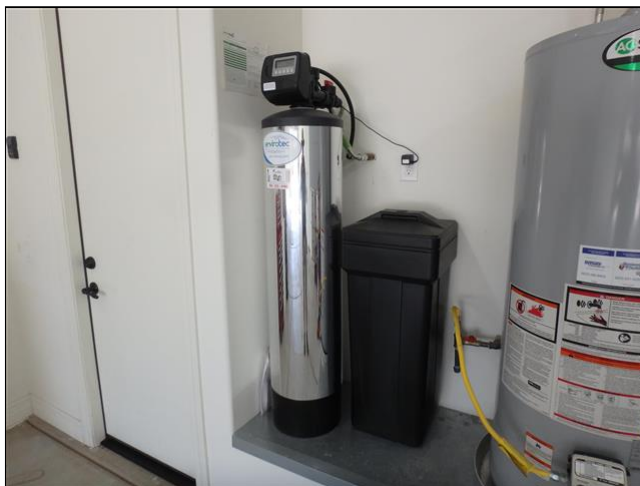
4.19 Item 1(Picture)

The performance characteristics of the water treatment system were not evaluated. If the performance of this system is a material factor of your purchase, I recommend professional evaluation during your inspection period, with service and repair as needed.

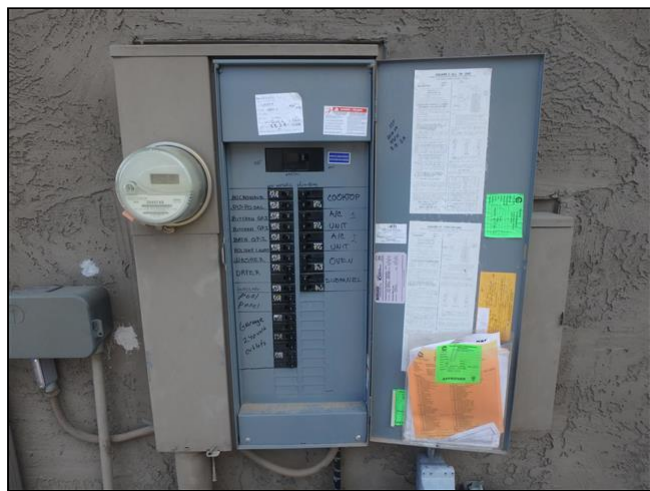
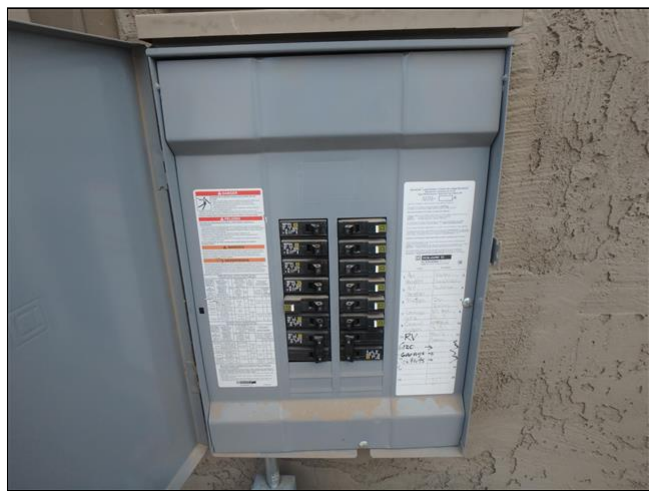
5.0 Item 1(Picture)

**Comments:** Inspected  
The main disconnect and distribution panels are located on the right side of the house.

The main and distribution panels are in satisfactory condition.

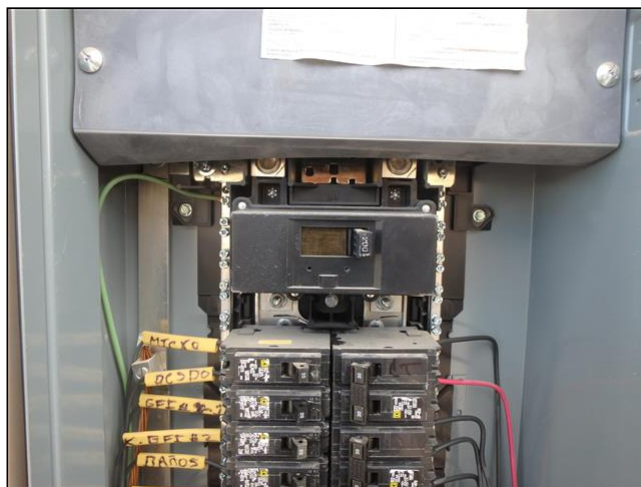
5.1 Item 1(Picture)

The visible portion of the electric service conductor and main overcurrent protection device are in satisfactory condition.

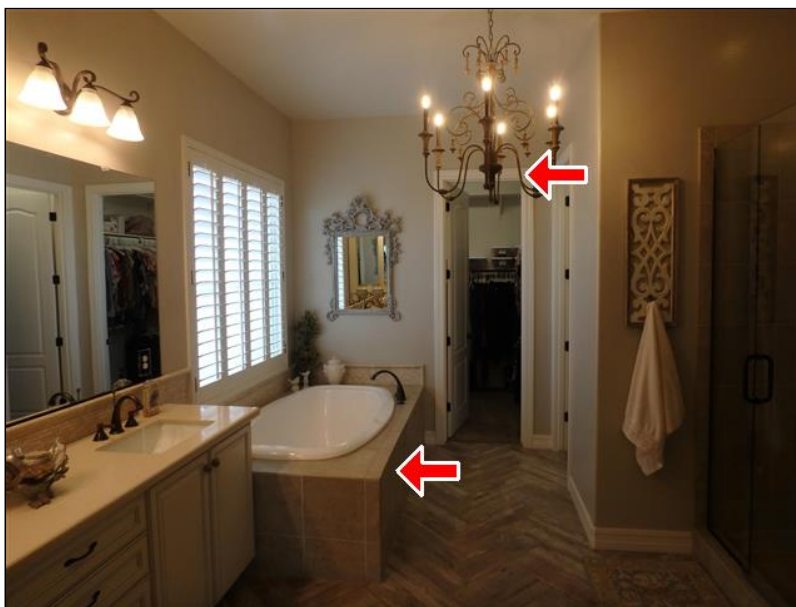
5.6 Item 1(Picture)

(2) Ceiling fans and pendant light fixtures are not allowed within 8 feet above or within 3 feet to the side of tub or shower thresholds. The pendant light over the master tub is within 8 feet of the top and 3 feet of the sides of the tub. I recommend a licensed electrician evaluate and remedy as needed.

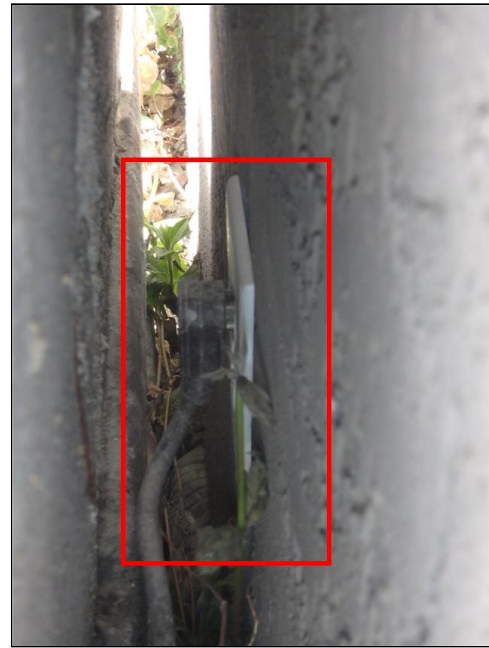
5.7 Item 2(Picture)

- (1) A representative number of receptacles were tested for polarity and ground and found to be operational and in satisfactory condition.
- (2) There is an interior grade outlet behind the fountain. I recommend replacement with an exterior grade covered outlet. I recommend the installation of GFCI protection at this outlet to prevent hazard.

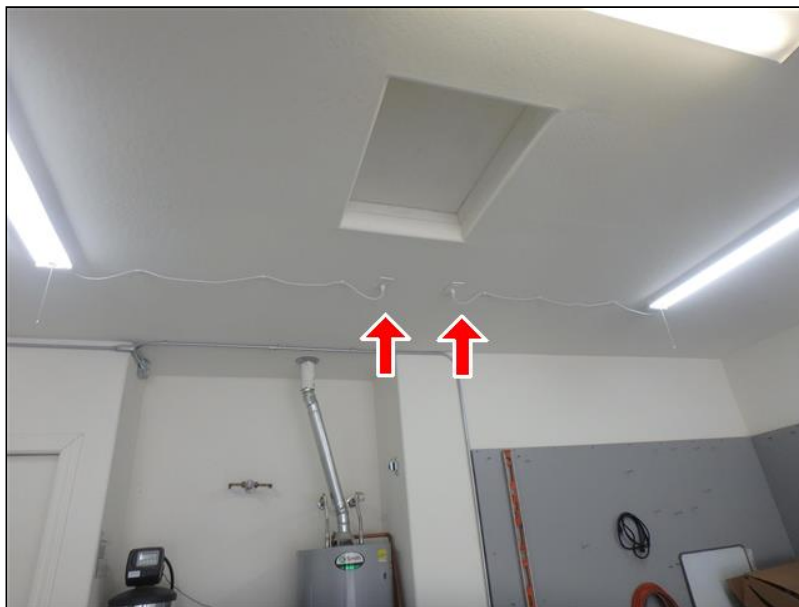
5.8 Item 1(Picture)

- (1) All existing GFCI protected outlets function as intended.
- (2) I recommend the installation of GFCI protection at the rear garage ceiling outlets.

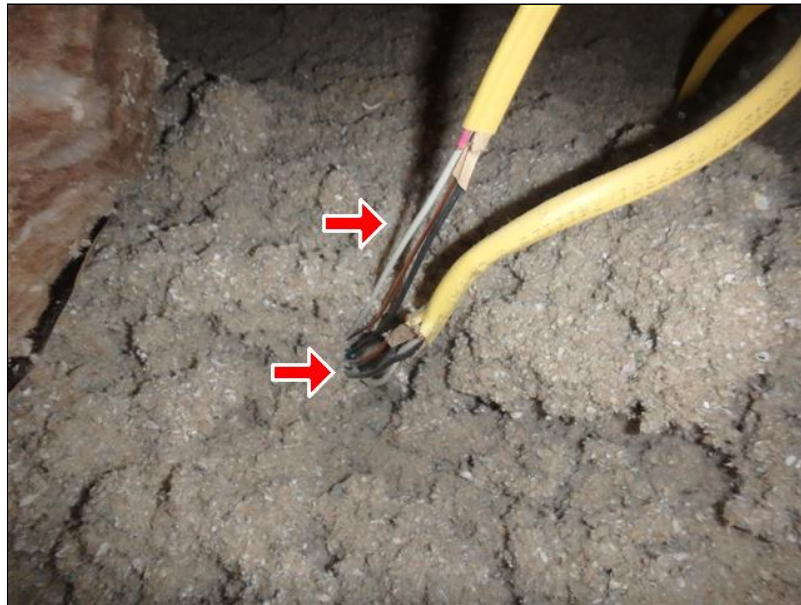
5.10 Item 1(Picture)

(1) The sheathing has been removed from the conductor running to the rear garage ceiling outlets, I recommend repair by a licensed electrician.

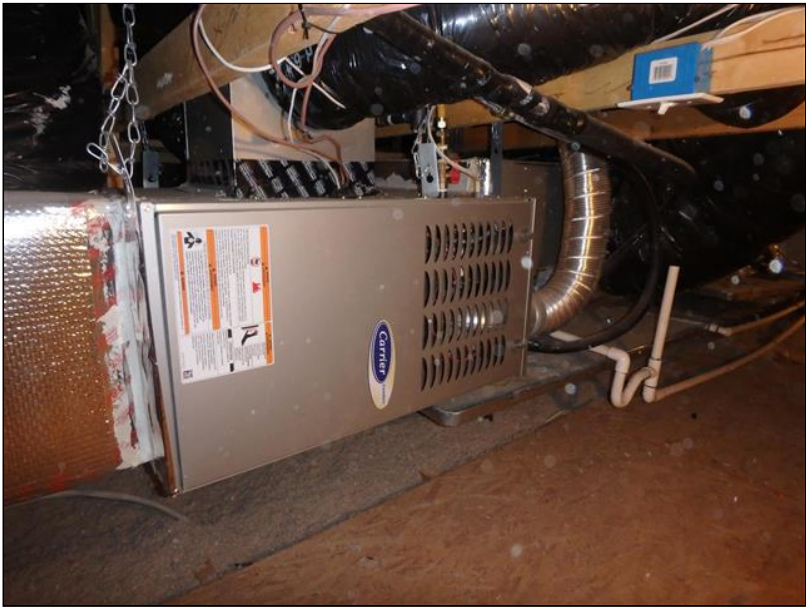
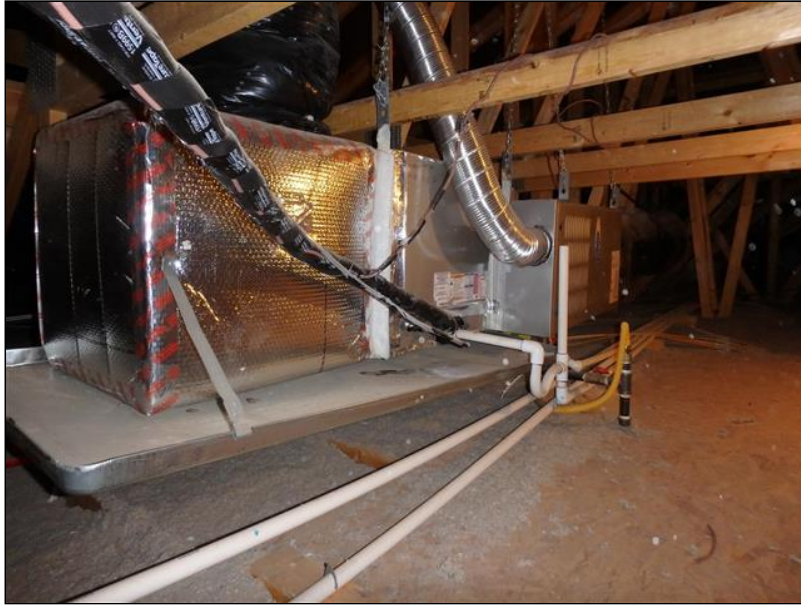
6.0 Item 1(Picture)

Comments: Inspected  
The heating equipment is in satisfactory condition and operational.

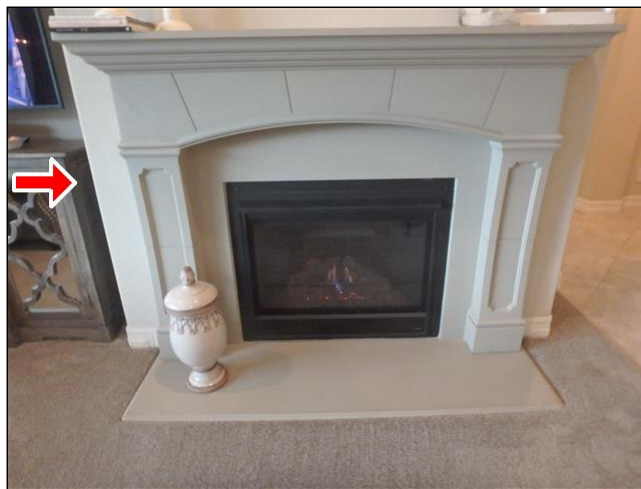
6.3 Item 1(Picture)

None present. The switch operated gas fireplace is in satisfactory condition and operational.

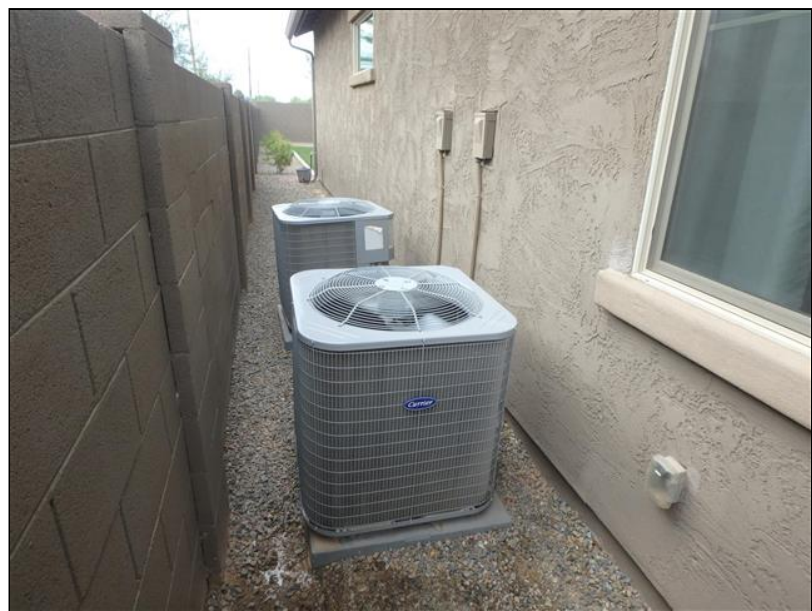
**Comments:** Inspected  
The visible portions of the cooling equipment are in satisfactory condition and operational.

7.0 Item 1(Picture) 2015 models, 3 ton each

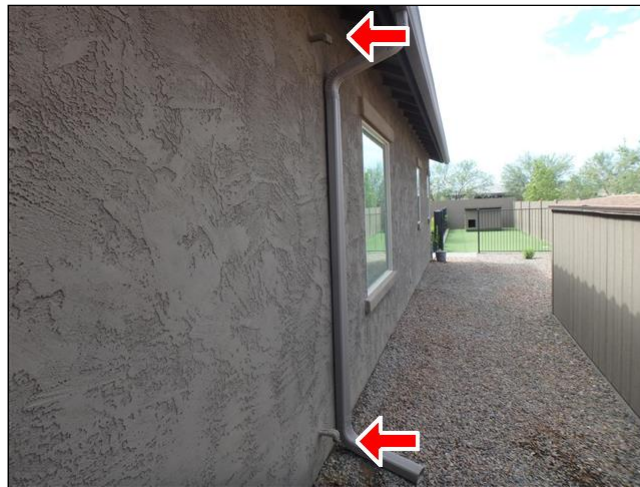
7.8 Item 1(Picture)

The primary and secondary drains are visible.

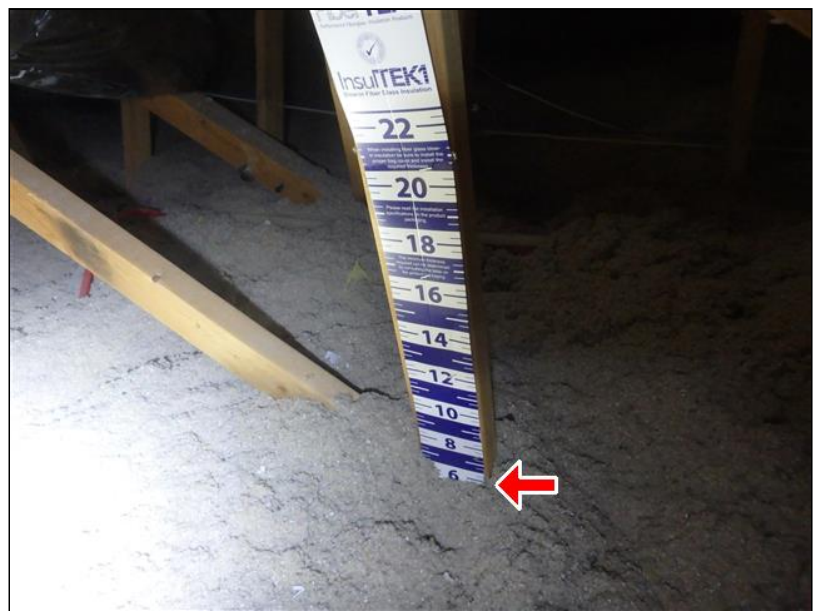
9.0 Item 1(Picture)

- Comments: Inspected
- (1) Overall, the visible insulation is in satisfactory condition. Attic visibility is limited, portions of the attic are not visible from the attic access.
  - (2) The attic insulation is thin over the guest bedrooms. Consider additional insulation as needed.

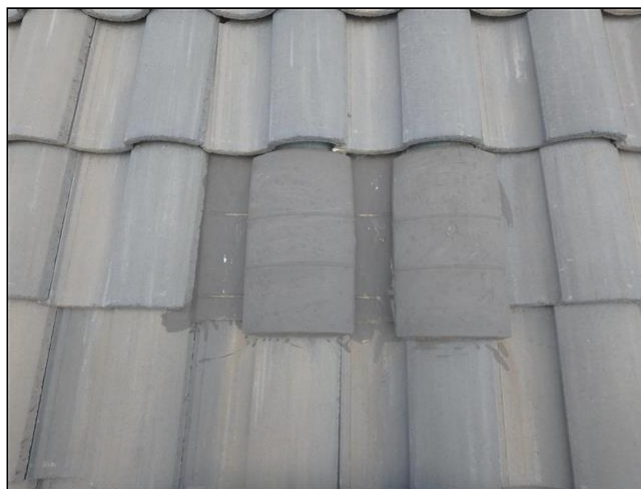
The visible portions of the attic ventilation are in satisfactory condition.

9.2 Item 1(Picture) Ohagen vents.

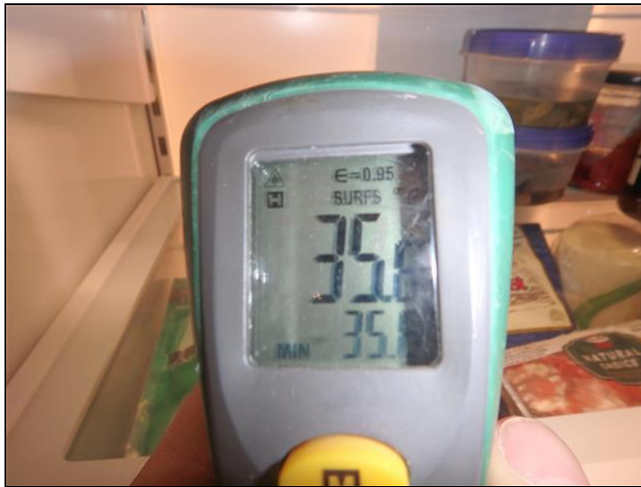
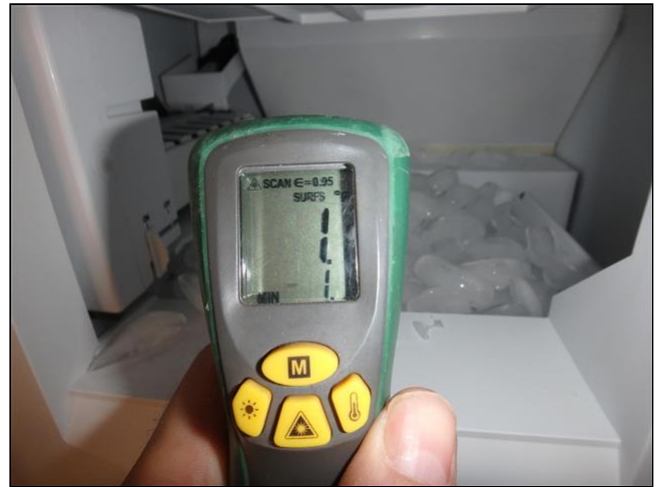
10.5 Item 1(Picture)

The built in refrigerator and freezer are satisfactory condition and operational.

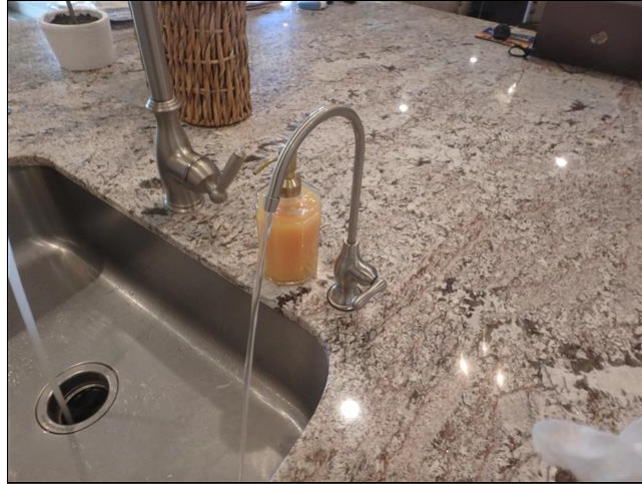
10.8 Item 1(Picture)

The reverse osmosis system is operational.

Reverse osmosis systems are prone to leakage and cause water damage to sink base cabinets. Monitor for leakage and repair as necessary.

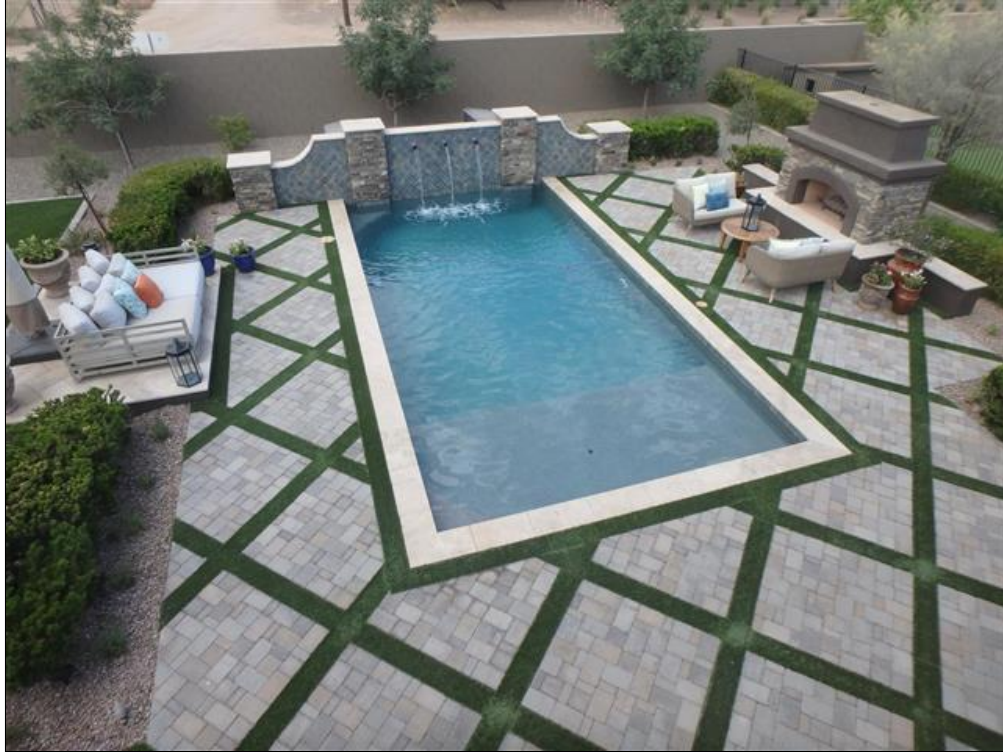
11.0 Item 1(Picture)

In ground.

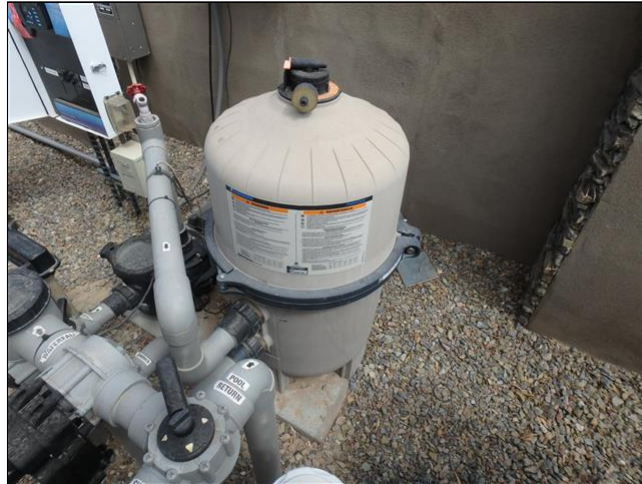
11.3 Item 1(Picture)

(1) Cartridge.

Overall, the filter is in satisfactory condition.

(2) The filter pressure gauge is not visible, I recommend professional replacement.

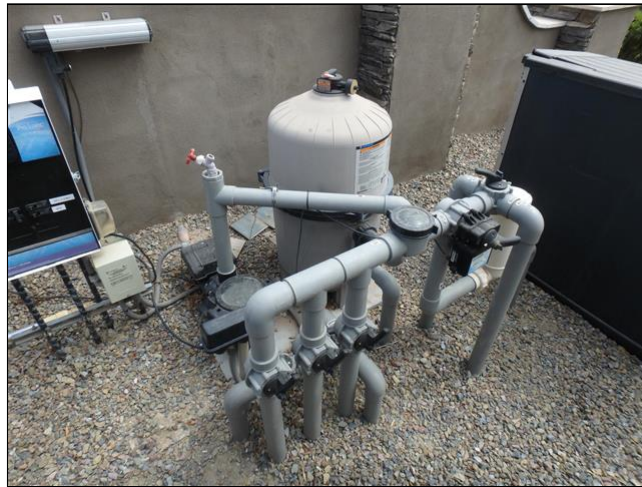
11.5 Item 1(Picture)

(1) Overall, the pool equipment is in satisfactory condition.

(2) The water level is low, I recommend professional adjustment of the auto fill valve so that the water line is halfway up the perimeter tiles.

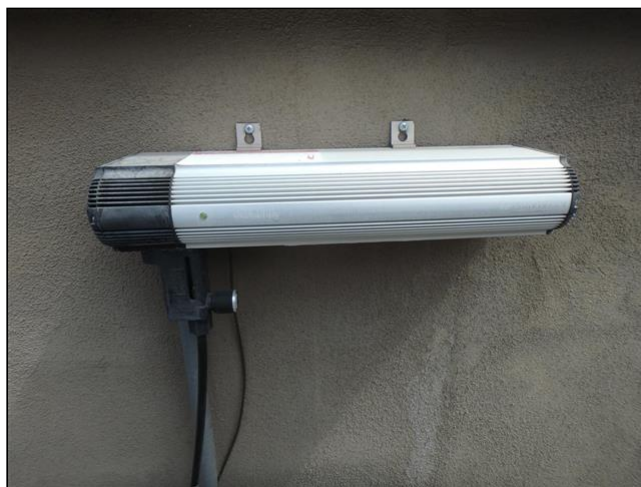
11.13 Item 1(Picture)

**Comments:** Inspected  
Satisfactory condition.
