# **Inspection Report**

**Property Address:**  
1234 W Paradise Lane  
Chandler AZ 11111

**John Owens InterNACHI Certified Master Inspector, AZ License #62984**  
4939 W Ray Rd Ste 4  
PO Box #362

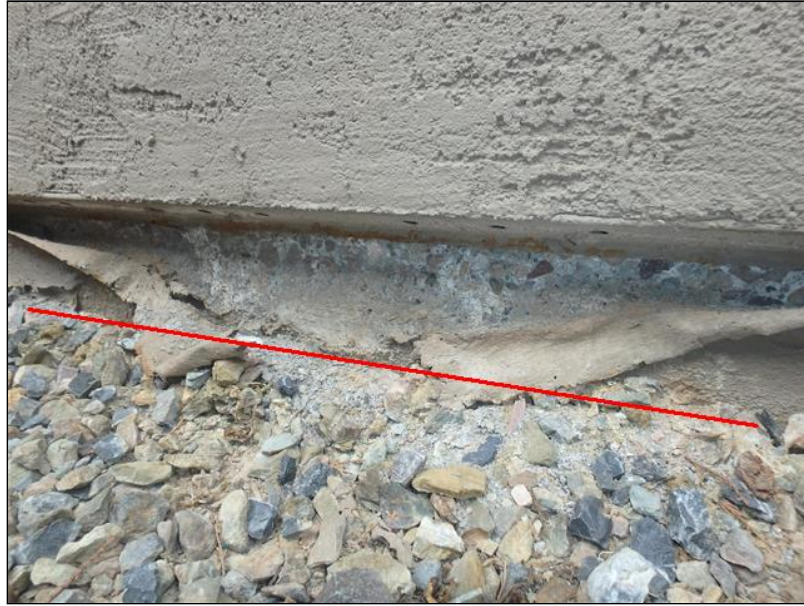
1.0 Item 1(Picture)

There is evidence of water penetration into the foundation on the left side of the house. This is likely due to too much irrigation water in the adjacent planter beds. The excess water wicks into the concrete and through hydrostatic pressure pushes to the surface. As the water evaporates it pushes the paint off the concrete and leaves a mineral residue which will eventually de-grade the concrete. You can remedy this condition by reducing the irrigation to the adjacent planter beds, let the concrete dry, scrape off the loose material and re-paint.

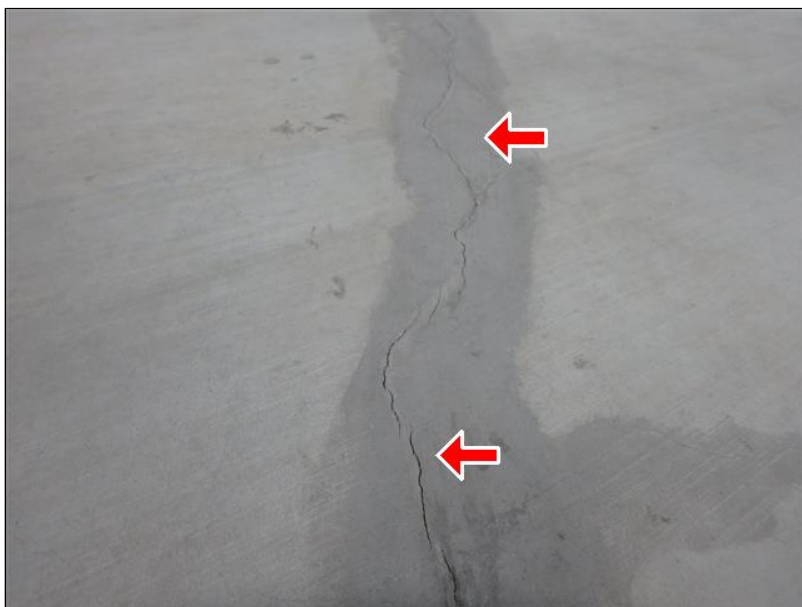
1.1 Item 1(Picture)

There is evidence of movement in the left rear of the garage. I recommend sealing of the crack by a licensed contractor and monitoring it for further movement with further repair as necessary.

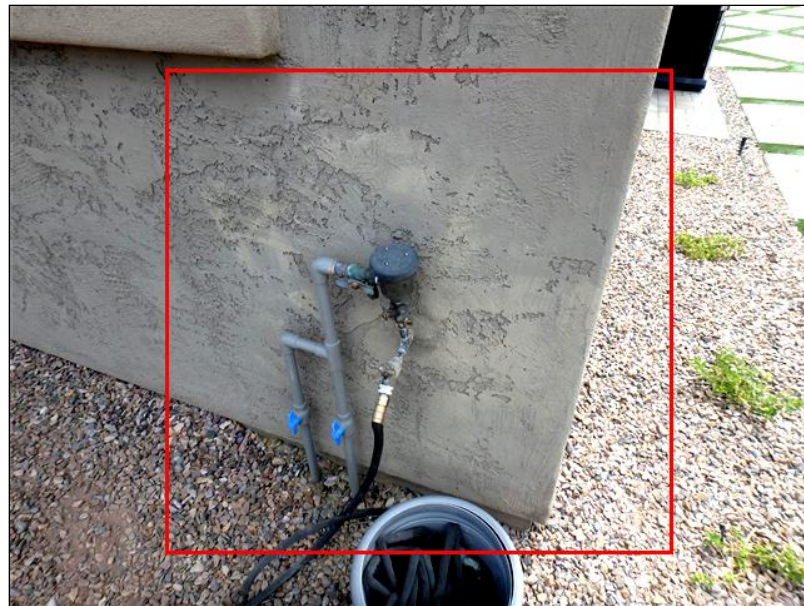
2.0 Item 1(Picture)

(1) The exterior paint is beginning to fade on the rear, budget for exterior re-paint in the future.

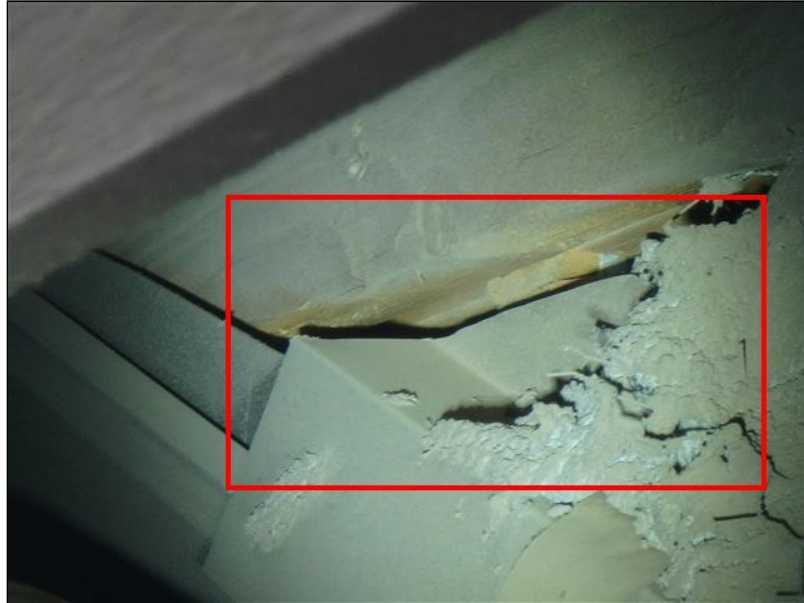
2.0 Item 2(Picture)

(2) The stucco is unfinished at the left and right side of the dining room roof. I recommend professional sealing to prevent pest intrusion.

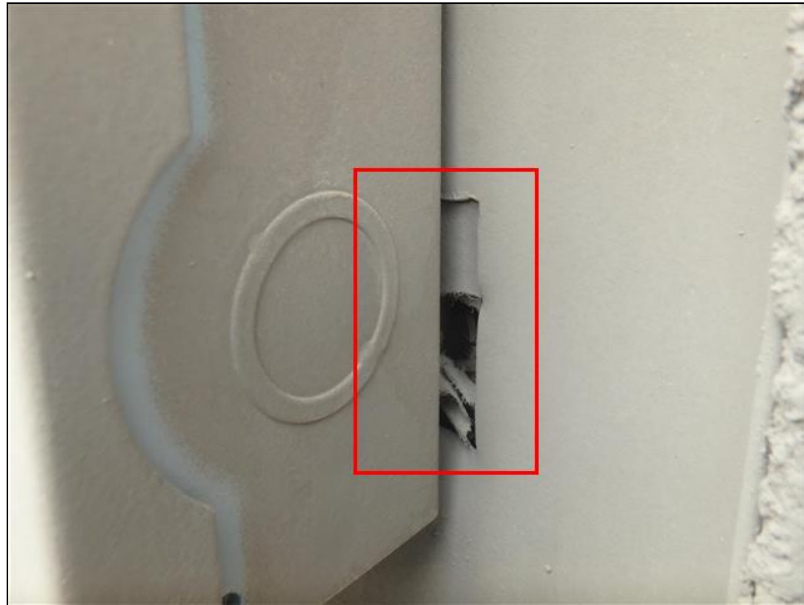
2.0 Item 6(Picture) Left side condenser disconnect

(3) Seal all exterior penetrations to prevent water and pest intrusion.

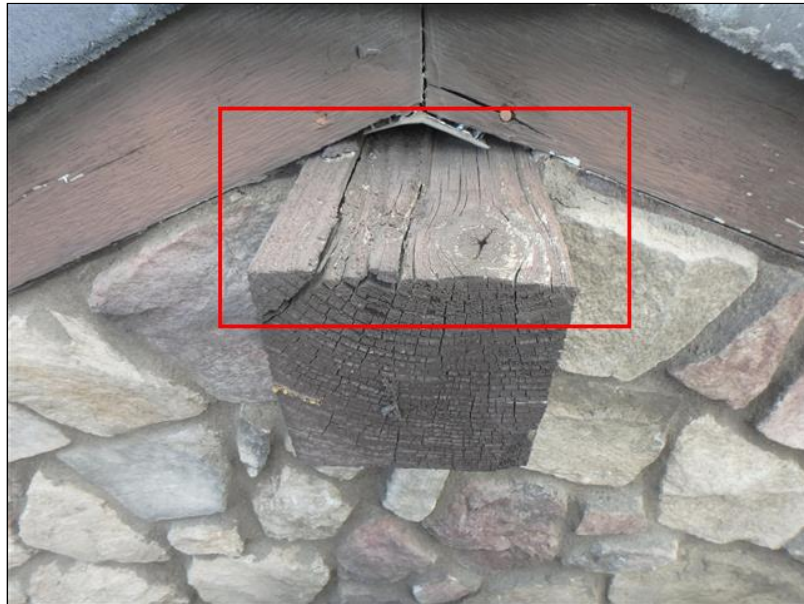
2.1 Item 1(Picture)

(2) The tops of the faux beams are exposed, Consider the installation of full width cap flashing to prevent weathering.

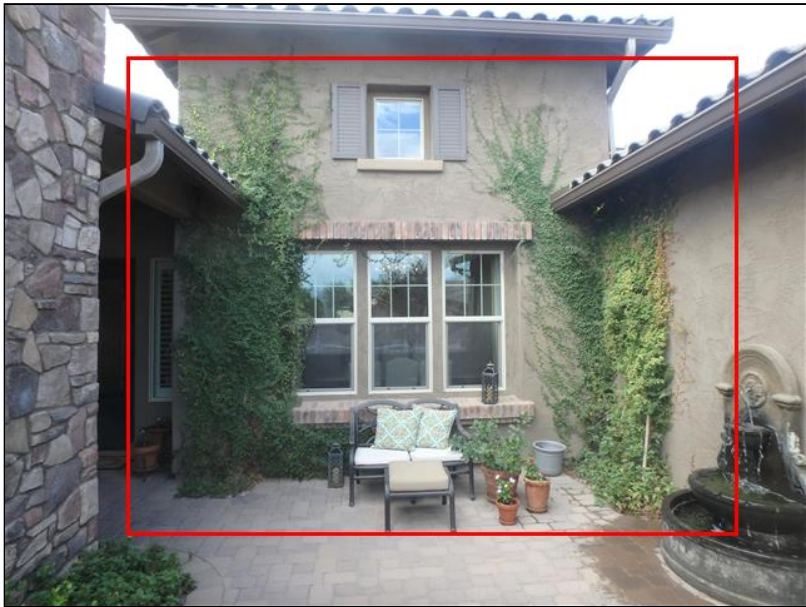
2.8 Item 1(Picture)

Tree limbs/vegetation in contact with the exterior and roof can cause damage and provide access for rodents. Trim as needed to prevent damage.

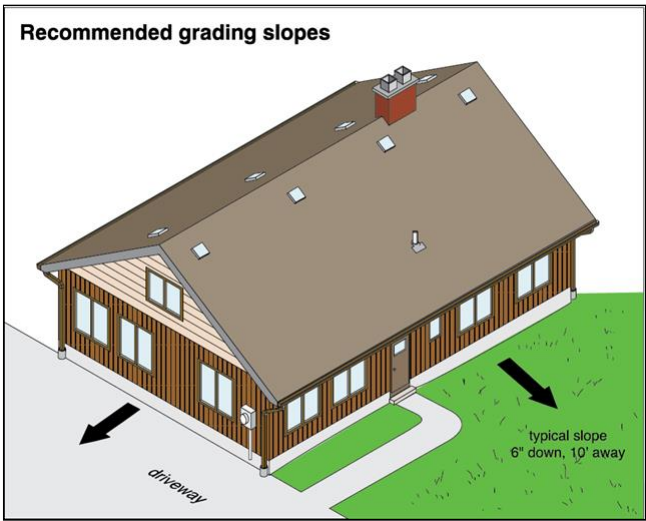
2.9 Item 1(Picture)

(1) The grade is sloped toward the house on the right rear. This will direct surface water into the soil adjacent to the foundation and cause water damage to the foundation concrete. Adjust the grade to direct surface water away from the foundation to prevent water damage.

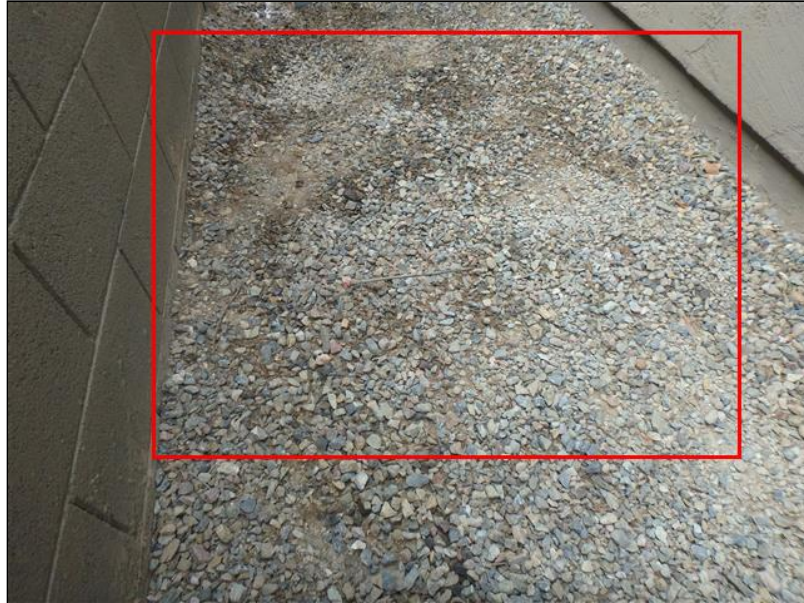
2.9 Item 3(Picture)

(2) There is excessive moisture in the soil on the left side. This is condition is conducive to water damage and encourages termite activity. Reduce the irrigation to the affected areas and adjust the grade as needed to direct water away from the foundation to prevent water damage.

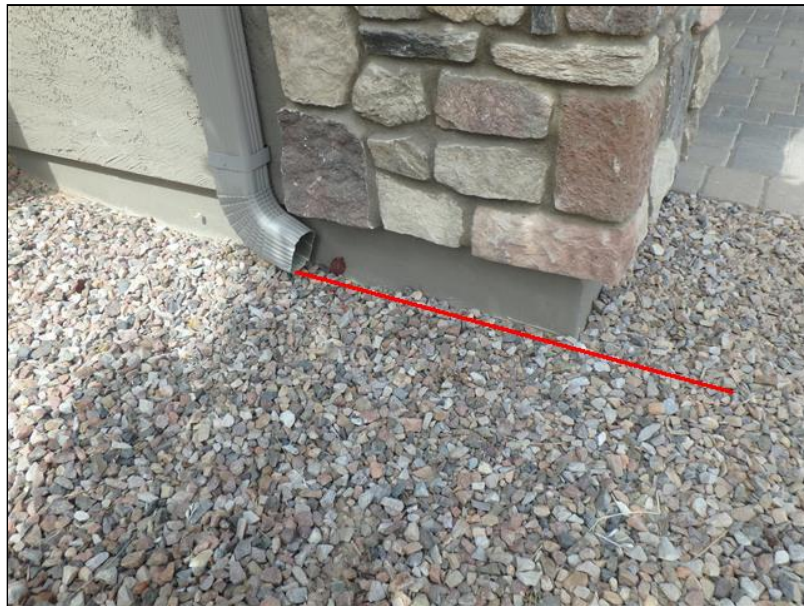
2.9 Item 4(Picture)

(3) I recommend extending the gutter downspouts so that they drain away from the foundation.

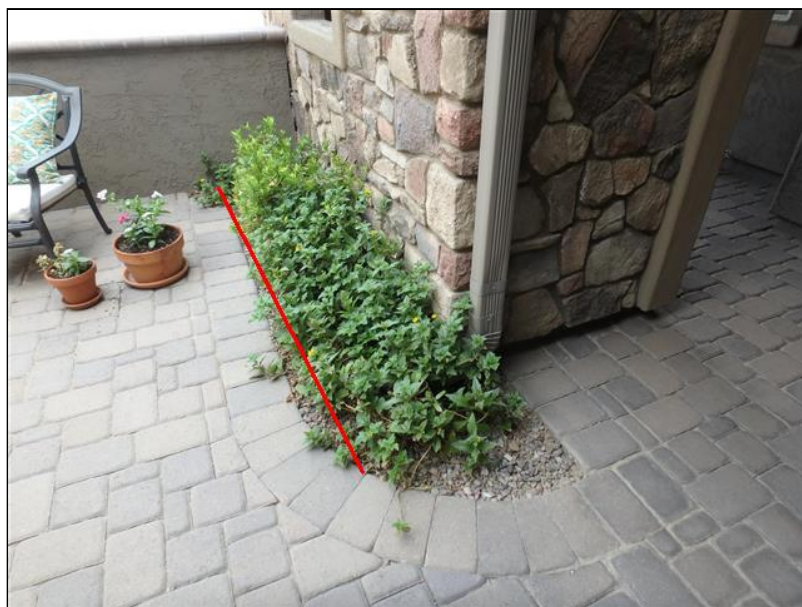
2.9 Item 6(Picture)

(4) Planters hold moisture in the soil adjacent to the foundation. This condition is conducive to water damage to the foundation concrete and encourages termite activity. Keep the planters as dry as possible, provide drainage, or remove them to prevent water damage.

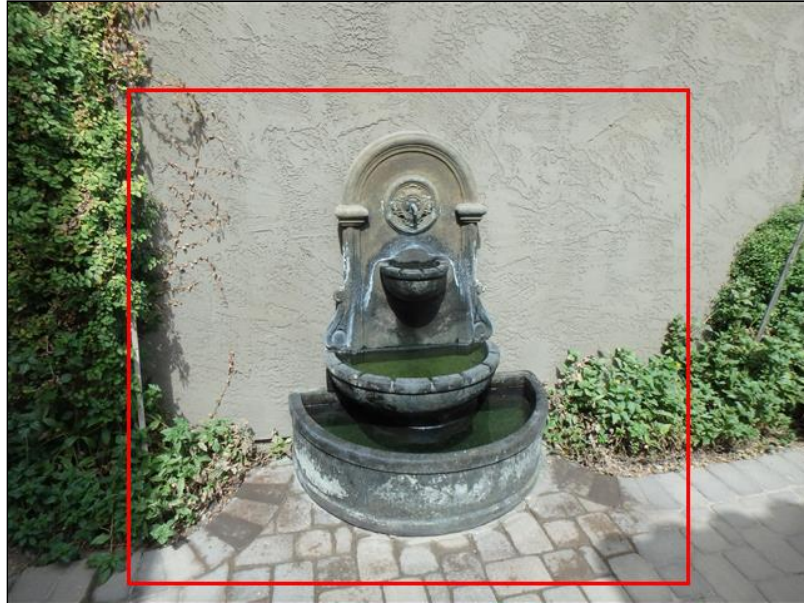
2.12 Item 1(Picture)

(1) I recommend moving the fountain to a more suitable location to prevent water from splashing on the stucco and foundation.

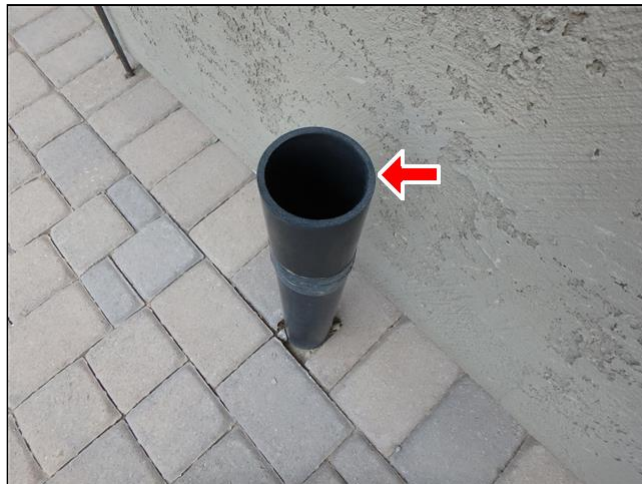
2.12 Item 2(Picture)

(2) There is an exposed ABS pipe on the right side of the garage, I recommend further evaluation to identify if this is part of the french drain system or a drain line hook up for an RV. I recommend capping the line to prevent water and pest intrusion.

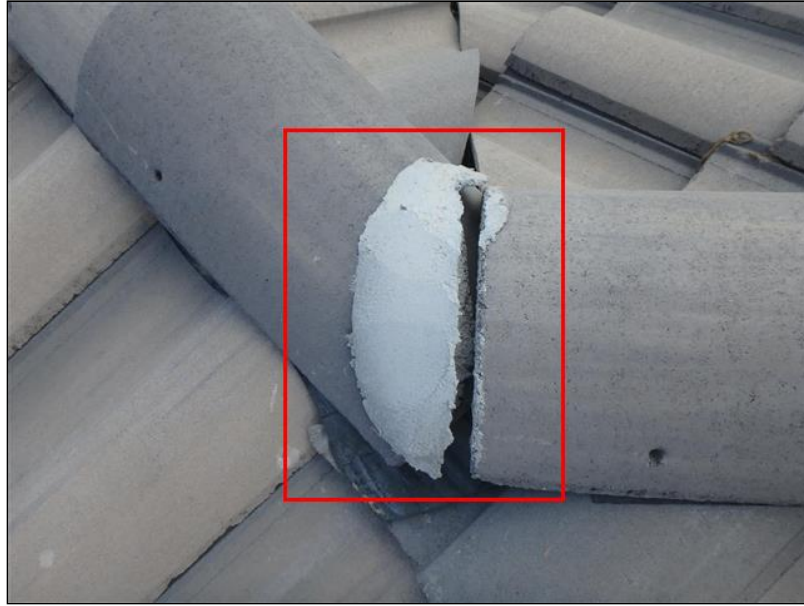
3.0 Item 17(Picture)

(2) Routine maintenance required to repair cracked tiles, secure slipped tiles, and repair cracked mudballs.

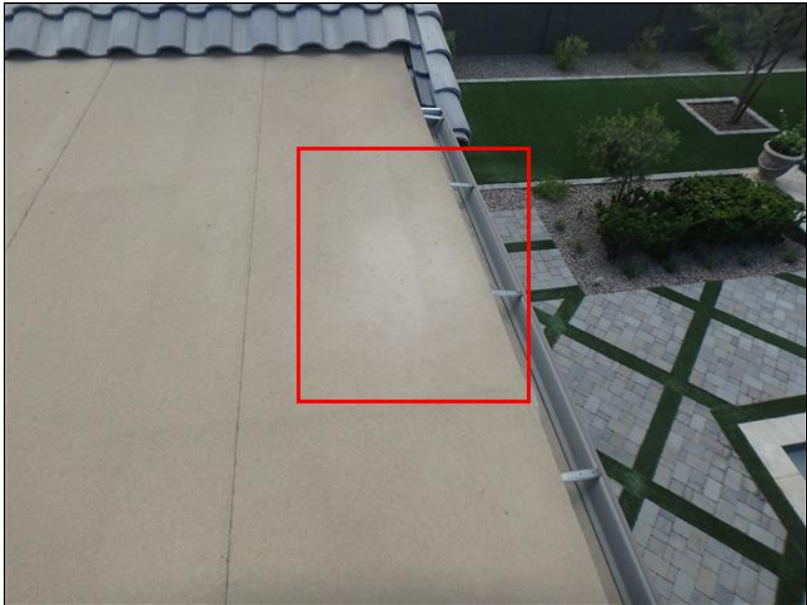
3.1 Item 1(Picture)

(2) There is evidence of ponding water on the rear patio roof, adjust as needed to prevent damage to the finish and leakage.

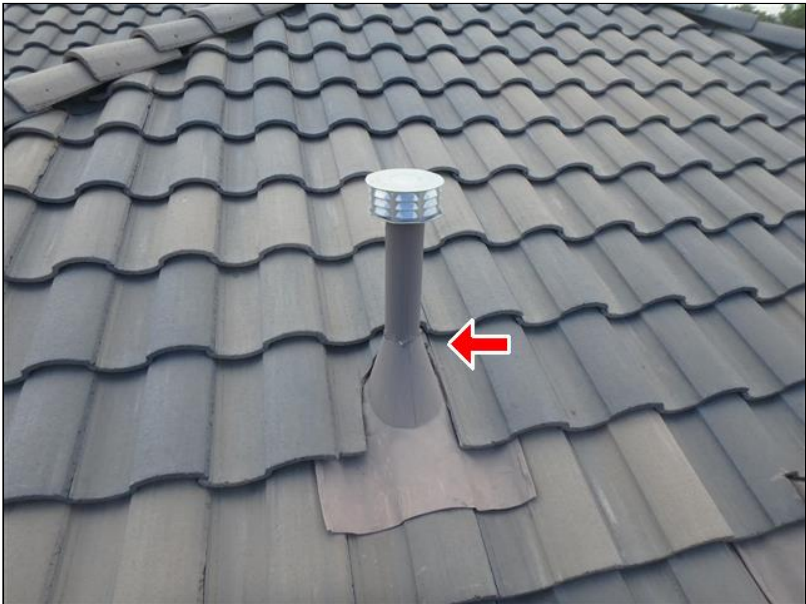
3.2 Item 2(Picture)

Add a storm collar to the two piece water heater and dryer vents to prevent leakage between the vent and primary flashing.

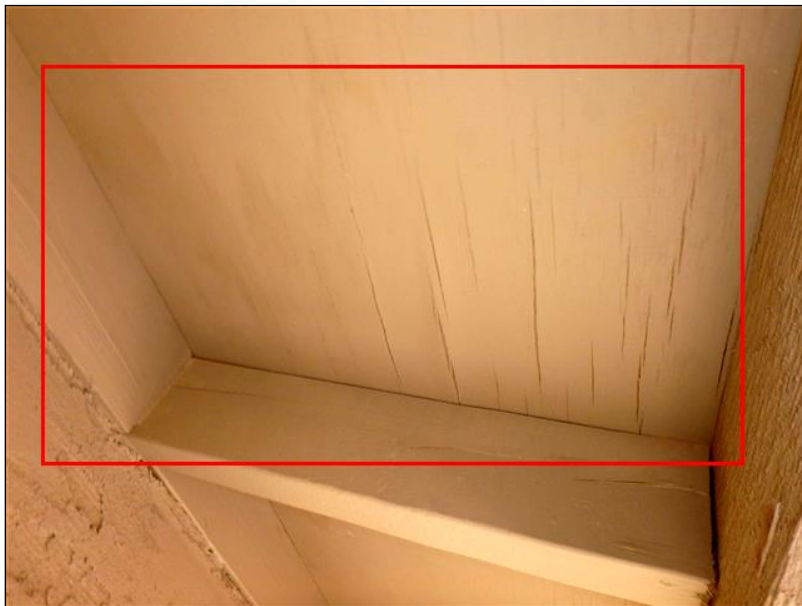
3.3 Item 1(Picture)

There are signs of leakage (water stains) at the eaves on all sides and minor water damage at the left rear eave over the condensers (Item 1). I recommend professional evaluation and repair as necessary.

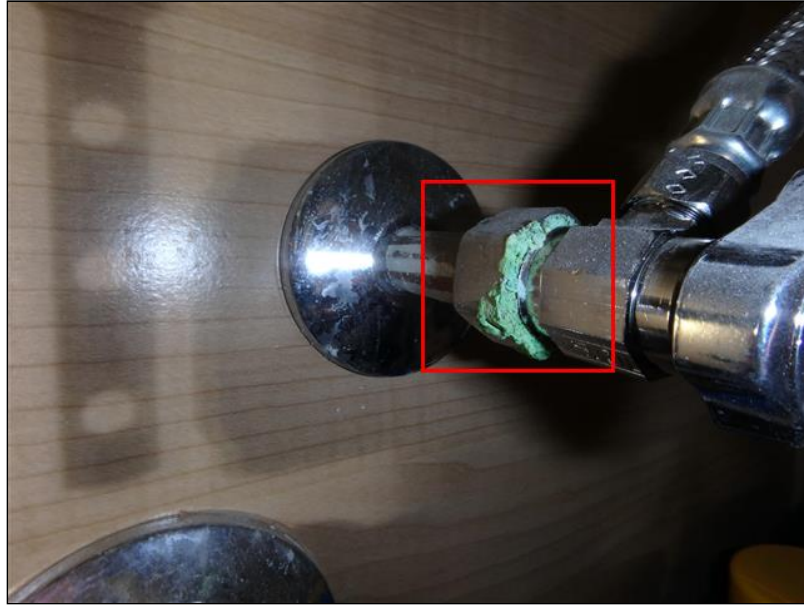
4.3 Item 1(Picture)

(2) There is evidence of leakage at the front left guest suite and master bathroom sink supply valves. I recommend professional repair/replacement to prevent further leakage.

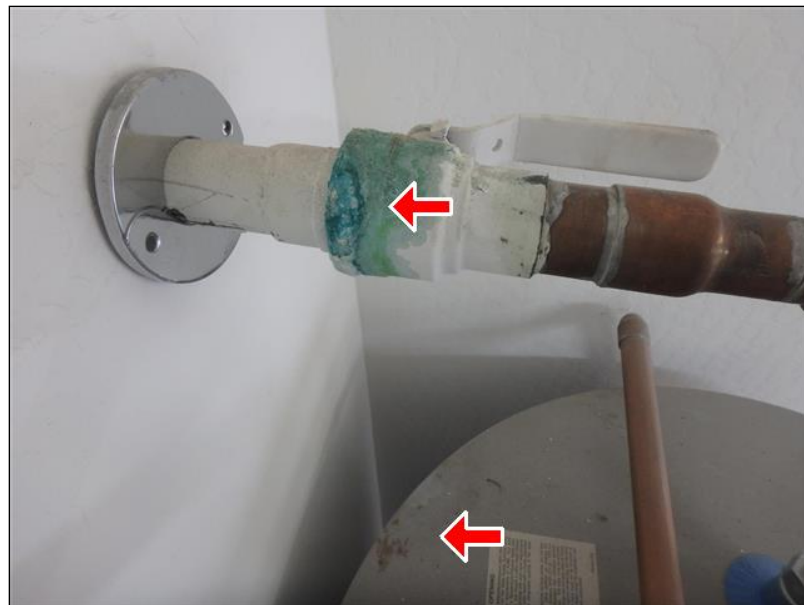
4.10 Item 2(Picture)

(2) There are leaks in the cold water supply valve body. I recommend replacement with a ball valve by a licensed plumber.

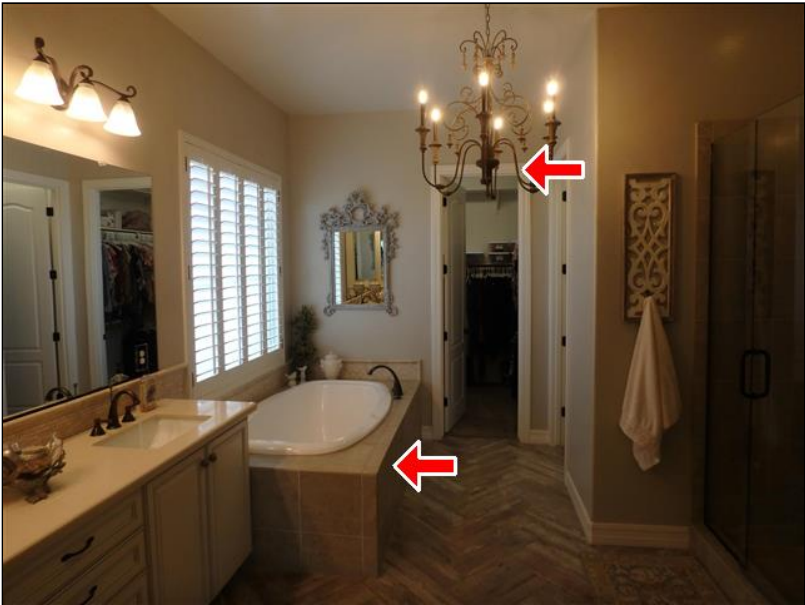
5.6 Item 1(Picture)

(2) Ceiling fans and pendant light fixtures are not allowed within 8 feet above or within 3 feet to the side of tub or shower thresholds. The pendant light over the master tub is within 8 feet of the top and 3 feet of the sides of the tub. I recommend a licensed electrician evaluate and remedy as needed.

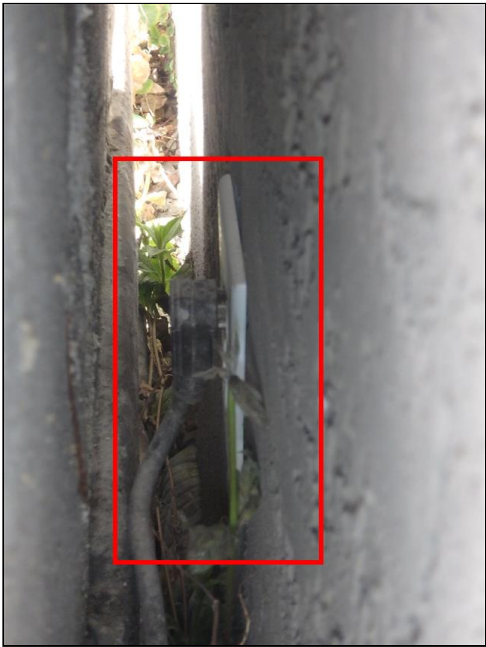
5.7 Item 2(Picture)

(2) There is an interior grade outlet behind the fountain. I recommend replacement with an exterior grade covered outlet. I recommend the installation of GFCI protection at this outlet to prevent hazard.

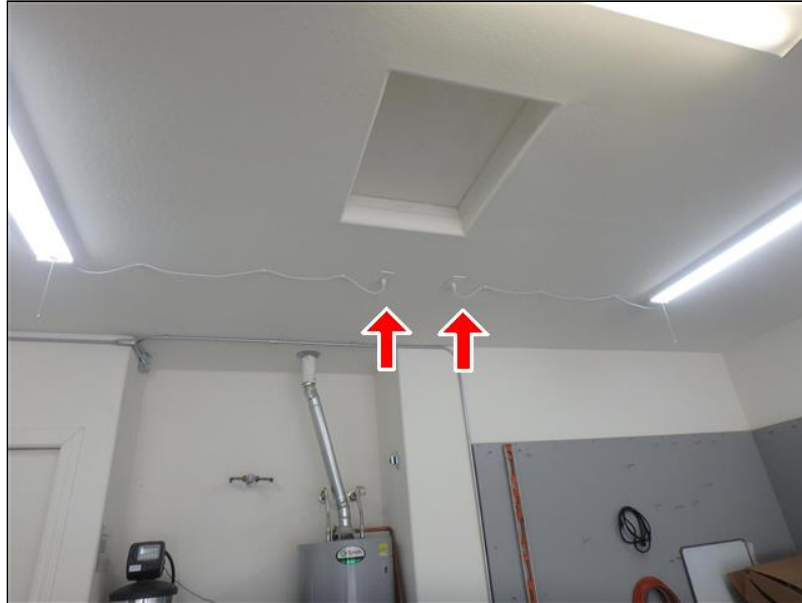
5.8 Item 1(Picture)

(2) I recommend the installation of GFCI protection at the rear garage ceiling outlets.

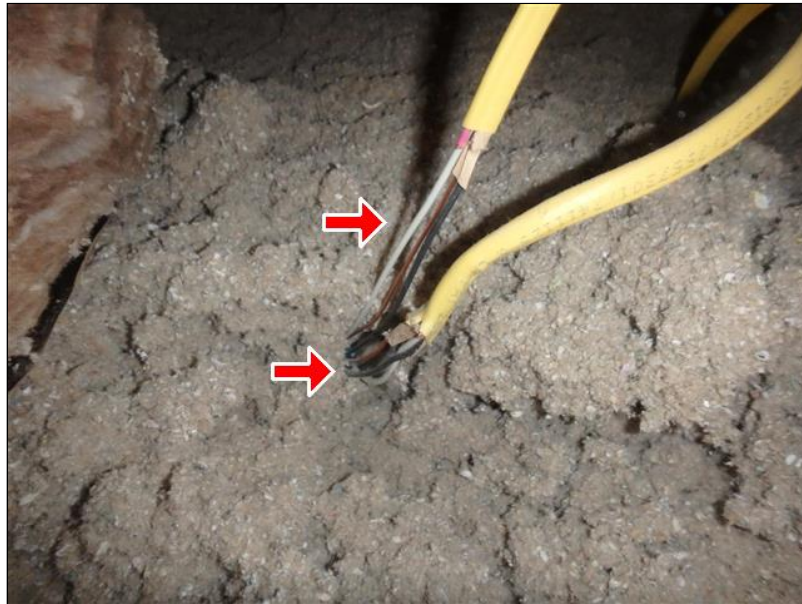
5.10 Item 1(Picture)

(1) The sheathing has been removed from the conductor running to the rear garage ceiling outlets, I recommend repair by a licensed electrician.

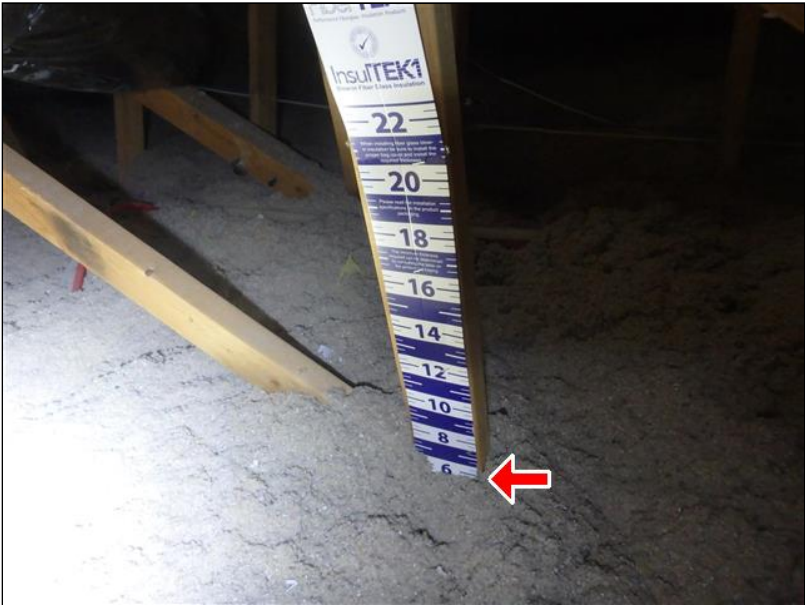
9.0 Item 1(Picture)

(2) The attic insulation is thin over the guest bedrooms. Consider additional insulation as needed.

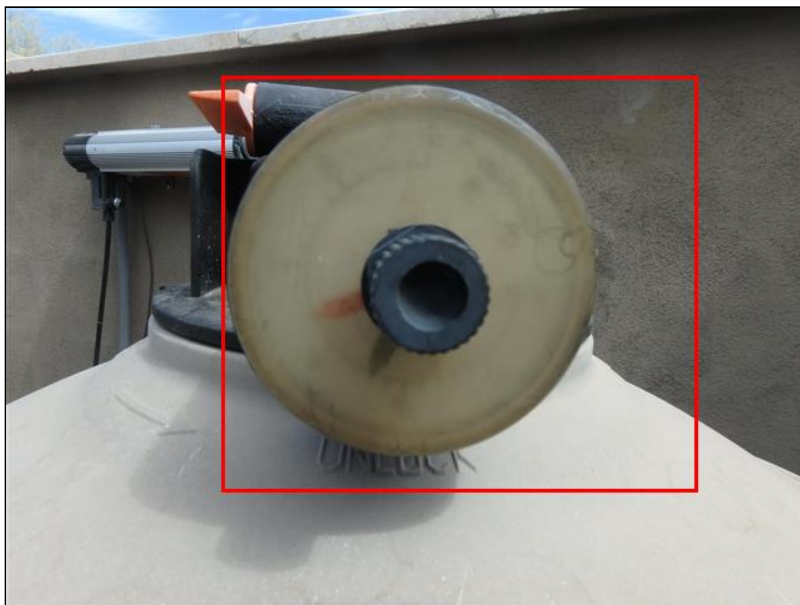
11.3 Item 2(Picture)

(2) The filter pressure gauge is not visible, I recommend professional replacement.

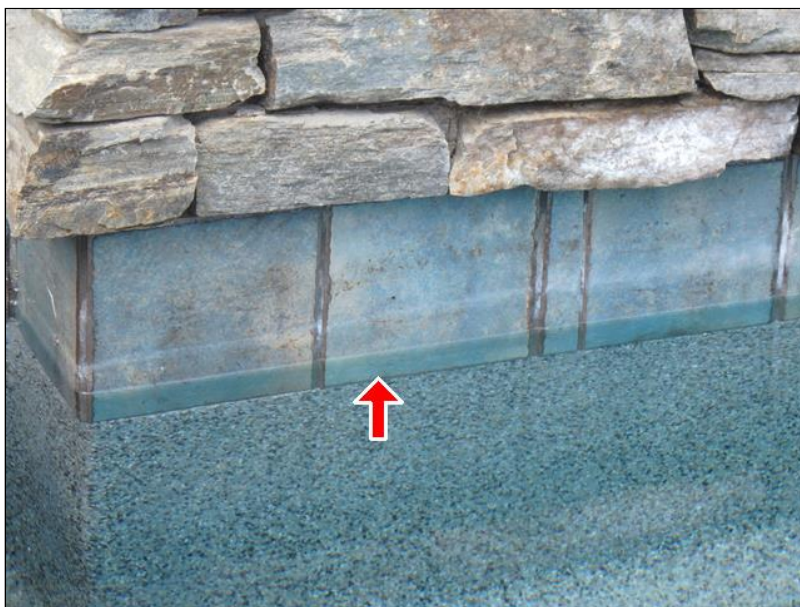
11.5 Item 2(Picture)

(2) The water level is low, I recommend professional adjustment of the auto fill valve so that the water line is halfway up the perimeter tiles.
