NEW MEXICO STEAM LOCOMOTIVE & RAILROAD HISTORICAL SOCIETY

Vol. XII, No. 1

2926 REASSEMBLY GETS SERIOUS

**After Years Of Hard Labor—Disassembly, Cleaning, Refurbishment, Acquisition, Fabrication,
And Reassembly Of Thousands Of Parts And Appliances, 2926 Is Coming Back To Life**

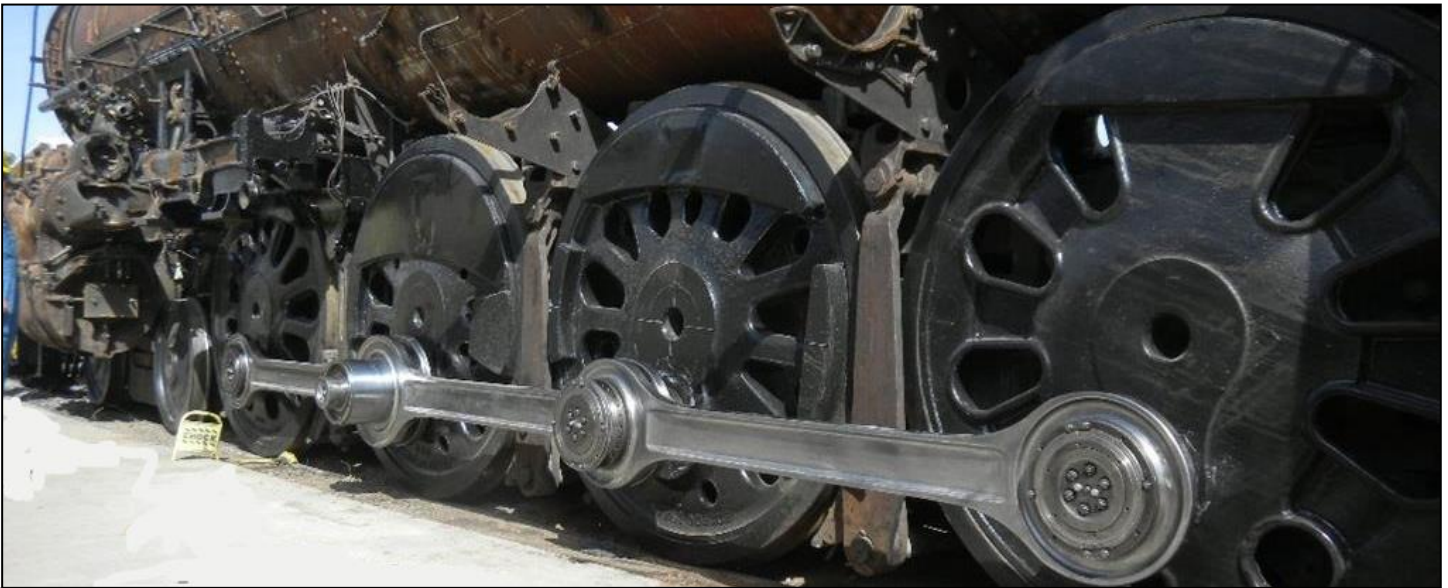
Pictured here, on the fireman's side, the 80 inch drive wheels of 2926 are once again connected with the recently refurbished Timken roller bearings and sparkling drive rods

The side rods had been off 2926 for a year while the Timken tapered roller bearings were pulled, rebuilt, and reinstalled. Plenty of work went into polishing off the city's black park paint. The stacked and stashed "light weight" rods shined. A rack was built to hold them while Perez Collision on 2nd Street clear-coated them two at a time.

All the while we did not dare move 2926 since our curved siding and bumpy rails would probably get the drivers "out of time" with their crankpins at slightly different degrees of rotation. Tolerances are tight. If the drivers did not line up just right we would never get the side rods back on. Several of our mechanical guys philosophized that we might jack up a driver, grease the rails, and try to turn it with come-a-longs or something heavier. A fair amount of worry and wonder about this problem was put aside the day Glen Powers stopped by for a visit.

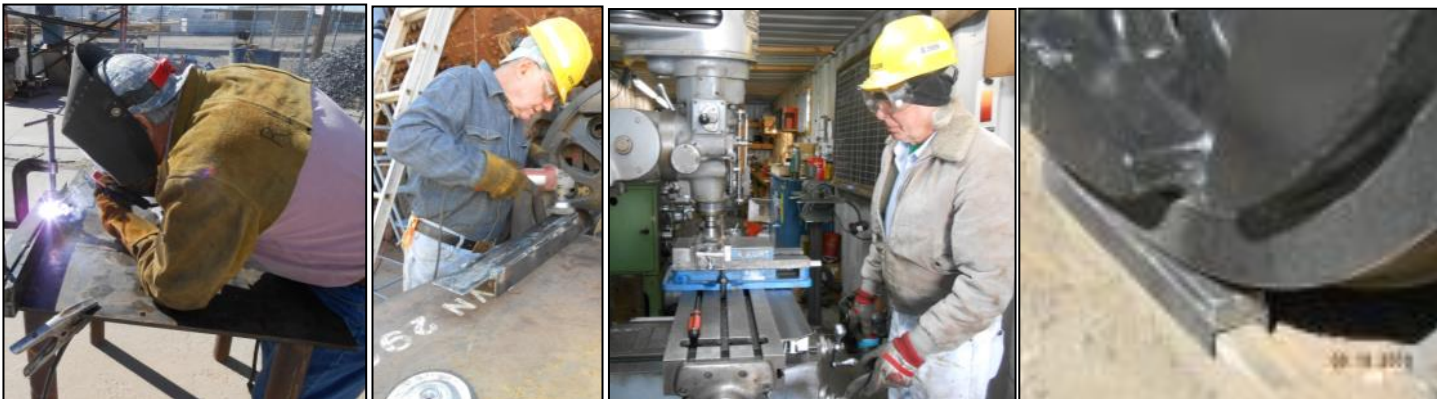
GOT TALENT? This is how the 2926 team works—with a bit of basic common sense guidance from a retired steam era pro. At Glen Powers suggestion, Rick Kirby, Dave Van de Valde, and Ron Taylor make short work of fabricating the wedge pictured in use in the last photo.

A brief time later Glen held his hands apart at shoulder width and his fingers a few inches apart as he described a long thin wedge that tapered from a couple of inches at one end to a sharp edge at the other. If we made the wedge right, it would fit over the top of a rail. If a pair of drivers needed to be a bit closer or a bit further apart we could use Lurch the car mover to pull 2926 and a drive wheel up on to a wedge. That driver would roll a bit further climbing the wedge than its neighbor and the gap between crankpins would be changed a few thousandths of an inch. We realized that what was a common sense, routine procedure for Glen was basic mid-school math. Maybe our 'mechanical experts' missed that class.

Bob DeGroft visited Reliance Steel, our helpful neighbors across the tracks. Reliance provided steel for the wedge. Dave Van Devalde designed the wedge, Rick Kirby welded the parts together, and Ron Taylor milled it to the proper profile.

Next came the inside rod between two and three on the fireman side. It just wasn't going back on. That's where the wedge came to the rescue on the March 16 work session.

I am told that high school member, Henry Roberts, one of the testosterone gang, figured out the sweet spot for the number three driver as it was pushed on to the wedge by Lurch. Then the rod "slipped right on" once the gap between crankpins was correct.

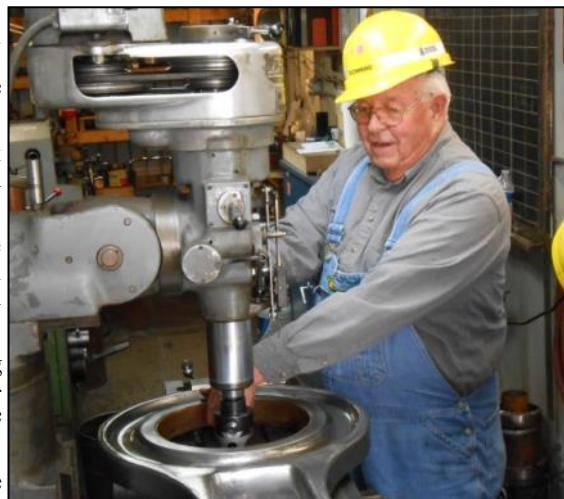
Machinist Dick Downing polishes the brass bushings to match the bearing sleeves. Dick tells the folks back home in Indiana he is visiting his grandchildren in Albuquerque. This photo reveals another reason.

Meanwhile, with a little polishing of the brass bushings to match the diameters of new sleeves on the Timken bearings the first fireman side rod slipped back on with relative ease. It took a bunch of guys, a forklift, lots of gentle persuasion with a wooden hammer, teeth clenched at just the right angle, and some luck for the number one to number two side rod.

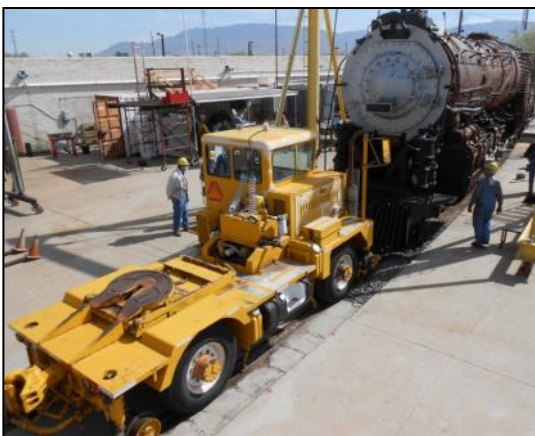
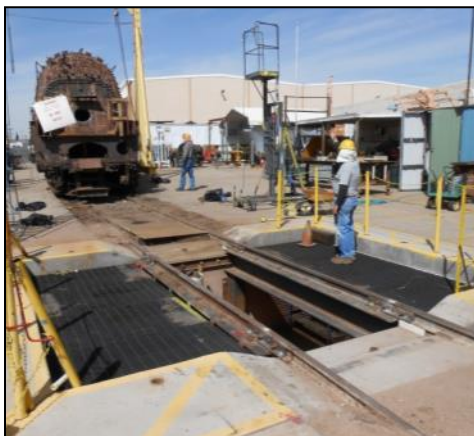
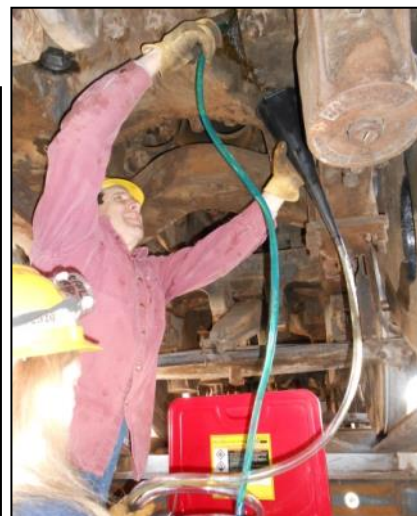
Left and Center: Lurch takes 2926 for a stroll, clearing the pit for a bit of cleanup before moving it back over the pit. Right: Once repositioned over the pit, flushing of the number three and four bearing reservoirs could be done,

The fireman side three to four rod was tough to install but did not require the wedge. The first three rods on the engineer side went on later with much less difficulty and the 2926 was taken for a stroll to loosen up old main axle bearing lubricant.

Spotted over the pit the number three and four bearings have been drained of their molasses-like oil and flushed repeatedly with diesel by the testosterone gang and their assistants.

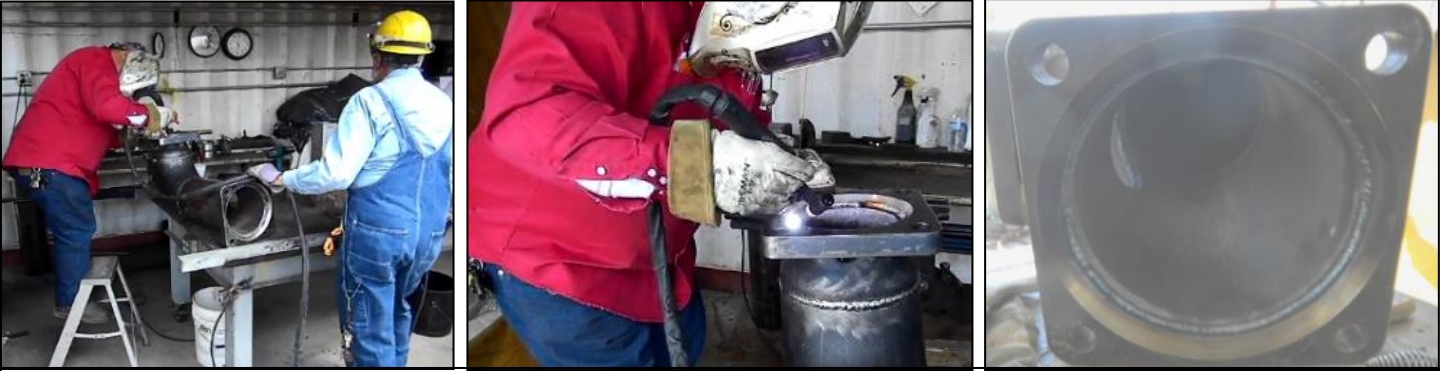
With Ken Dusenberry looking on, Carlos Osuna, long time Local 412 member (now an NMSLRHS member as well) applies his welding skills to attach flanges to one of the large pipe sections. With extensive experience at welding everything from critical piping at nuclear power plants to maze of stainless steel piping at large dairy facilities, Carlos has become a real asset in preparing and refitting the pipes fabricated in Utah.

That's when Local 412's associates in Utah stepped forward. They had the pipe fabrication capability that was lacking at the 2926 restoration site. They had heard about the 2926 restoration from Local 412's business manager. With NMSLRHS members providing transport of the rusted pipes between Albuquerque and Utah, building new pipes began last year. Now back at the site, Carlos Osuna is doing the welding to prepare the pipes for reinstallation. He and a number of other members are reinstalling them.

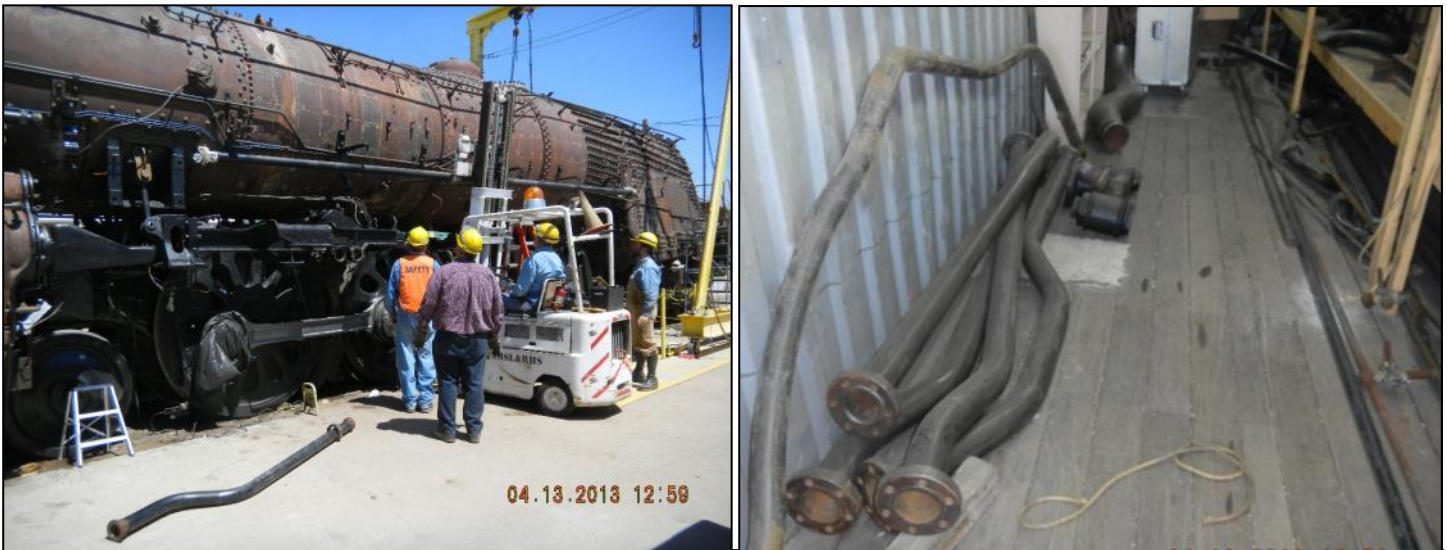
Left: Reinstallation of the 2926 piping begins. Right: Additional recently fabricated pipes are in a storage unit awaiting reinstallation. Without the specialty cranes and other tools that once were available in the backshops, this can be a slow process.

The reinstallation is a slow and demanding process that probably would draw laughs from the oldtimers who worked on the locomotive when numbers of them were still operating. After all, we have neither the skills nor equipment that the steam repair crews had when 2926 was operating. Thankfully, there are skills to be found, and we found just the right skills to perform the critical pipe fabrication and reinstallation job. It is the folks at Plumbers and Pipefitters Local Union 412 and their buddies in Utah.

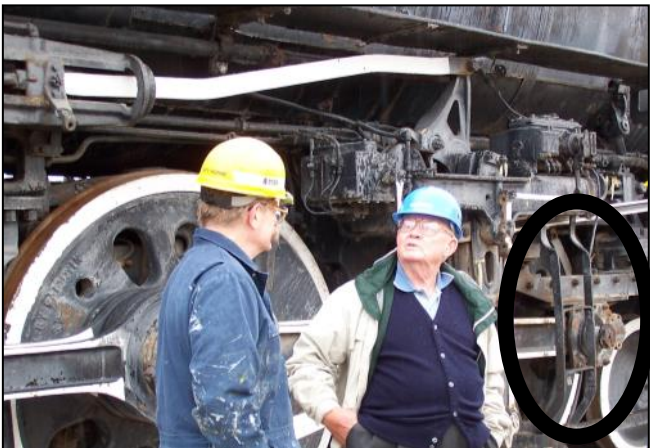
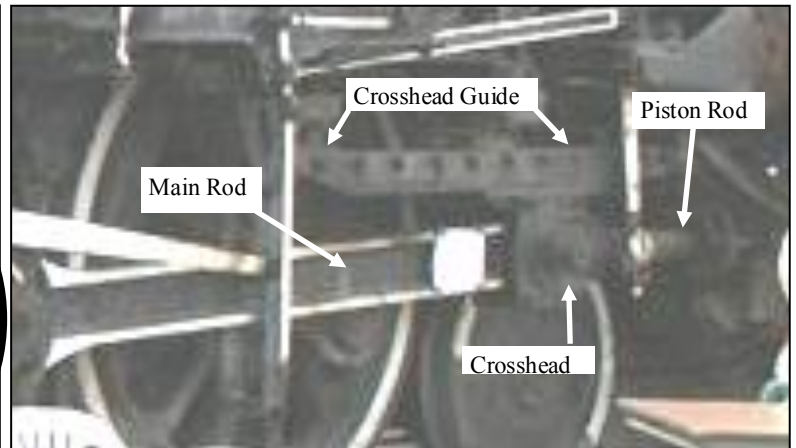
NMSLRHS Archive Photos: In the first photo, AT&SF retiree Glen Powers discusses the restoration with Dr. Mike Hartshorne before removal of the engineer's side crosshead. The area at far right (inside black oval) depicts the location of the crosshead assembly. Major components of the crosshead assembly are pinpointed in the second photo.

For those who are unfamiliar with steam locomotive design and operation, the crosshead assemblies, one on each side of the locomotive, are the links that deliver power from the pistons to the drive wheels. Their strength and precision of movement are critical to the locomotive's smooth and long-term operation. Connected to the piston rod on one side and the main drive rod on the other, the top of the crosshead is fitted into the crosshead guide. In the guide, the crosshead slides back and forth on a surface of babbitt, also called 'bearing metal', that can be replaced at set maintenance intervals.

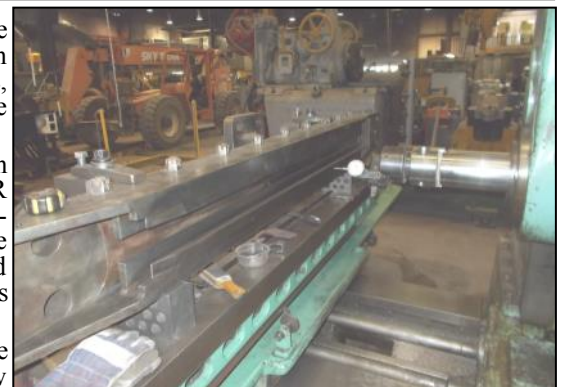
Bottom view of one crosshead guide as it is being checked for alignment.

The GCR shops offered to help by replacing and resurfacing the babbitt in the crosshead guides. Late last year the guides were hauled to the GCR shops, and an order was placed for the babbitt. Once the GCR crew took a look at the guides, they determined that there was also an alignment problem. The guides were slightly bent, perhaps due to wear or abuse.

Regardless of the cause of the bend, in a situation where tolerances are in thousands of an inch, the problem needed to be addressed. Fortunately, the GCR shop had the capability, in the form of a huge hydraulic press, to handle the problem. To ensure that the entire assemblies were in alignment, they needed the mounting brackets for the guides. Rick Kirby and Bob DeGroft quickly loaded the crosshead mounting brackets and hauled them to Williams so that the various parts of the crosshead assembly could be matched for smooth operation.

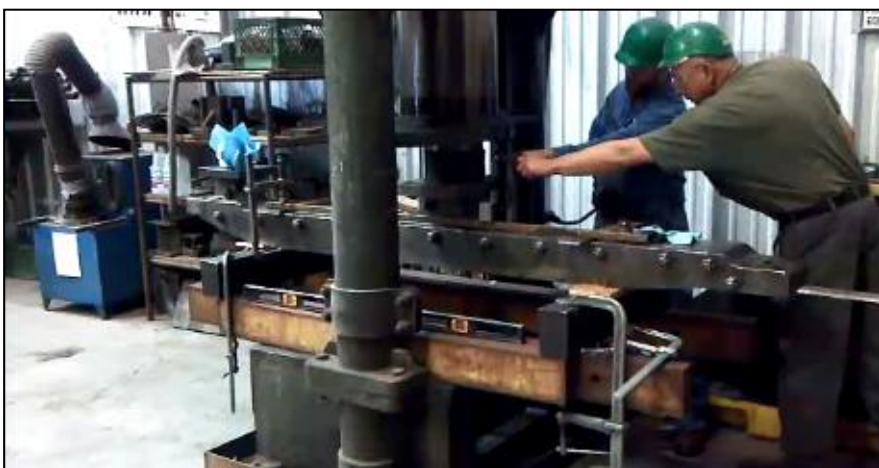
In the two photos on the right, precise gauges are used to determine the amount of adjustment necessary to correct the bends. Below two GCR crew members are using their hydraulic press to straighten one of the guides. Once the rebabbiting process is complete, the crossheads will be returned to Albuquerque to be installed on 2926, along with the main drive rods.

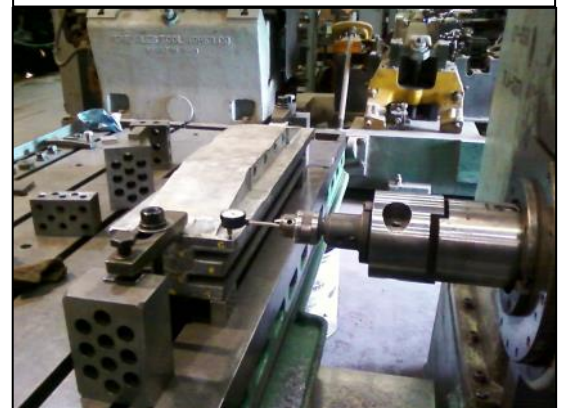
A view of the crosshead 'shoe' that contains the layer of Babbitt to provide a wear surface.

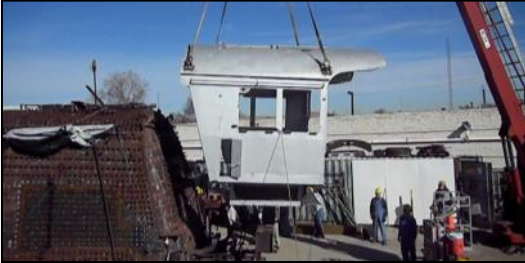
February 2012, Cab Move: The cab was lifted from 2926, placed under a canopy and measurements were made in preparation for installing the cab woodwork.

In February 2012, the cab was removed and placed under a canopy in a corner of the worksite. To keep wanderers, would-be 'helpers', and other nosey types away, the canopy was surrounded by yellow caution tape. Members learned quickly that if you were not assigned to Randy's crew, or had a very good reason for entering the cab site, you didn't cross the caution tape.

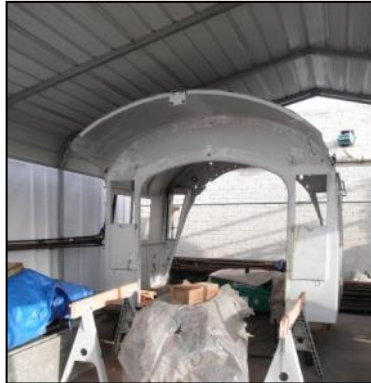
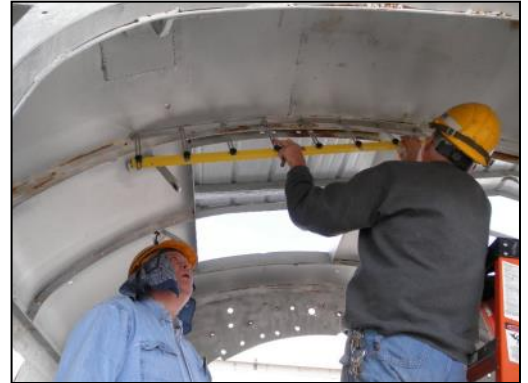
Throughout the past year, work progressed steadily, though with considerable difficulty because of the intricacy required to fit the wood around all the cab openings, fittings, and other obstacles. By early this year, all those funny shaped pieces were beginning to come together like a big upside down jigsaw puzzle.

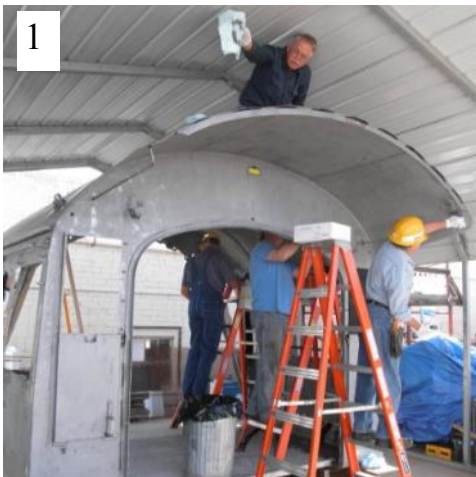
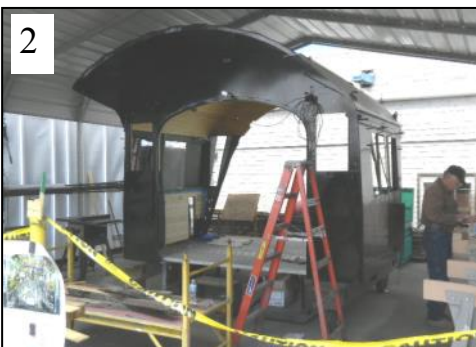
The photos below show stages of the cab work. Photo number 1 shows preparation for the black paint. That's Pete Ormson taking care of the top cleaning while other crew members work inside. In Photo number 2, the cab sits under the canopy with the woodwork nearing completion.

There were also tasks other than woodworking. One was application of a nice black coat of paint over the grey primer. Another involved the sun roof openings. In that case, Randy had to call on super welder Carlos Osuna to fabricate a new rail for the moveable roof panels. The sunroof panels are power operated—but unlike electrical power of current BMW, Lexus, Volvo, etc, the power required is *manpower*.

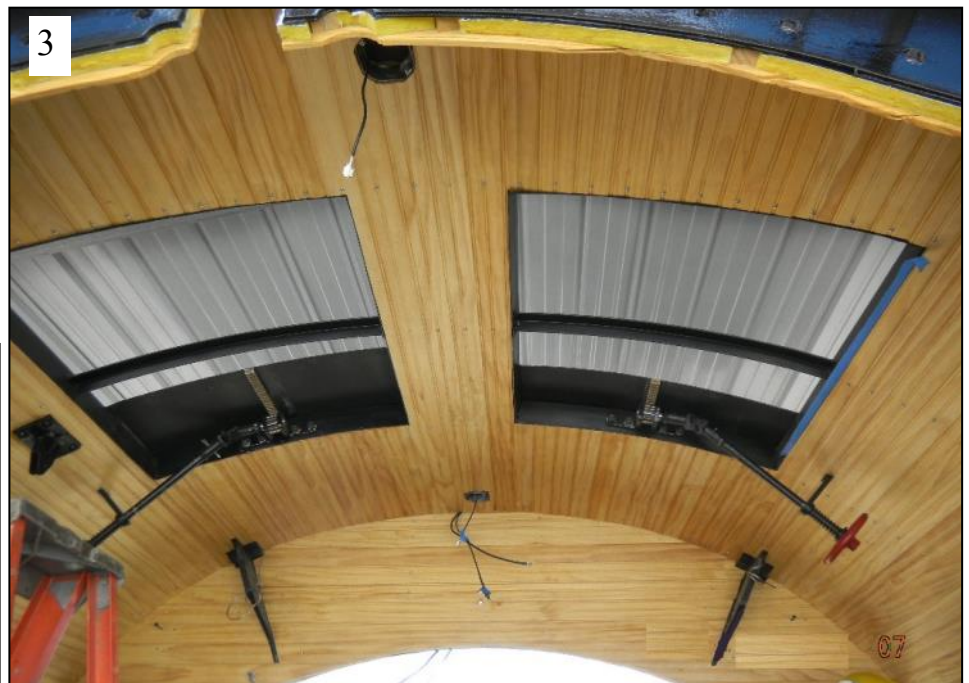
In Photo number 3, looking from front to rear of the cab, the difficulties of fitting the wood paneling can be seen. The sunroofs, brackets, electrical fixtures and other intrusions presented a challenge. Randy and his team deserve kudos for an excellent job. However, if there is anyone else who has a locomotive cab woodwork job, odds are that Randy and his crew will not be among the volunteers..

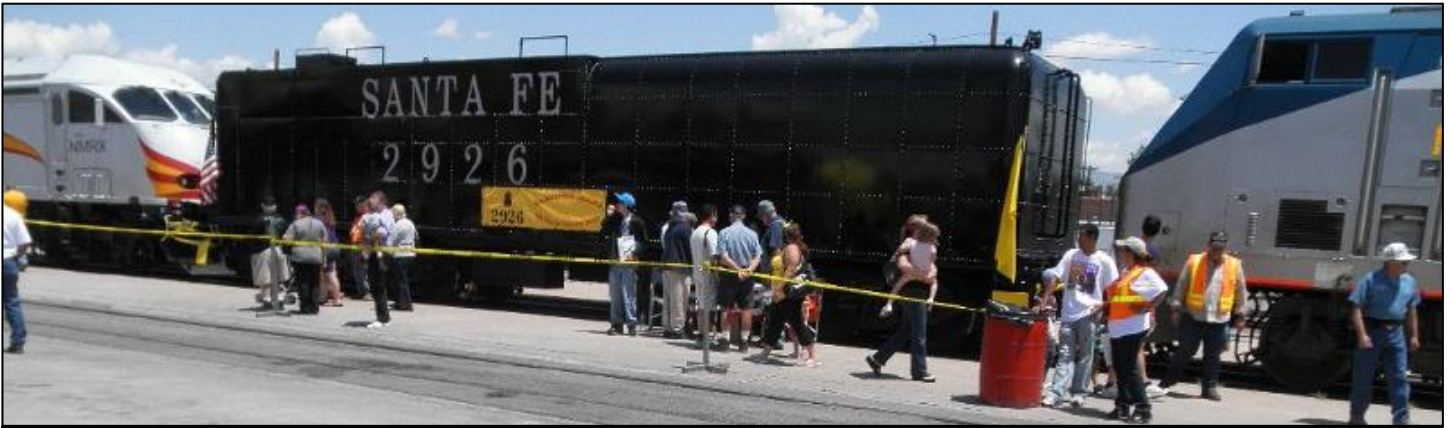
Train Day 2012, the 2926 tender is displayed center stage between Rail Runner and Amtrak diesels.

For the younger Train Day visitors—and the older ones who may have forgotten—generating steam to power steam locomotives meant that water had to be available to produce the steam. Additionally, there had to be fuel to heat the water. Historically, the fuel was wood, coal or oil. That fuel was burned in the locomotive's firebox to heat water to make steam that powered the locomotive. The tender carried both water and fuel, and was coupled directly to the locomotive. Thus, it functioned in the same role as the fuel tank on a car or truck. Since 2926 burned oil, its tender, one of the largest steam locomotive tenders ever built, carried 7,150 gallons of oil in a tank resting in a pocket in the front of the water tender. If 2926 had been coal powered, that pocket in the front of the tender would have contained coal. The main body of the water tender has capacity for 24,500 gallons of water.
