**INTEGRATED  
INSPECTIONS**

## **Inspection Report**

**Property Address:**  
9876 E. Main St.  
San Tan Valley AZ 85143

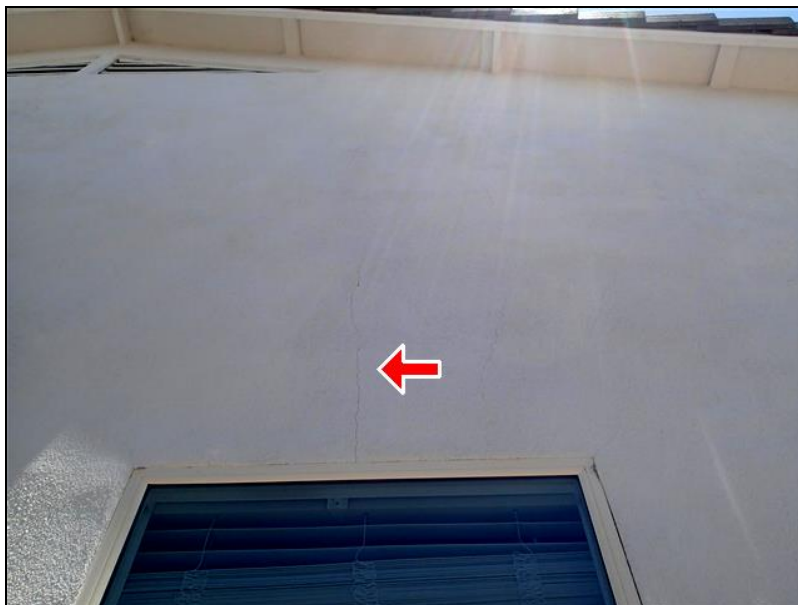
(2) There is evidence of previous movement on the walls in several areas throughout. Seal as needed, monitor for further movement and repair as necessary.

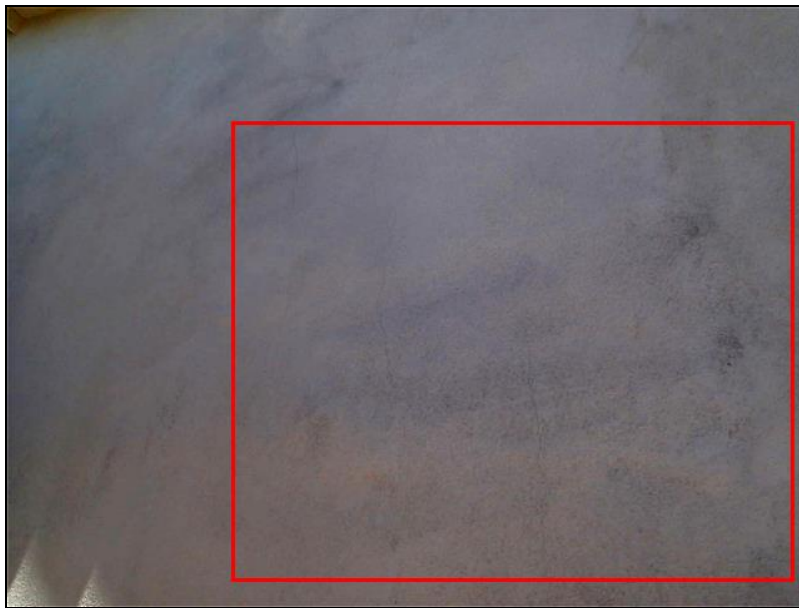
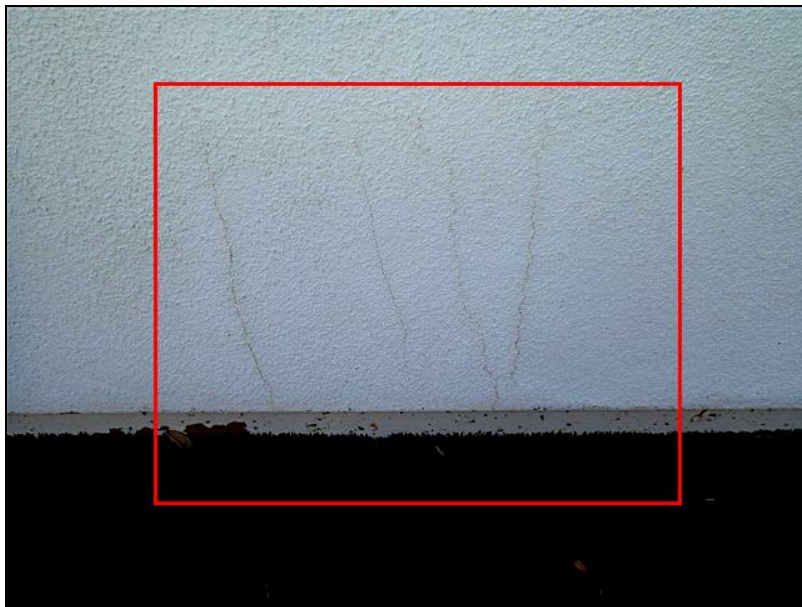
(1) There is excessive cracking in the stucco in several areas throughout. I recommend professional evaluation with repairs as needed.

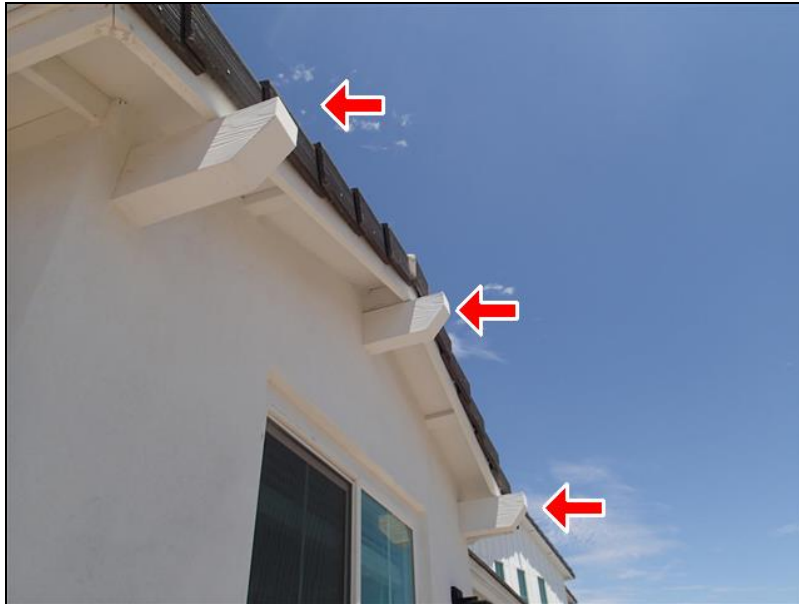
2.1 Item 1(Picture)

(2) The tops of the exposed beams are exposed, I recommend the installation of full width cap flashing to prevent further weathering.

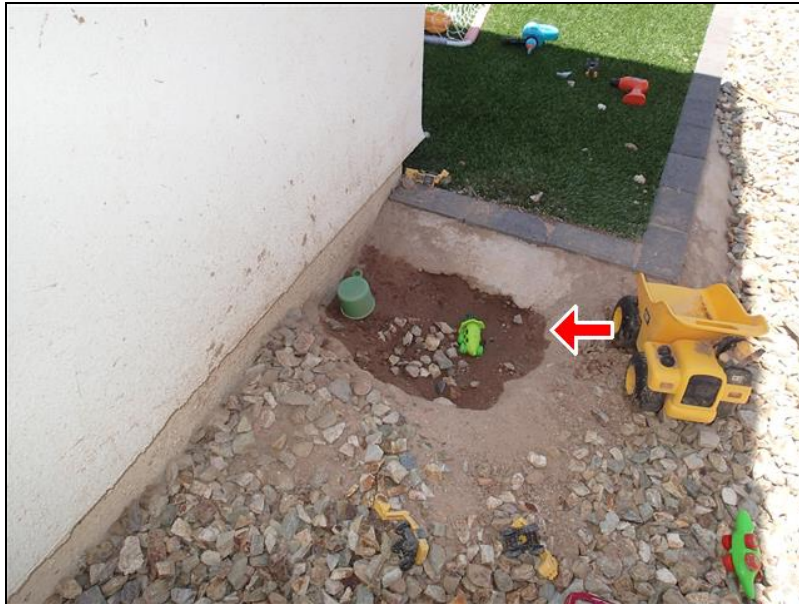
2.9 Item 1(Picture)

The grade is sloped toward the house on the right side. This will direct surface water into the soil adjacent to the foundation and cause water damage to the foundation concrete. Adjust the grade to direct surface water away from the foundation to prevent water damage.

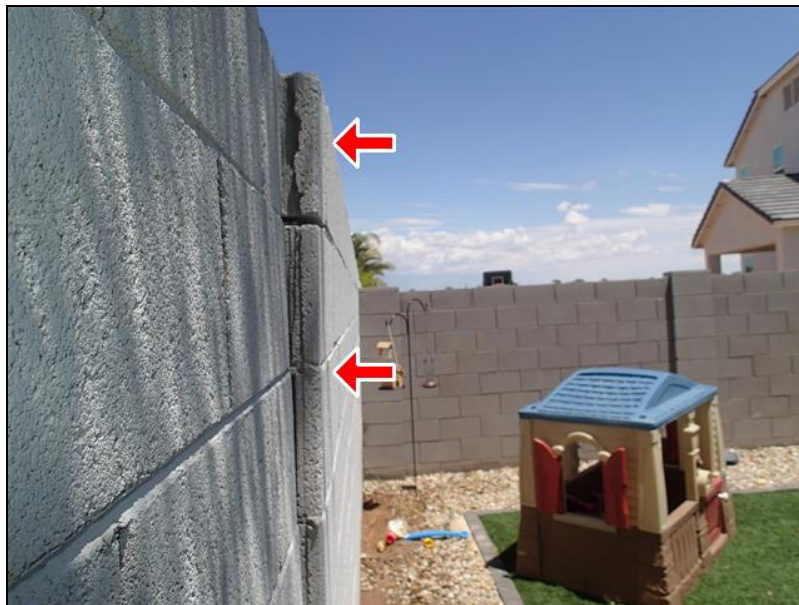
2.12 Item 1(Picture)

The rear block fence is leaning. I recommend professional evaluation with repairs as needed.

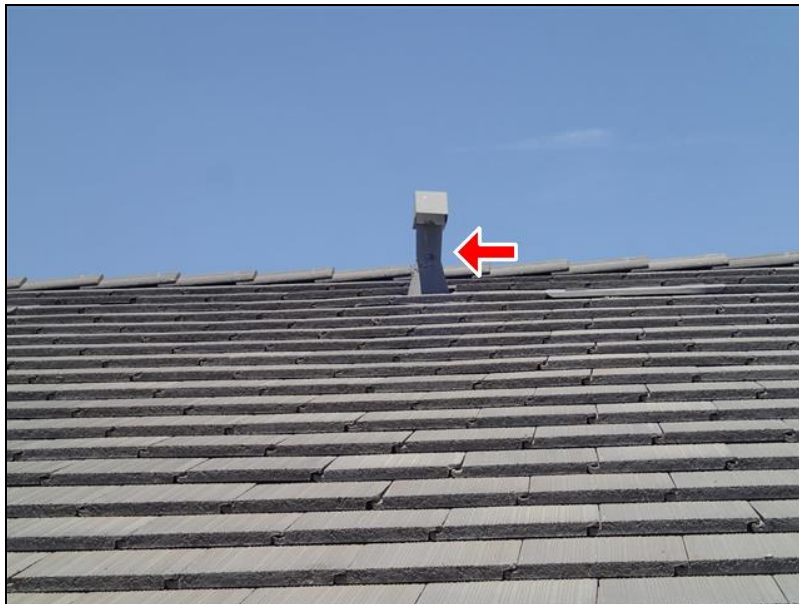
3.2 Item 1(Picture)

(2) Add a storm collar to the dryer vent to prevent leakage between the vent and primary flashing.

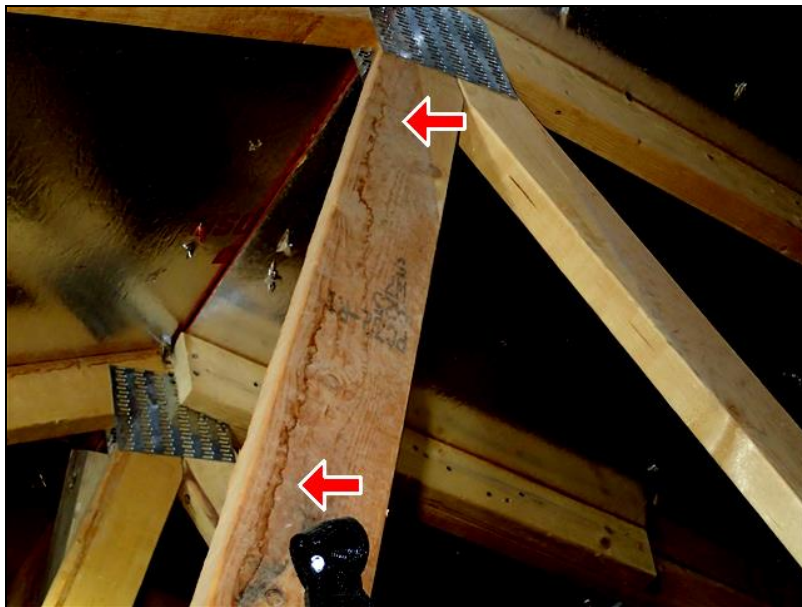
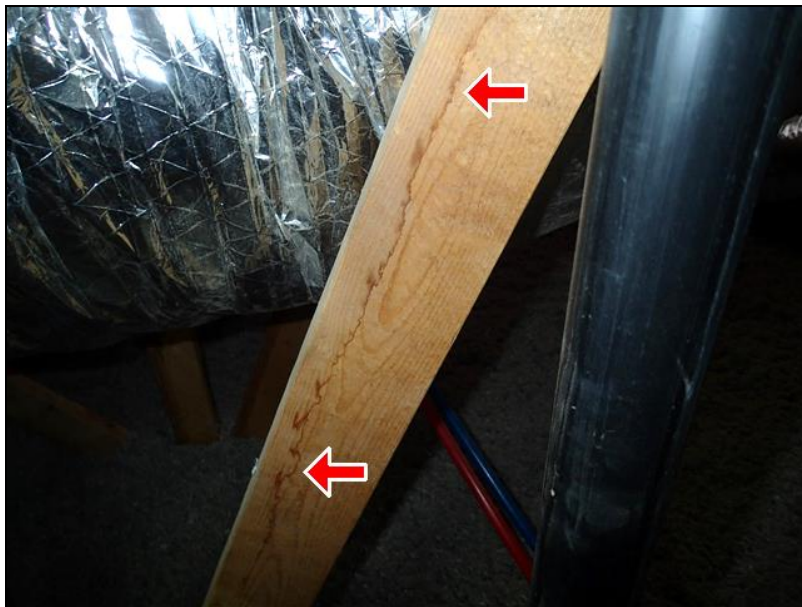
There are signs of leakage (water stains) in the attic on the decking and on the trusses. I recommend professional evaluation and repair as necessary.

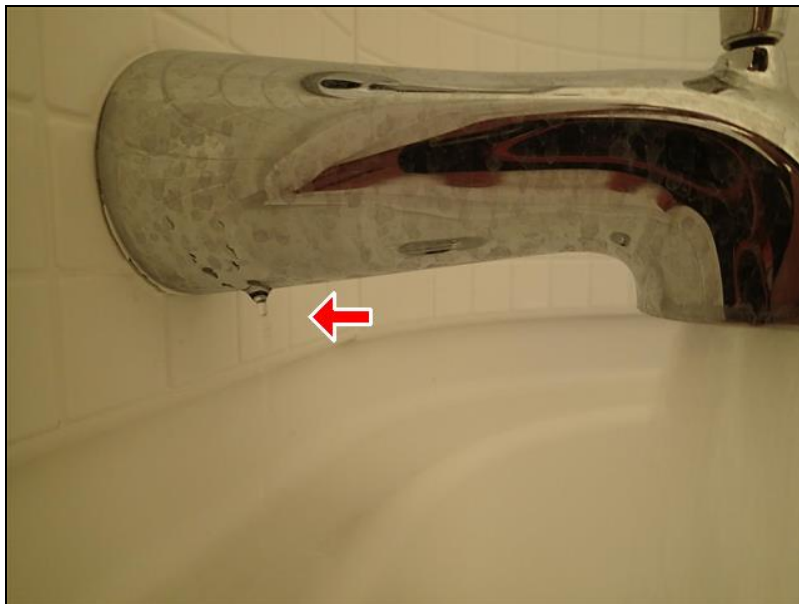
4.3 Item 1(Picture)

(2) The hall bathroom tub faucet is leaking. Repair or replace as necessary.

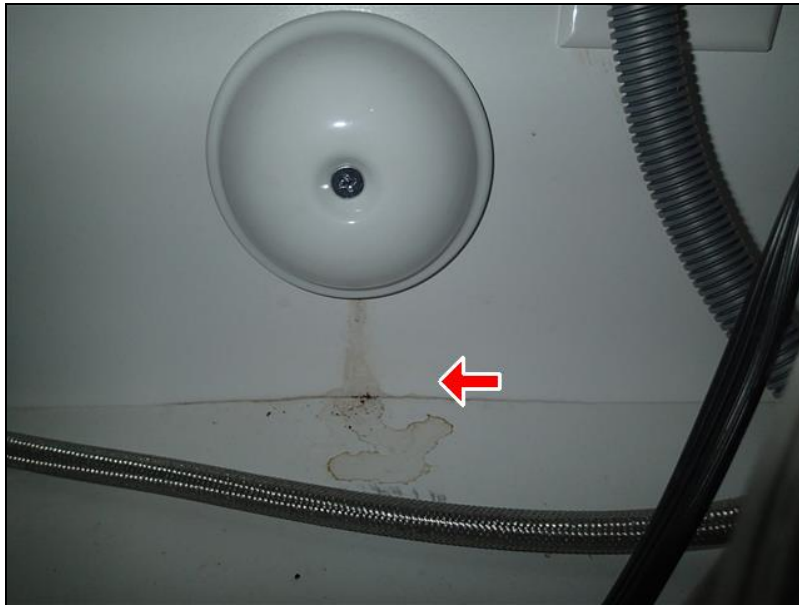
4.7 Item 1(Picture)

(2) There is evidence of leakage at the waste and vent piping cleanout underneath kitchen sink, I recommend professional evaluation with repairs as needed.

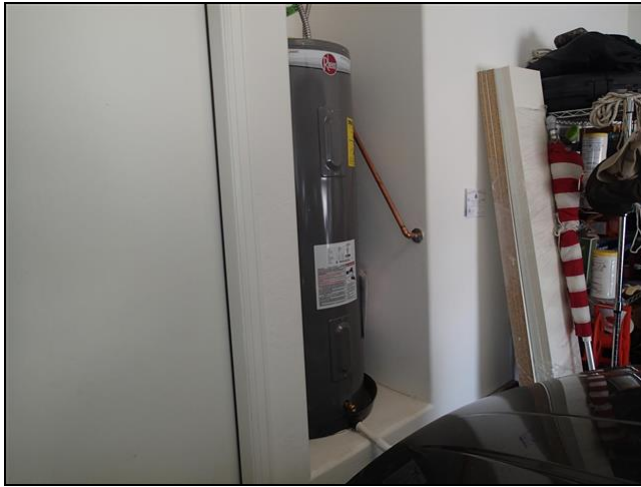
The water heater is in satisfactory condition and operational. The service life of a water heater in Arizona is 8-12 years.

4.10 Item 1(Picture) 2019 model, 50 gal

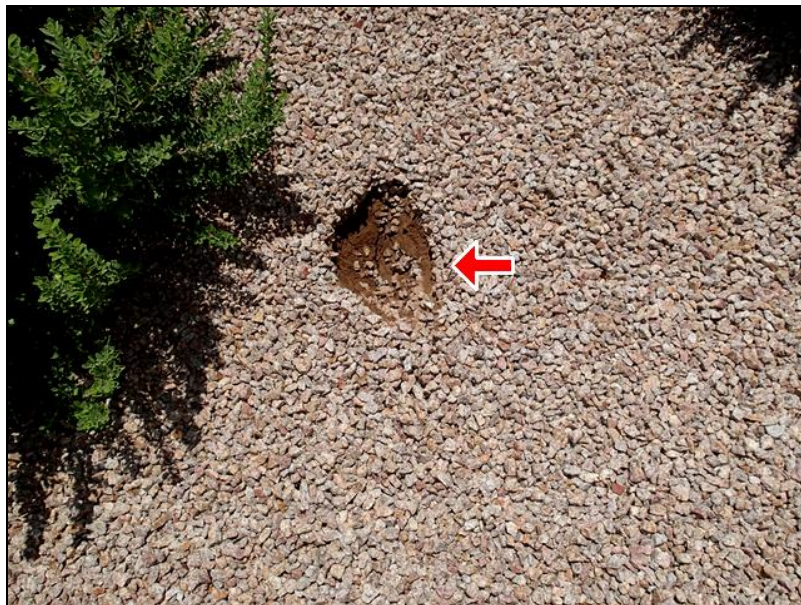
4.19 Item 1(Picture)

There is leakage at the irrigation plumbing at the front and rear yards. Additionally, there is water damage to the block fence at the rear yard. I recommend professional evaluation with repairs as needed.

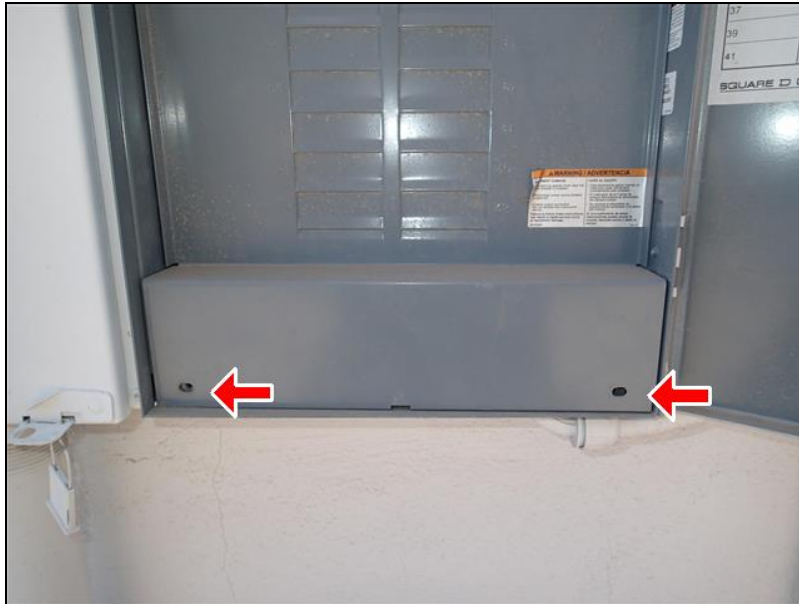
5.0 Item 2(Picture)

(2) Replace missing screws to secure the dead front panel.

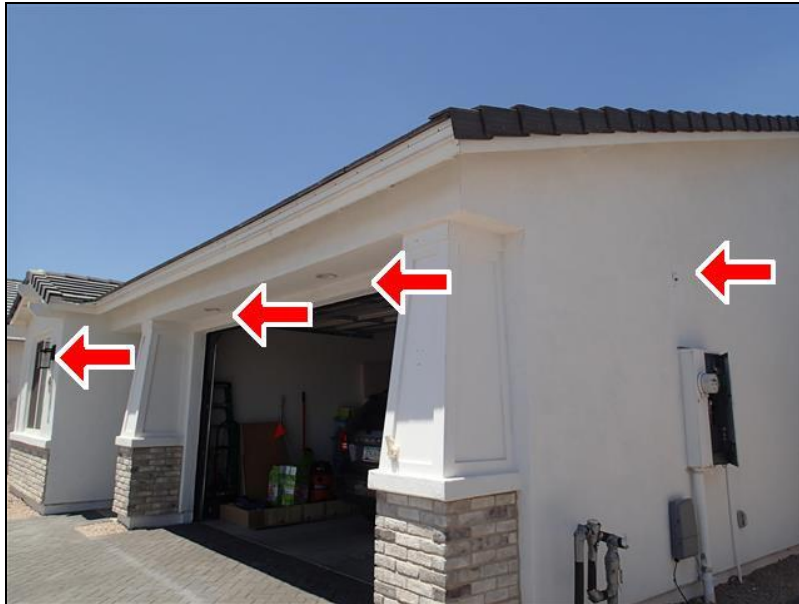
5.6 Item 1(Picture)

(2) The light fixtures on the front exterior of the house (above the front door, and on either side of the garage) are inoperable with the wall switches. These fixtures will often operate on a photo sensor. Verify their operation after dark. Replace the fixtures/bulbs as needed to verify operation or repair as necessary.

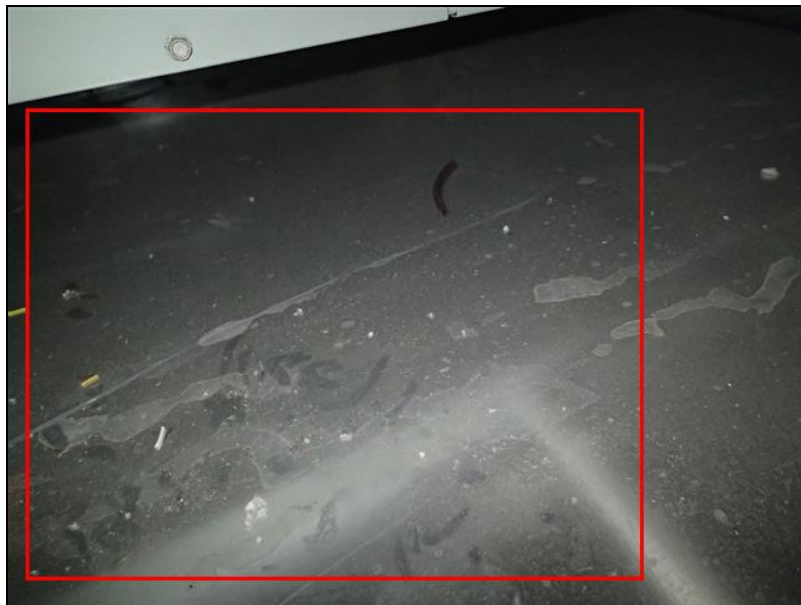
7.10 Item 1(Picture)

(2) Remove the debris from the secondary condensate drain pan to prevent obstruction of the drain lines.

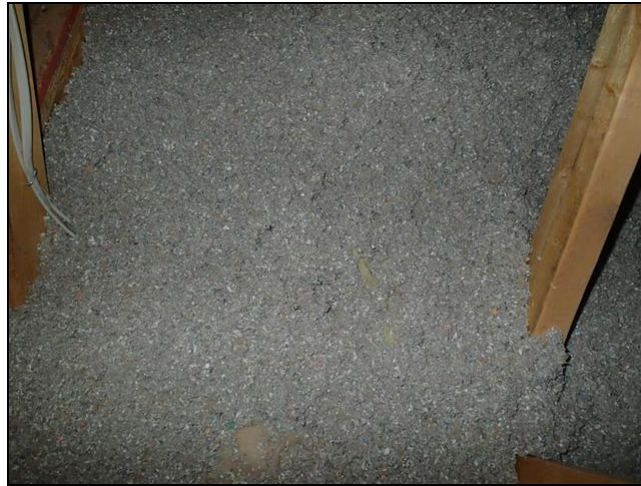
The visible insulation is in satisfactory condition. Attic visibility is limited, portions of the attic are not visible from the attic access.

9.0 Item 1(Picture) Blown cellulose insulation.

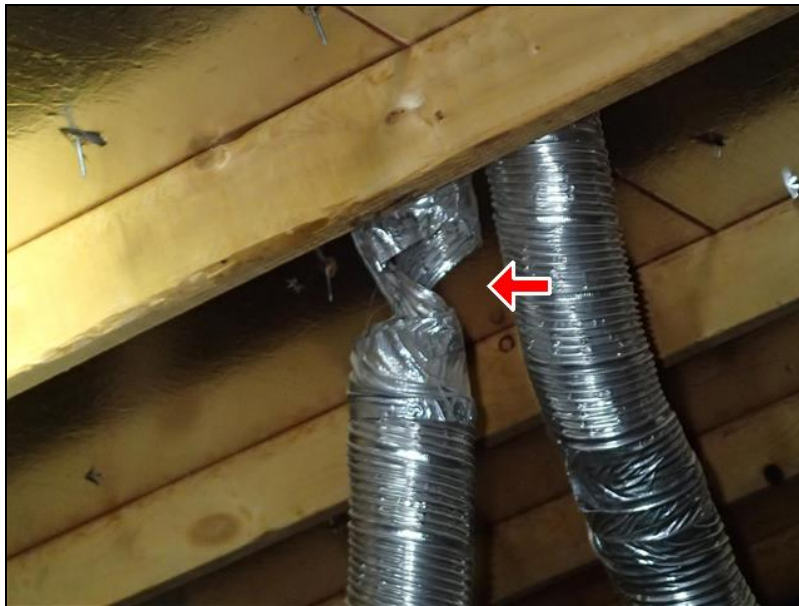
9.5 Item 1(Picture)

The master bathroom vent fan terminates in the attic. Remedy to allow the vent fan remove the warm moist air to the exterior of the home.

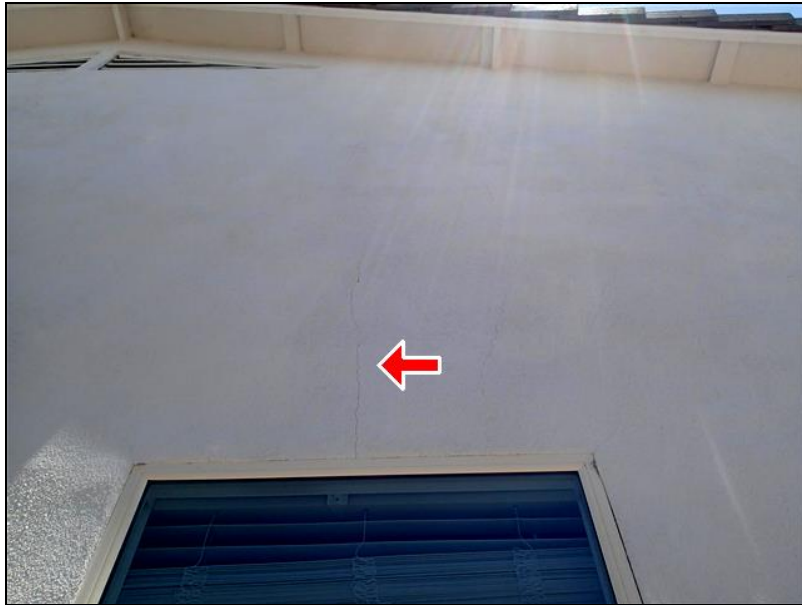
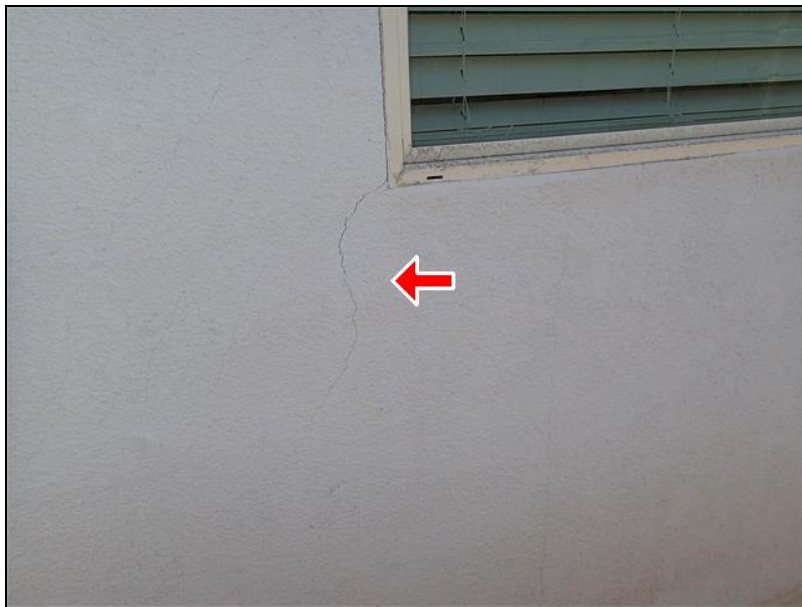
(2) There is evidence of previous movement on the walls in several areas throughout. Seal as needed, monitor for further movement and repair as necessary.

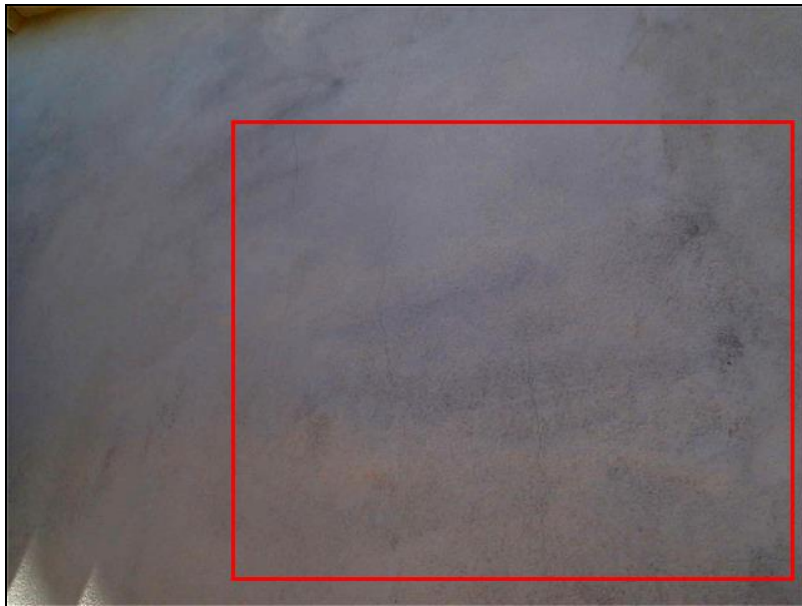
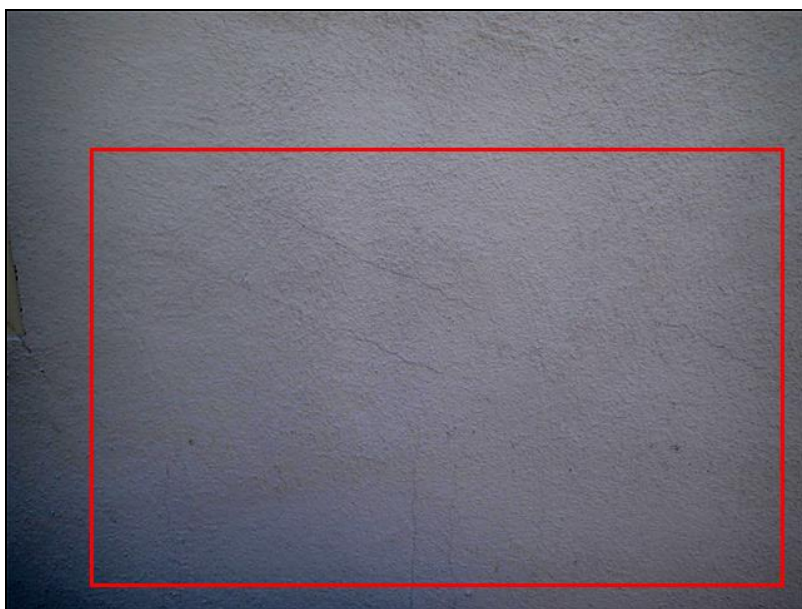
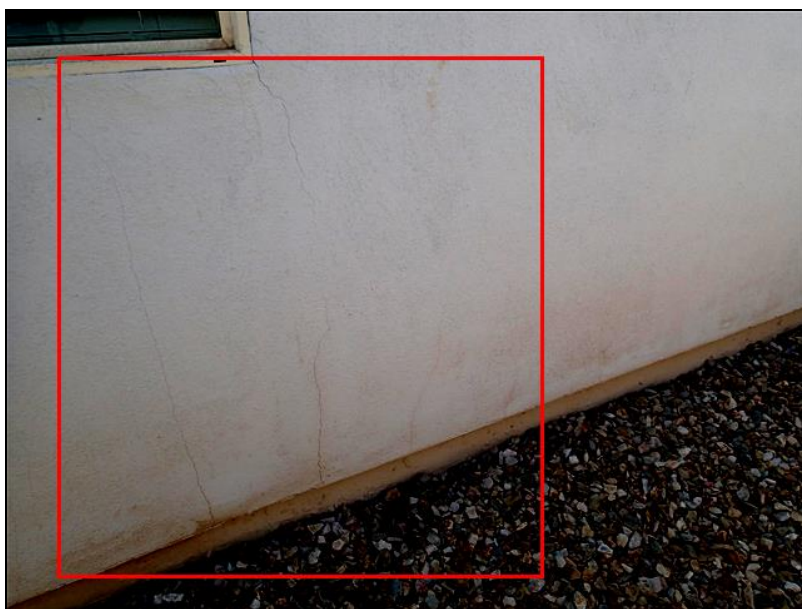
(1) There is excessive cracking in the stucco in several areas throughout. I recommend professional evaluation with repairs as needed.

(2) Seal all exterior penetrations as needed to prevent water intrusion.

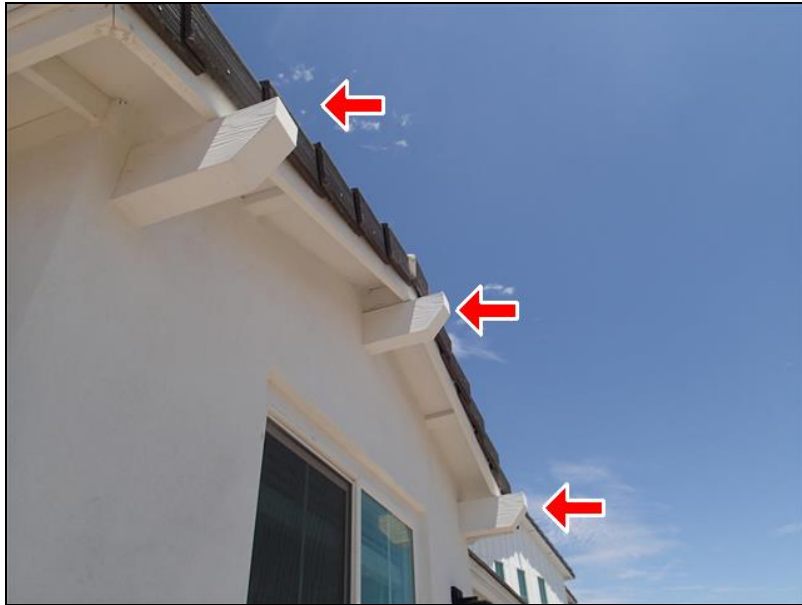
2.1 Item 1(Picture)

(2) The tops of the exposed beams are exposed, I recommend the installation of full width cap flashing to prevent further weathering.

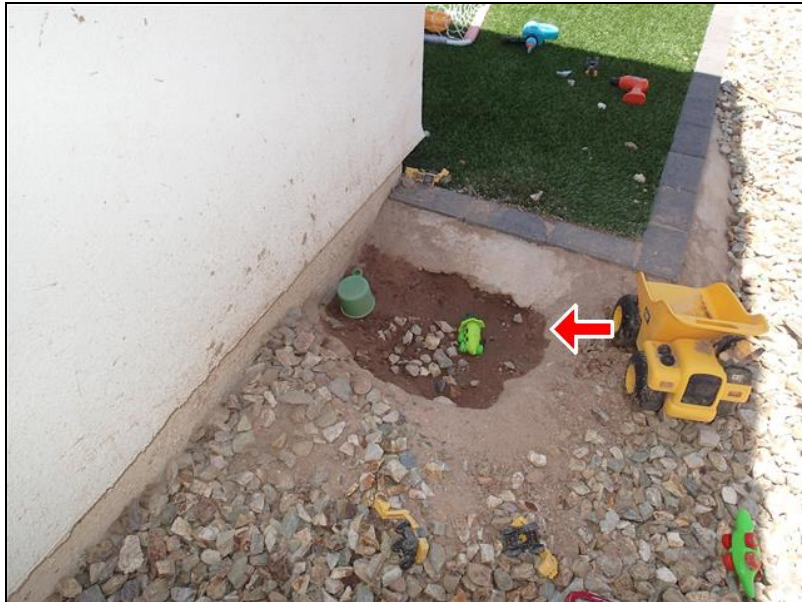
2.9 Item 1(Picture)

The grade is sloped toward the house on the right side. This will direct surface water into the soil adjacent to the foundation and cause water damage to the foundation concrete. Adjust the grade to direct surface water away from the foundation to prevent water damage.

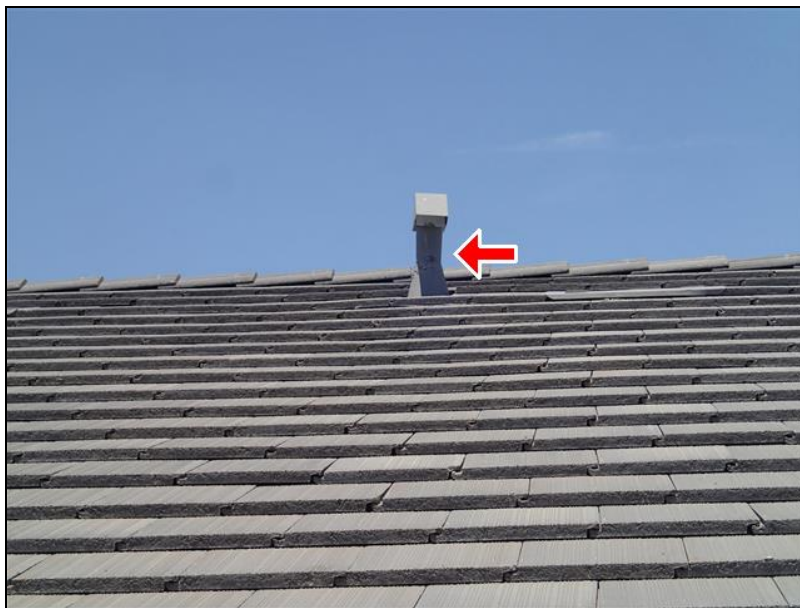
3.2 Item 1(Picture)

(2) Add a storm collar to the dryer vent to prevent leakage between the vent and primary flashing.

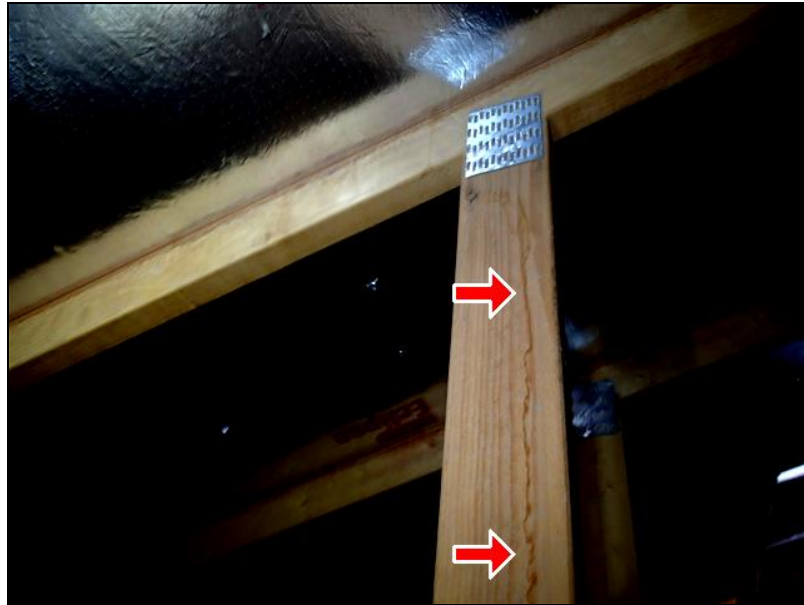
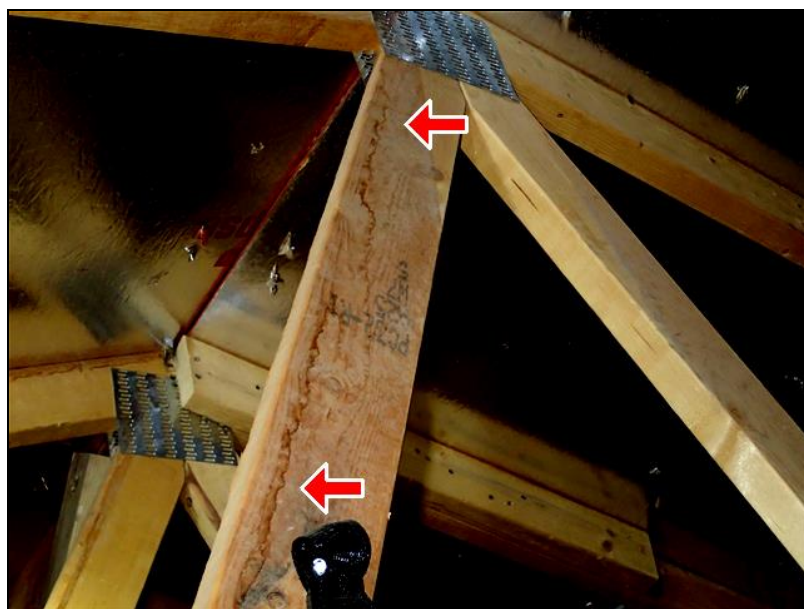
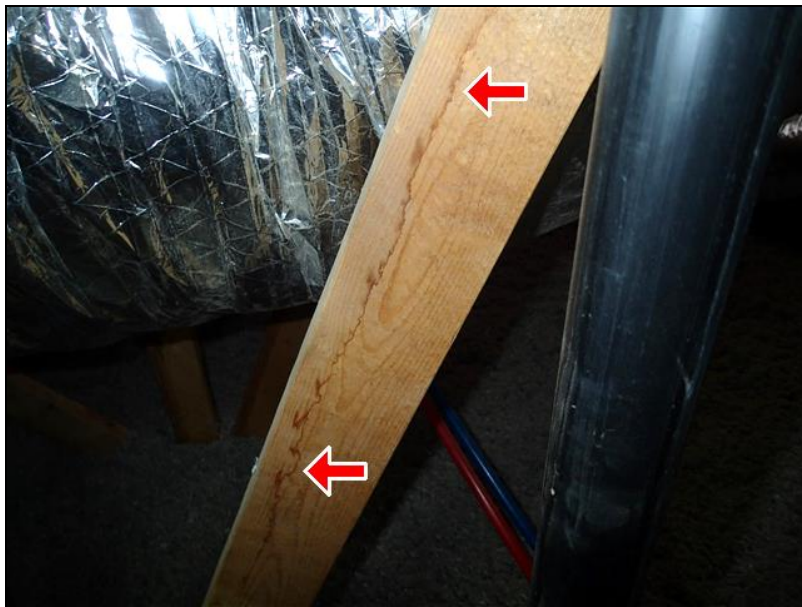
There are signs of leakage (water stains) in the attic on the decking and on the trusses. I recommend professional evaluation and repair as necessary.

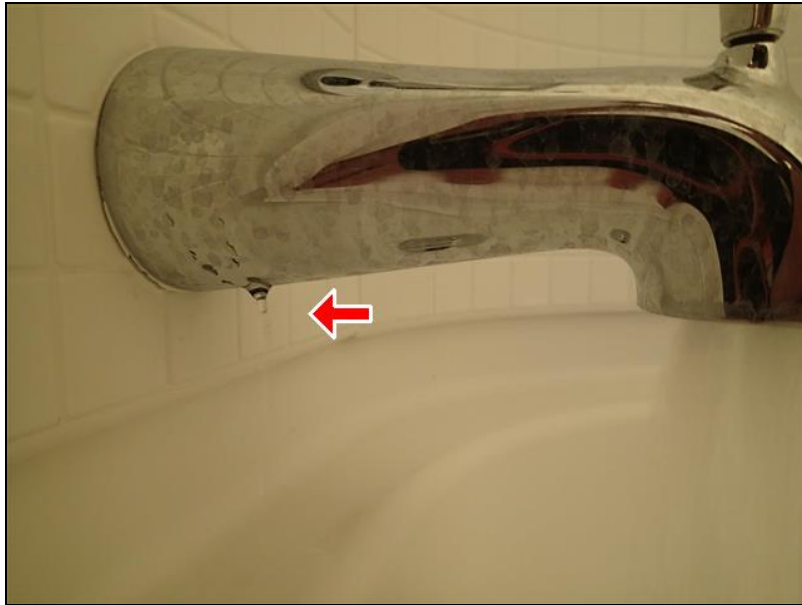
4.3 Item 1(Picture)

(2) The hall bathroom tub faucet is leaking. Repair or replace as necessary.

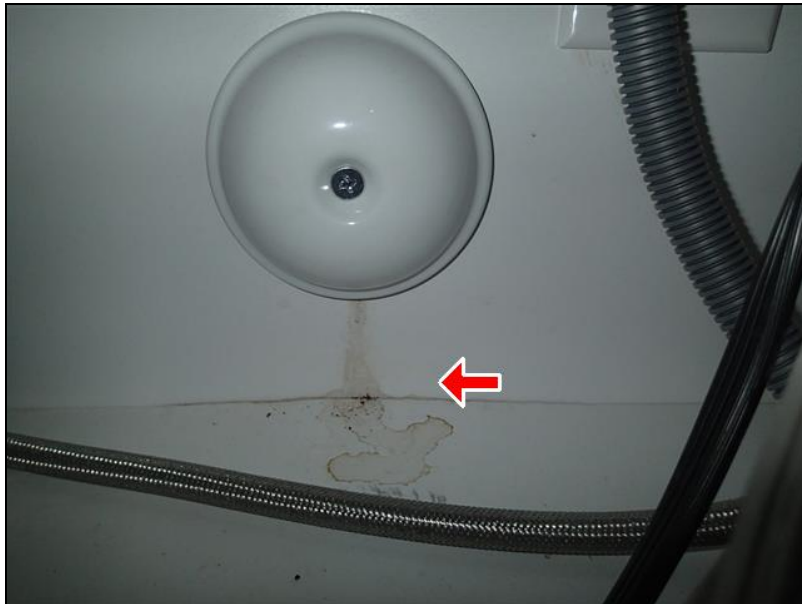
4.7 Item 1(Picture)

(2) There is evidence of leakage at the waste and vent piping cleanout underneath kitchen sink, I recommend professional evaluation with repairs as needed.

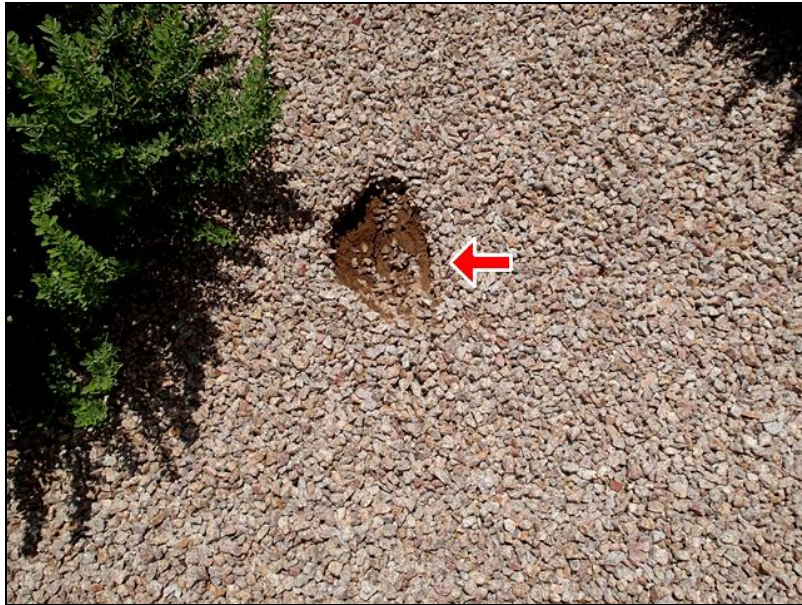
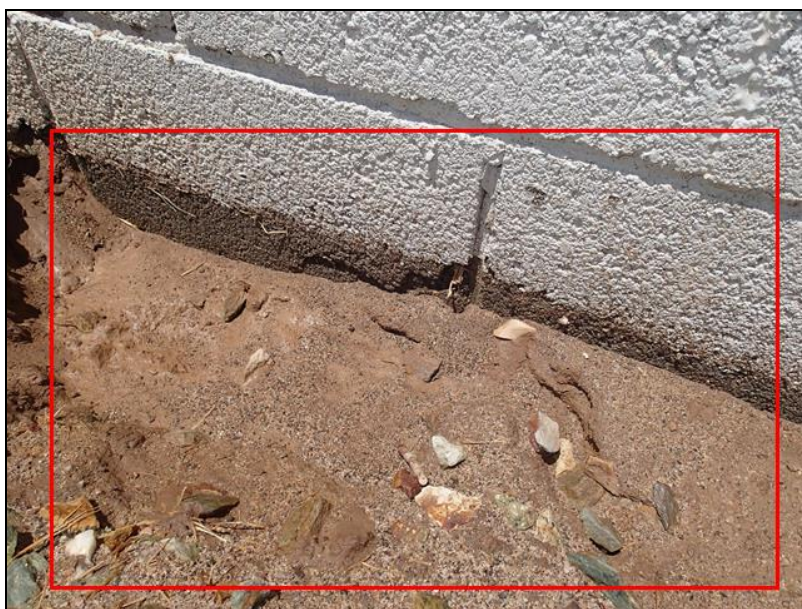
There is leakage at the irrigation plumbing at the front and rear yards. Additionally, there is water damage to the block fence at the rear yard. I recommend professional evaluation with repairs as needed.

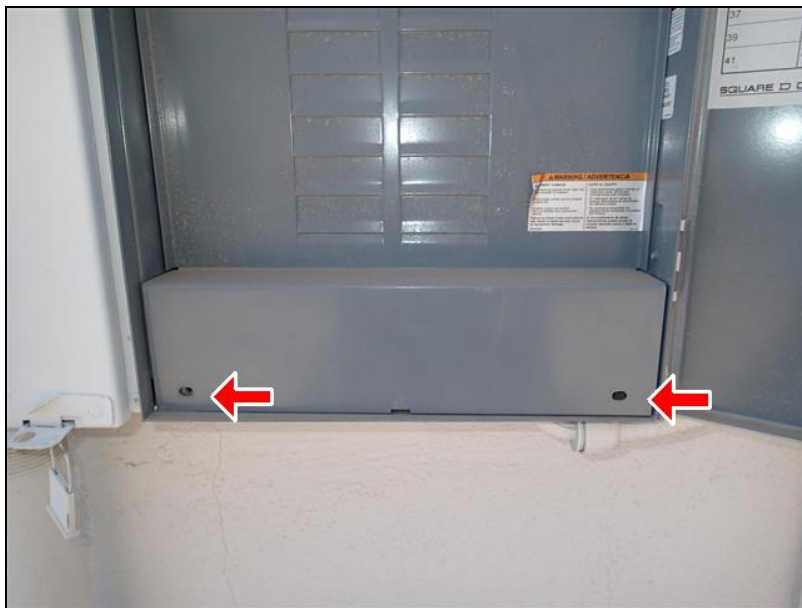
5.0 Item 2(Picture)

(2) Replace missing screws to secure the dead front panel.

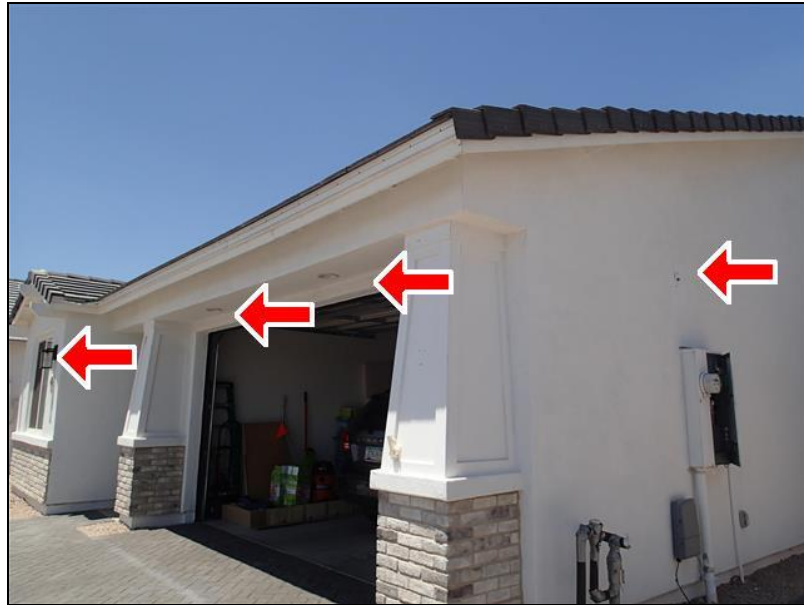
5.6 Item 1(Picture)

(2) The light fixtures on the front exterior of the house (above the front door, and on either side of the garage) are inoperable with the wall switches. These fixtures will often operate on a photo sensor. Verify their operation after dark. Replace the fixtures/bulbs as needed to verify operation or repair as necessary.

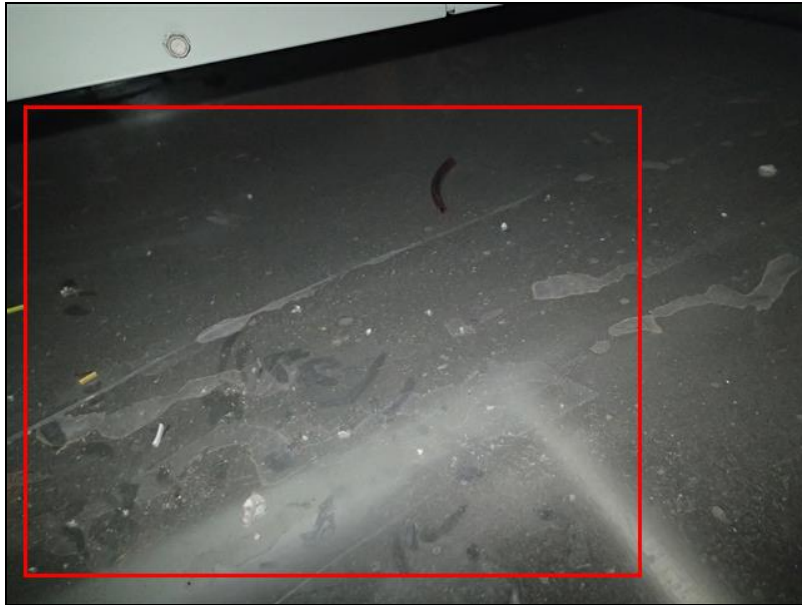
7.10 Item 1(Picture)

(2) Remove the debris from the secondary condensate drain pan to prevent obstruction of the drain lines.

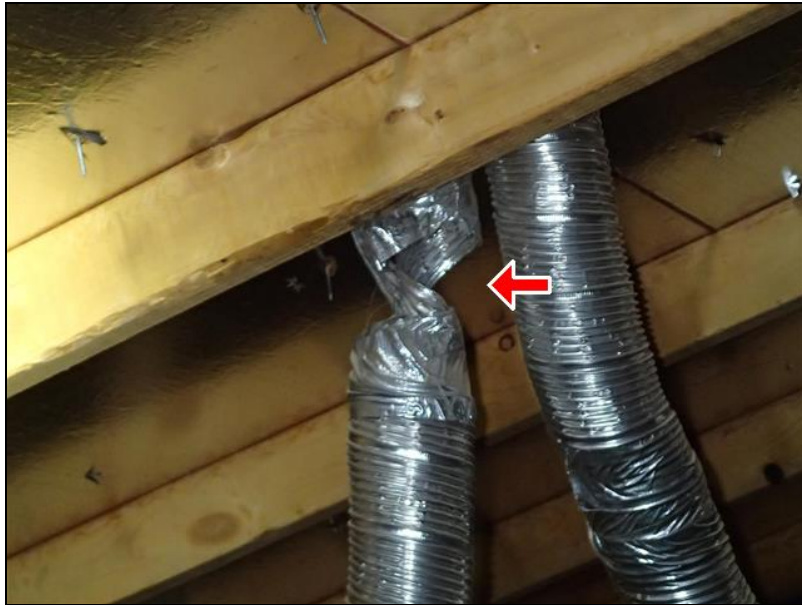
9.5 Item 1(Picture)

The master bathroom vent fan terminates in the attic. Remedy to allow the vent fan remove the warm moist air to the exterior of the home.
