# IMPROV\* AT THE 2926 RESTORATION SITE

Improvising With Available Resources To Solve Problems And Reduce Cost

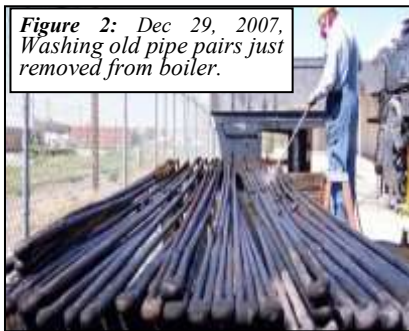
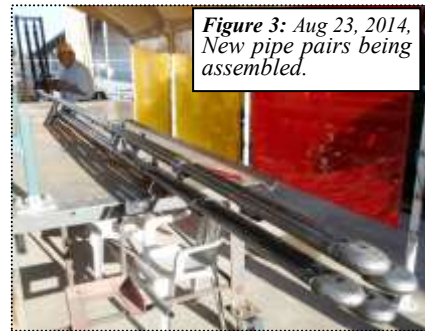
Figure 4: Fittings used to pair superheater pipes at the firebox end of the flue tubes are pictured above. Except for purchase of the fittings, this portion of the superheater tube task was on-site labor—a lot of labor, as in highly skilled welding by Carlos O. and a handful of pipe handlers.

Using connectors like those in Figure 4, two pipes are connected at one end to create a superheater pair that can fit inside a large flue tube. The connected end will face the firebox to resist the high heat and abrasiveness of sand used to clear the flue tubes. At the smokebox end, two pipes, (one each from two pairs) are connected with a fitting similar to the one at the firebox to create a four pipe assembly. The remaining two pipes are connected to the header, one on the inlet side (wet steam), and one to the outlet side (dry superheated steam).

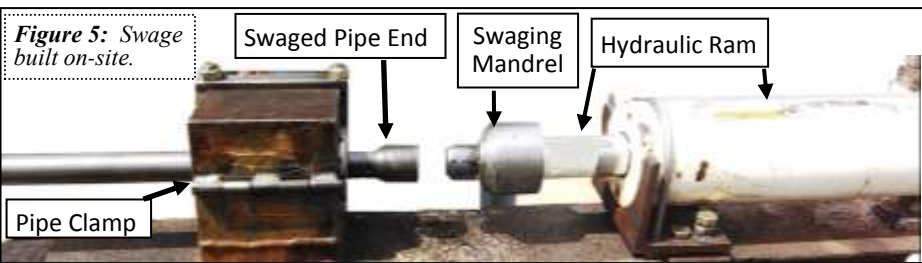
Figure 5, right shows the improvised swaging device up close. The clamp, mandrel and other parts were assembled on site. The setup may not look like a slick commercial model, but it did the job at a large cost saving.

That is when Dave V. decided to design and build a swaging device. With some high pressure hydraulic equipment, and the talents of the 2926 machinists and welders, the device soon began to take shape. It was mounted on a steel shop wagon that once hauled parts at the AT&SF backshops. With several volunteers pulling pipes out of storage, carrying them to the wagon for swaging, and placing them back in storage for easy access to welders building the assemblies, the entire stock of pipes was quickly swaged.

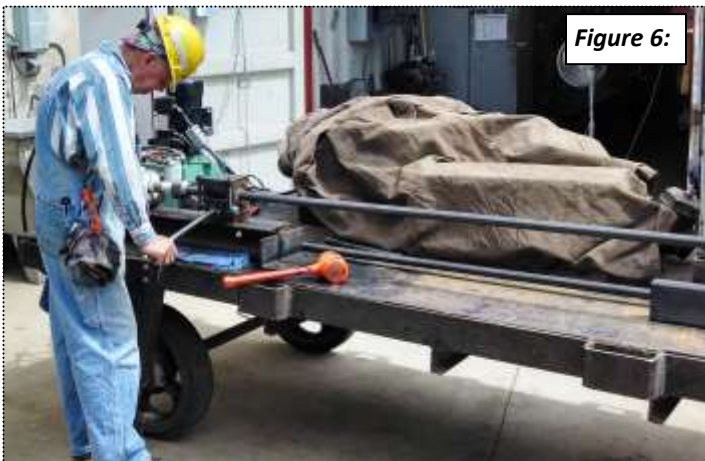
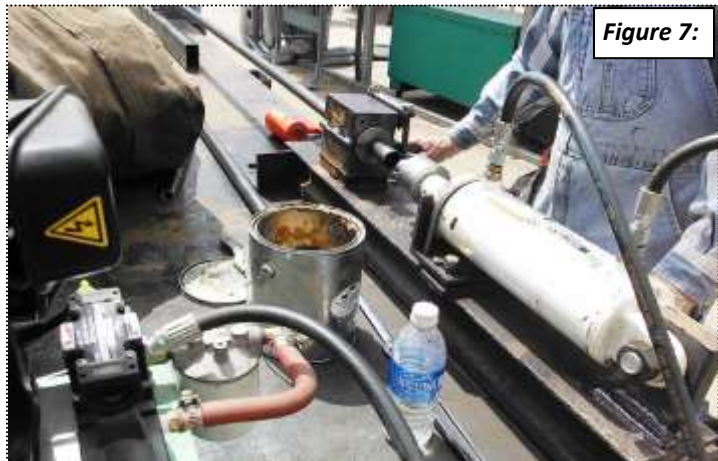
Figures 6 & 7, The swaging setup mounted on the wagon and operating. A brief video clip of the swage at work can be seen at the NMSLRHS web site ([nmslrhs.org](http://nmslrhs.org)) or on YouTube in a video titled “The 2926 Story”.

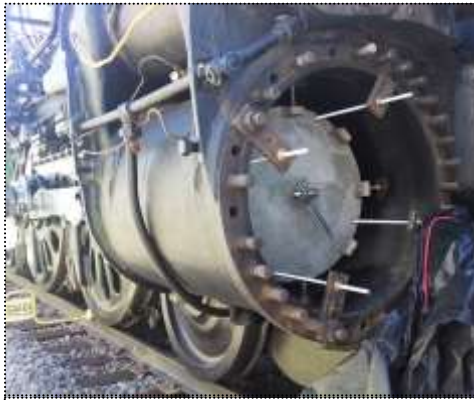
Figure 8, Above: Engineer side cylinder, front view., with center plate of hone in place.

the hone was mounted and centered in the cylinder. A bolt in the center of the plate then served as the front anchor point for the tramming line. Figure 8 at right shows the plate mounted in the front of the cylinder on the engineer's side of the locomotive.

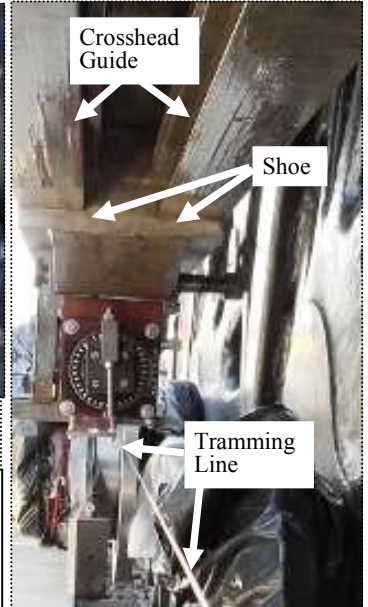
Figure 9, Right: The gauge (left center) is a key feature of the tramming setup. The bracket on which it and the rear terminus of the tramming line are mounted was fabricated in the 2926 machine shop.

The tramming line is then extended through the back of the cylinder directly beneath the crosshead guide and shoe to the rear anchor point on a bracket near the drive rod as shown in Figure 9.

Once the tramming line was installed and drawn tight, a number of measurements were made to check alignment of the drive rod, crosshead, crosshead shoe, and the center of the cylinder. Final adjustments were then made at the crosshead guide and crosshead shoe.

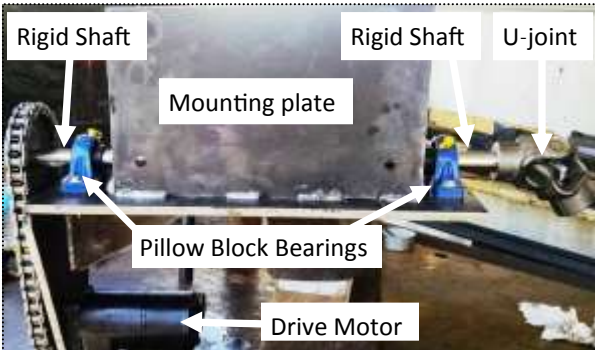
Figure 11: Cylinder hone drive under construction.

Material needed for the drive assembly of the hone was either available on-site, could be picked up at local parts and hardware stores, or across the tracks at Reliance Steel. In Figure 11, the drive assembly under construction on a work bench., and in Figure 12, it is mounted on the crosshead shoe.

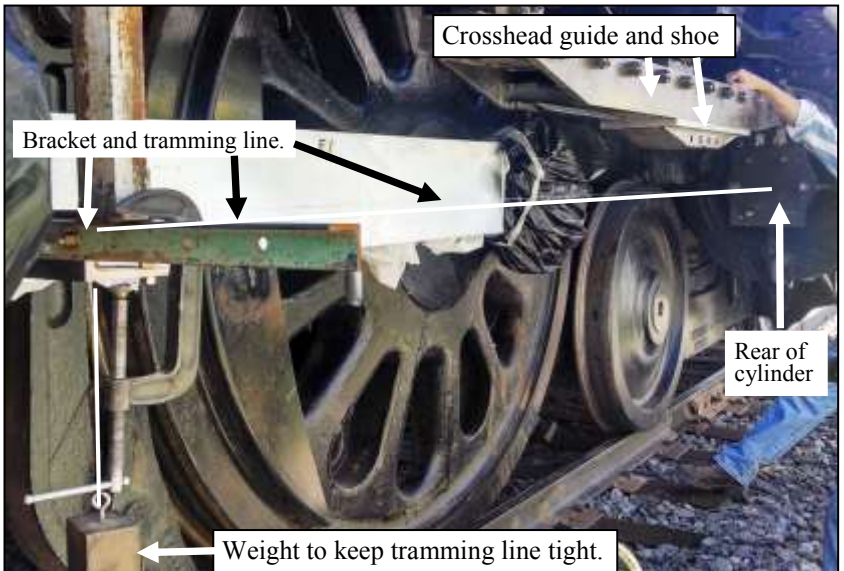
Figure 10: Oblique rear view of tramming line looking toward cylinder.

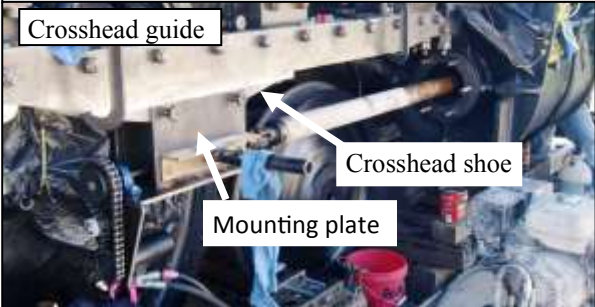
Figure 12: Cylinder hone drive assembly mounted to the crosshead shoe and connected to cylinder hone.

Heavy steel plate was used to build a frame for the drive assembly. A portion of that frame was used as a mounting plate to be attached to the crosshead shoe. That allowed the assembly to be moved back and forth manually as the drive rotated. A handle was attached to facilitate the movement.

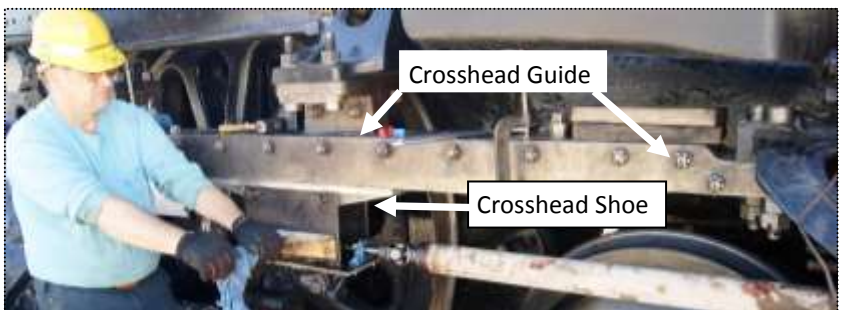
Figure 13: Using a handle attached to the drive assembly mounting bracket, Don MacCornack moves the crosshead shoe and attached hone assembly back and forth.

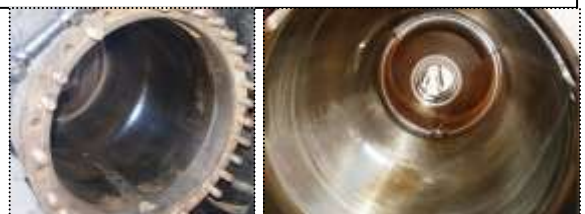
Figure 14: Left, before honing. Right, after honing.

The 'homebuilt' honing system worked fine. There was plenty of volunteer labor available at the 2926 site, and the parts cost was minimal. The before and after pictures in Figure 14 reveal once again that ingenuity, determination, a few bolts and nuts, and assorted scrap items can meet challenging tasks and significantly reduce cost. Next, a less complex, but important improv case.

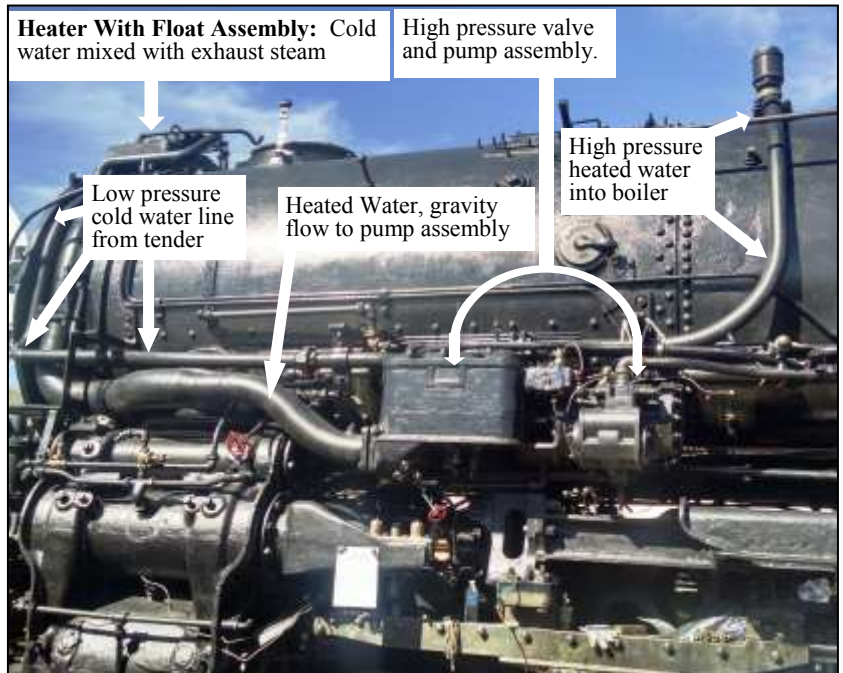
Figure 17: Fireman's side front of 2926 shows feedwater components.

In the feedwater heater, the cold water from the tender is mixed with steam by spraying it into a body of exhaust steam. It then flows with gravity to the hot water reciprocating pump that pumps it into the locomotive boiler. Pump speed, cold water volume, and the steam that runs this pump are controlled by a float in the feedwater heater. See Figure 17 at right.

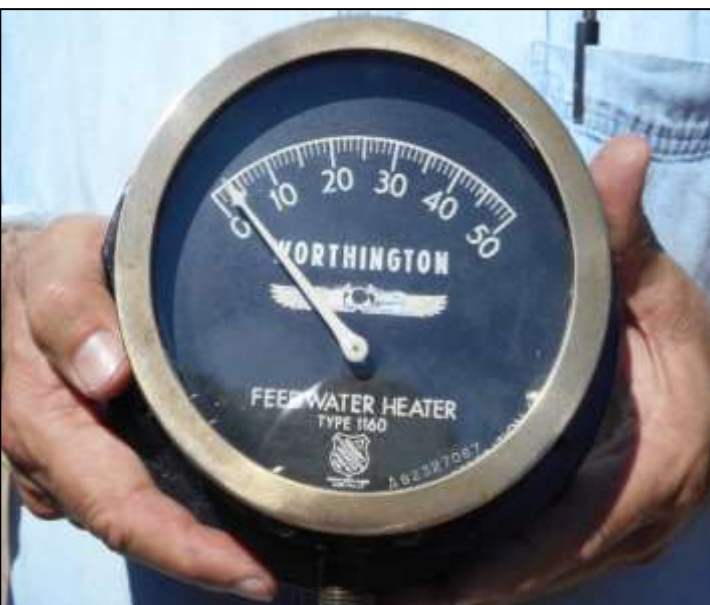
Figure 18: A functional gauge for 2926, courtesy Albert Leffler's eBay shopping, and David Thorpe's restoration skill.

There is an essential gauge in the cab Figure 18, that is connected to the cold water pump discharge pipe, and registers the pressure developed by the cold pump, in delivering water to the heater. The pressure is a combination of three resistances: 1) the resistance of raising water from tender level to feedwater heater; 2) Resistance created by the friction in discharge pipe, line check valve, and spray valve; and 3) Resistance of locomotive exhaust steam pressure in feedwater heater against which the water is delivered.

For ATSF 2926, both the cold water pump and the hot water pump were intact after years in the park, but the cab gauge was missing. A search began, and soon an authentic Ashcroft Worthington Feedwater Heater Gauge Type 1160 was offered on eBay, and we purchased it. The gauge was then restored and calibrated by antique gauge expert David Thorpe in far-away New Hampshire. . . Albert Leffler

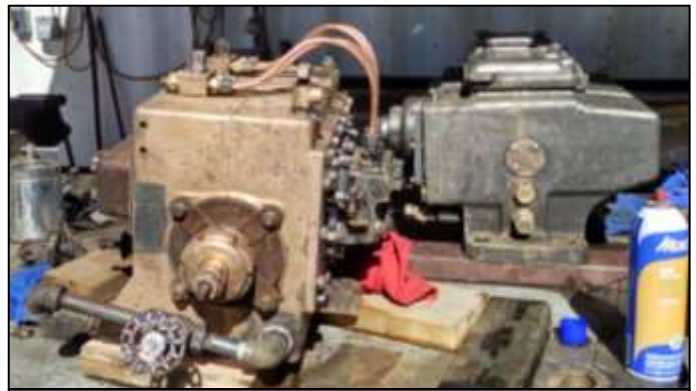
Figure 19: Two of the 2926 self lubrication units on workbench awaiting cleanup before reinstallation.

AT&SF 2926 has a self lubrication system, with three separate units, Figure 19. To reach all points that need a steady flow lubricating oil, there are hundreds of feet of small lines on the locomotive.

After a half century of inaction, those lines are clogged with gelled oil, rust, and in the lines that have been disconnected over the years, dirt, spiders, etc. Obviously, they need flushing. In discussing ways to clear the lines, machinist Dick Downing said, "Just get a power steering unit from an automobile, and drive it with an electric motor. Use it to pump solvent through the lines until they are clear."

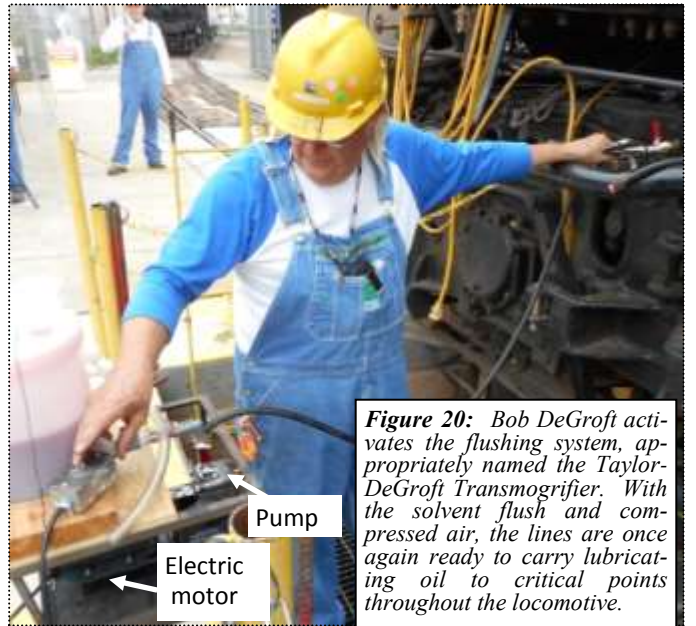
Figure 20: Bob DeGroft activates the flushing system, appropriately named the Taylor-DeGroft Transmogripher. With the solvent flush and compressed air, the lines are once again ready to carry lubricating oil to critical points throughout the locomotive.

At the site, the improv team went to work with the pump, an electric motor, hoses, fittings, and a plastic tank fluid reservoir. It was assembled and mounted on two pieces old garden train trestle and wood scraps—and **Presto!**—a custom built Swedish-American oil line flushing system shown in Figure 20 was ready to go. A combination of the jury-rigged flushing system and compressed air was immediately put to work clearing the many feet of clogged lines.
