BIG STEAM NEWS

NEW MEXICO STEAM LOCOMOTIVE & RAILROAD HISTORICAL SOCIETY

Vol XVI, No. 2

WRAP IT UP!

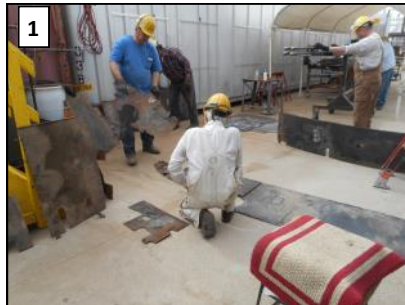
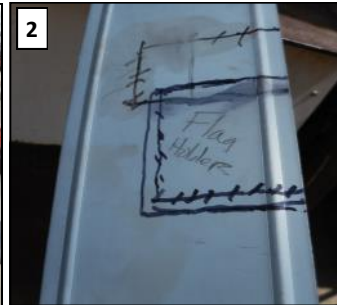
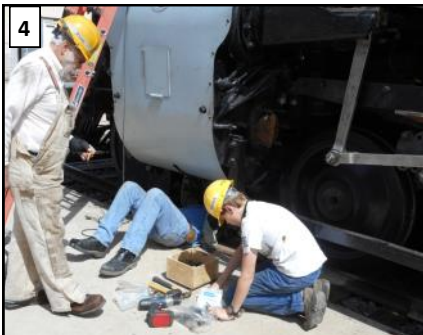
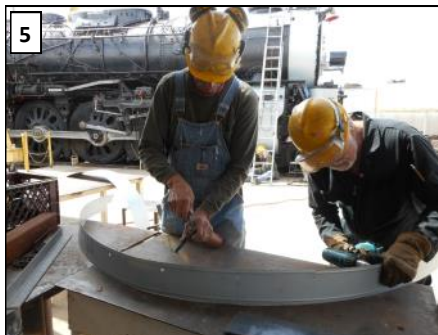
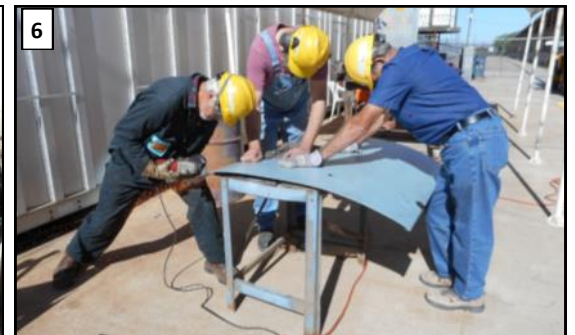
Photo 1: Some jacket pieces suitable for use to produce patterns are quite large. With no work benches large enough to use for layout, a large space on concrete next to a storage was used.

Photos 2&3: This small piece of jacketing was marked for final cutting to fit (2). Before cutting, it was double checked in the exact location that it would eventually be installed (3).

Photo 4: This shows the fit check of a large piece of jacketing that covers one of the locomotive pistons.

Photos 5 and 6: After the fit check and marking of any points that need additional cutting, each piece undergoes any necessary modification for a final accurate fit.

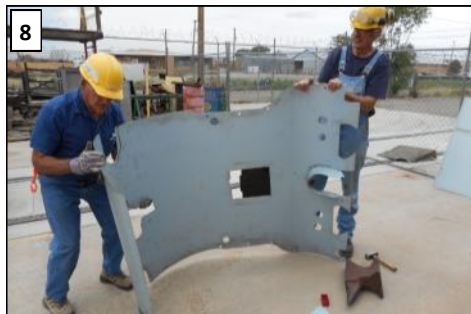
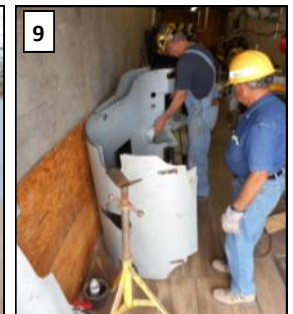
Photo 8: The large piece shown in Photo 4 is being held to demonstrate the complicated final shape of each piece of jacketing. Finally, once all fit checks and necessary trimming and cutting are done all pieces are placed in storage (Photo 9) to await a trip to the paint contractor.

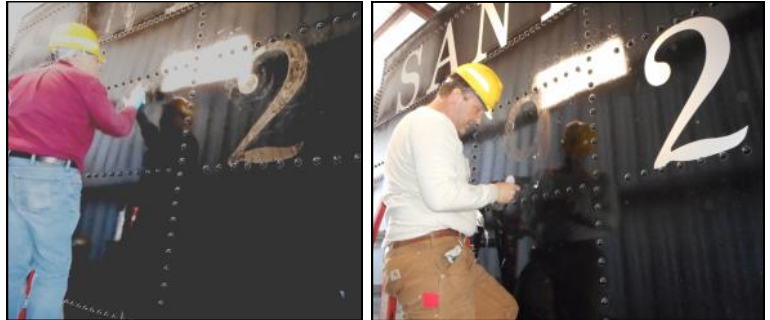
The task started with removal of the stick-on letters. That proved to be no simple task. After almost a decade cooking in the New Mexico sun, they were very set in place. Removal meant some hard labor by volunteers. The scraping, and sanding is pictured at right.

Removing Stick-on Letters: Ernie and Chris removing those pesky, letters that were really stuck—and incorrect according to some purists.

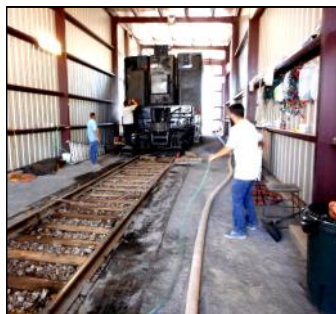
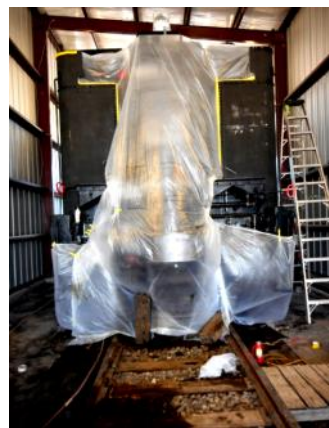
These two photos show the A Real crew at work on the preparation. All work was done inside the engine shed.

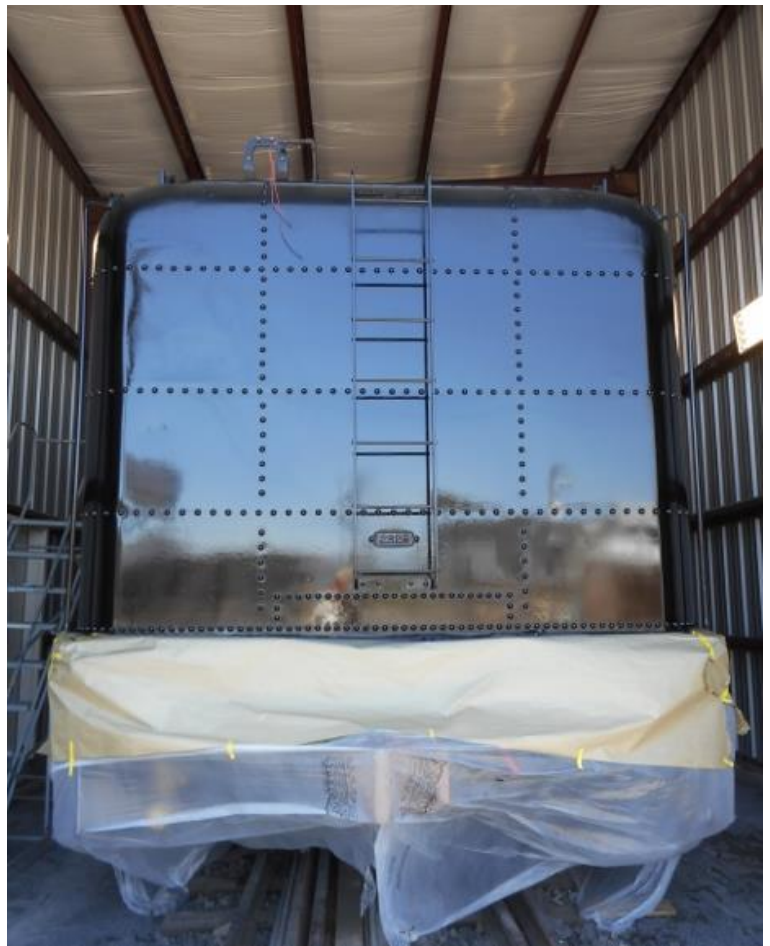
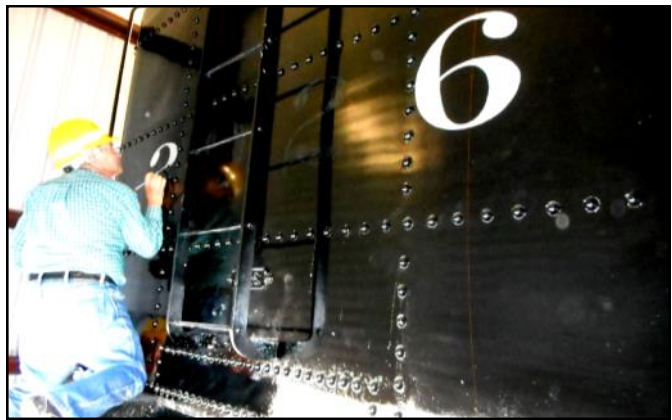
The Santa Fe 2926 water and fuel tender now sports a finish that looks like a black mirror. The large picture of the rear of the tender (above right) shows the reflectivity of the new paint job. The new coat of paint reflects both the quality of the Dupont Imron and the talent of the A Real team in applying it. In the picture, the fuzzy images along the bottom of the mirror finish are the photographer and a reflected view of buildings across 8th St from the entrance to the restoration site.

Finally, (above left) Ernie Robart begins work on the new letters—and they **are not stick-on**. A lifelong rail photographer and one of the group that founded the Cumbres and Toltec narrow gauge line that operates between Chama New Mexico and Antonito Colorado, he could be considered one of those font critiquing purists. He can be expected to do a good lettering job.

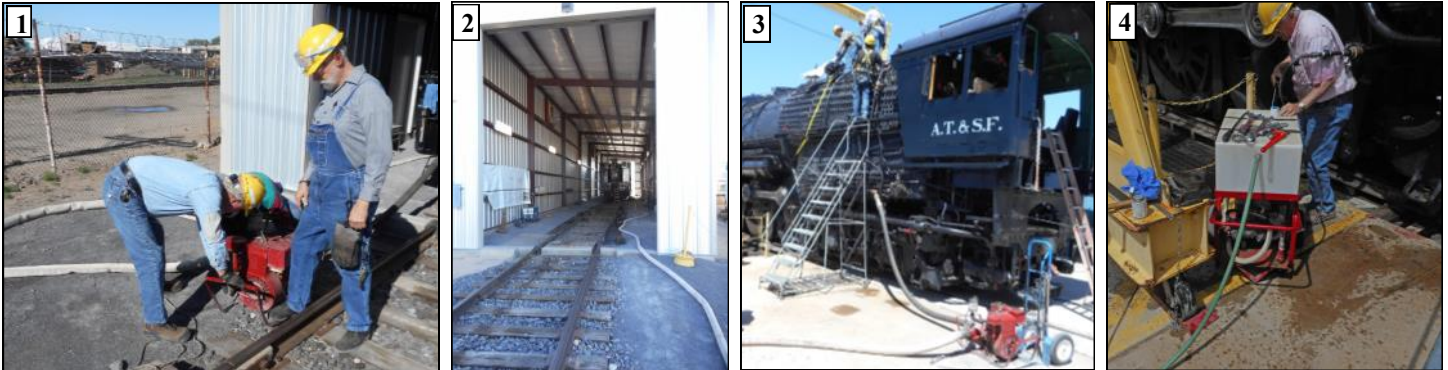
The pictures above show the four steps to water handling for the pressure tests. In the first photo, two volunteers attend to a pump at the end of the tender closest to the fireplug. The second shows the fire hose running the length of the engine house from the rear of the tender toward the locomotive at the test location. The connection at the rear was added by Rick Kirby during the tender restoration to facilitate the use of a second tender or water tank. Photo 3 shows the connection to the locomotive to fill the boiler. In photo 4, Rick sets up the rented hydro machine.

From March until that final pressure test in June, numerous water pressure tests were done at increasing pressure levels using a portable fire pump, and finally the hydro machine. Each time more leaks were found, they were marked, the water was pumped back to the tender, and the work crew went to work sealing them. Most of the leaks related to staybolts, but there were also leaks at washout plugs and valves.

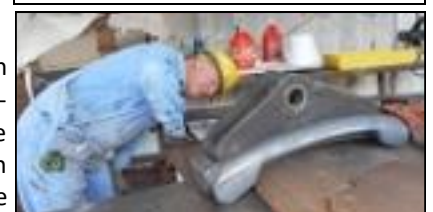
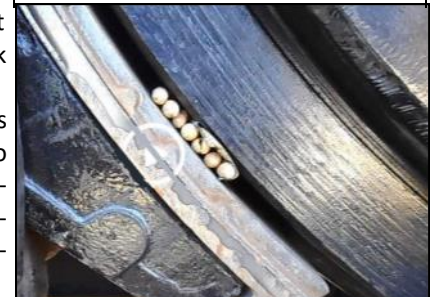
All the linkage was renewed and new cast brake shoes were produced by Horizon Metals, Inc. in Nephi, Utah. Reassembling the linkage, and installing the shoes called for a lot of physical work, often in tight spaces. The locomotive had to be repositioned over the pit often in order to gain access to various parts of the brake system. The last step in this task was adjustment of slack in the linkage.

When adjustment of brake linkage slack on all eight drive wheels was complete, it was time for a test. On Saturday, June 10, when Lurch the car mover was pushing 2926 back into the engine house, the brakes were tested. Lurch gave 2926 an extra quick push. Henry Roberts, sitting in the 2926 engineer's seat, applied the air brakes. That action brought the engine and Lurch to a smooth stop. Santa Fe 2926 had come to a stop with its own brake system—upgraded to current requirements—for the first time in more than 60 years.

Above: The size of brake units is revealed by this brake shoe carrier.
Below: New brake shoe mounted and properly adjusted can quickly turn these peanuts into peanut butter.

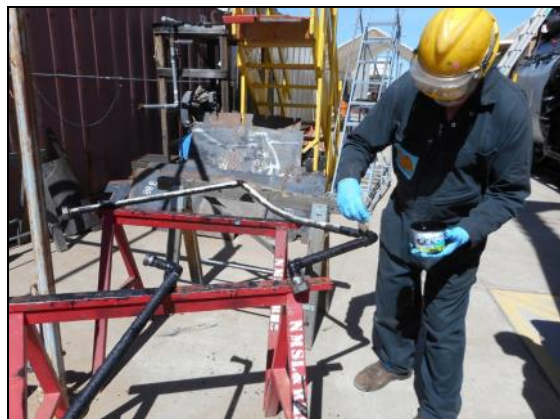
Without that handy parts source, acquiring piping for the 2926 restoration was only the first step. Lengths of stock pipe of the desired diameter were purchased. The new pipe was cut to proper length for the intended use. It was then bent to proper shape, fittings were added, and it was painted. (Photo at right) Installing the pipe usually meant producing new brackets, and welding them into place on the locomotive and tender. Most of the piping tasks were not as difficult as they were time consuming. They included appliance air piping in the cab, as well as conduit for the MU (Multiple Unit) equipment between the locomotive and tender.

Almost There: The piece of pipe being painted has been bent to fit the place it will be installed, fittings have been added. With such a crooked pipe, the final step, installation, may require a bit of manipulation.

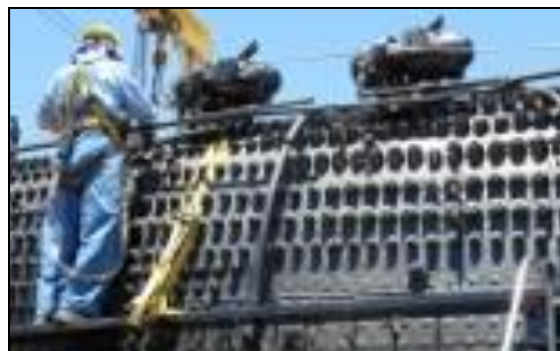
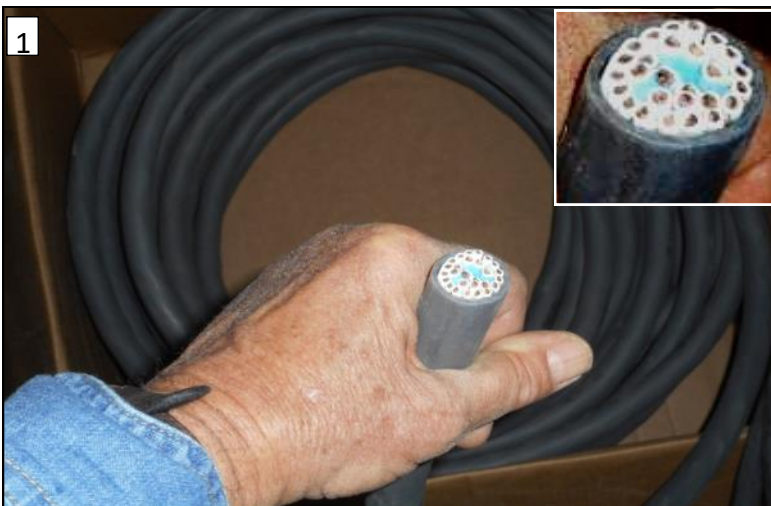
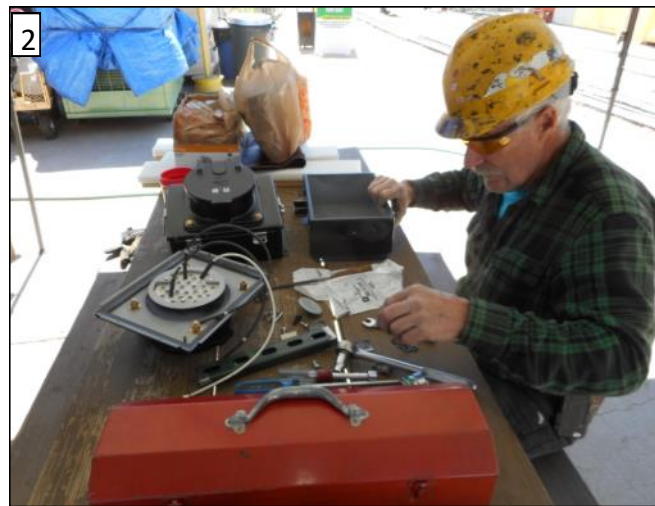
Upgrading Santa Fe 2926 to current requirements means more than just replacing the original wiring. The upgrade of the brake system created a significant need for increased electrical power. That, improved lighting, and other new electrical appliances required the addition of a second dynamo. That, in turn, required new brackets for mounting it next to the original. Both dynamos are shown in the picture at right.

Replacing old wiring and upgrading lighting fixtures was pretty straight forward electrical work. Upgrade of the MU system was a different task. In addition to adding brackets for the conduit on the tender, a lot of wiring was necessary on each end of the cable. For the MU installation, 85 feet of 27-wire cable was ordered. It is shown in Photo 1 below, with an inset showing an end of the 27 wire bundle.

The cable will reach from the locomotive cab to the rear of the tender. In Photo 2, George is working on wiring an MU plug for one end of the cable.
