BIG STEAM NEWS

NEW MEXICO STEAM LOCOMOTIVE & RAILROAD HISTORICAL SOCIETY

Vol. XVII No. 1

Jan--Feb--Mar 2018

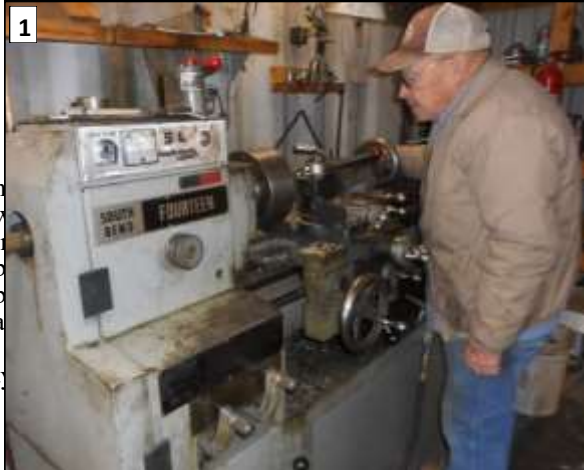
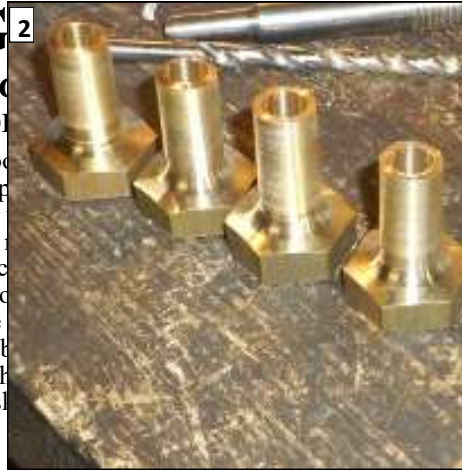
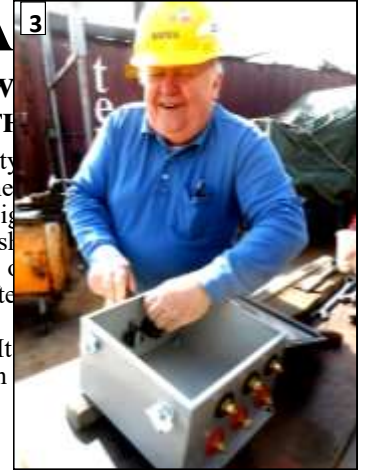
Replication of rusted, damaged or missing parts has kept the 2926 machinists busy making those that cannot be bought locally. In the first photo, John M. is producing some of the many small parts (Photo 2) needed for completion of the restoration.

Several of the tasks currently underway involve components that did not exist when 2926 was in operation. Typical of such items is the electrical distribution box (Photo 3) that Perry B. is assembling.

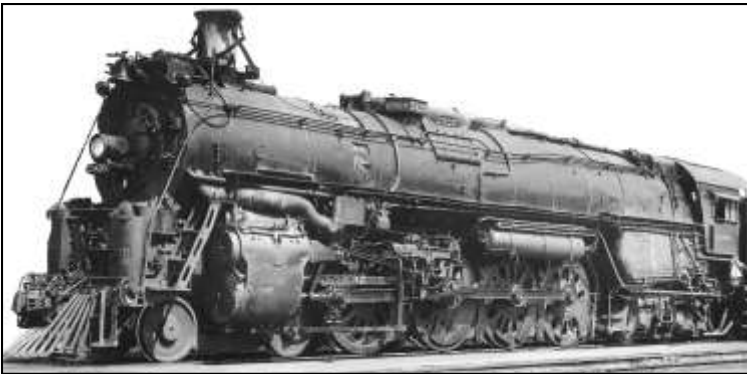
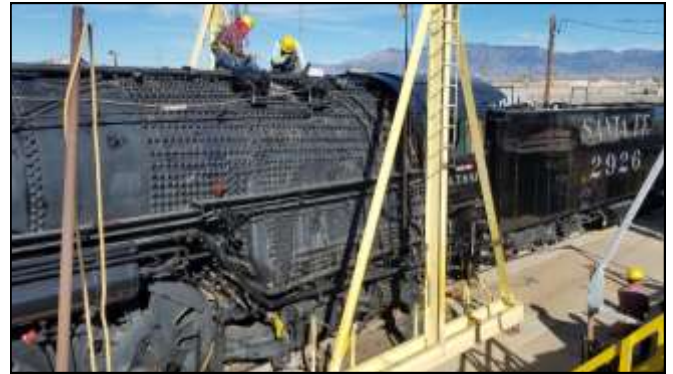
A glance at the two pictures below would seem to indicate that putting new sheet metal jacketing on 2926 would be little more difficult than replacing sheet metal on an automobile. Though the 2926 crew did have a lot of help from some skilled automotive metal specialists, the job was difficult and very time consuming. The first picture below shows 2926 before half a century rusting away in Coronado park. The second picture, taken a few weeks ago, reveals the many pipes, bolts, and related components that will be insulated and shielded with sheet metal jacketing to return 2926 to its original appearance.

There are numerous steps necessary to achieve this goal. The 2926 volunteers put many hours of labor into the insulating and jacketing project. They also needed help from local sheet metal and paint shops. Several of the resulting tasks are described in the following pages.

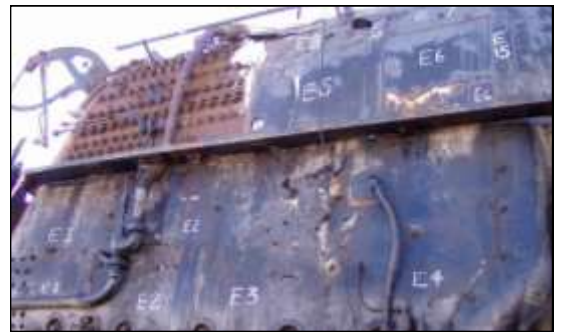
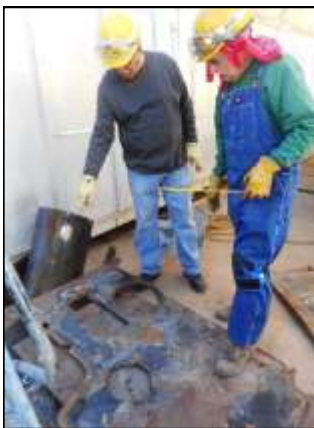
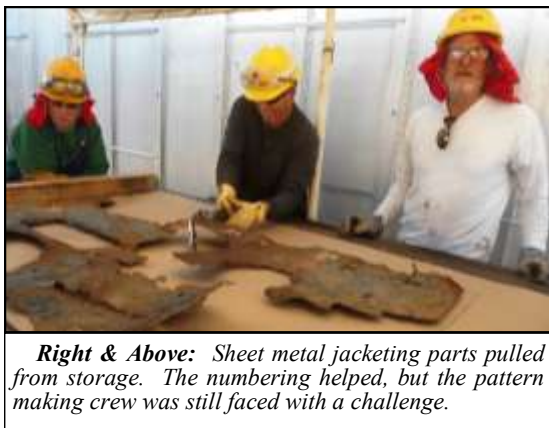
This task began by retrieving the old pieces of jacketing from storage. Most were in very sad condition. They were rusty, full of holes, and in some cases very fragile. One positive feature was that they were all numbered when removed in 2007 (Photo at Right). That foresight when removing the jacketing allowed the crew to start with an approximate location for each piece.

Right & Above: Sheet metal jacketing parts pulled from storage. The numbering helped, but the pattern making crew was still faced with a challenge.

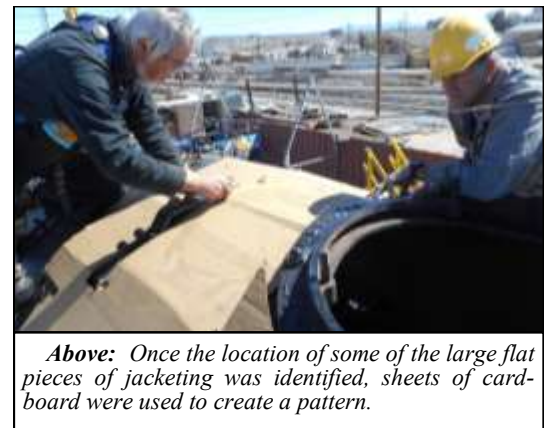
Above: Once the location of some of the large flat pieces of jacketing was identified, sheets of cardboard were used to create a pattern.

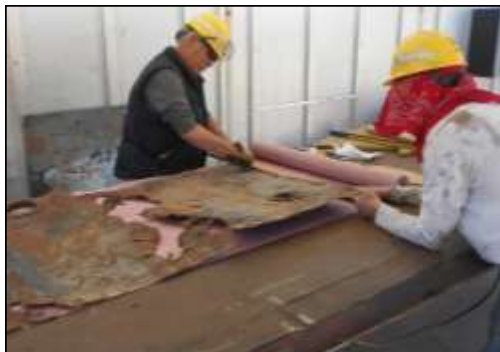
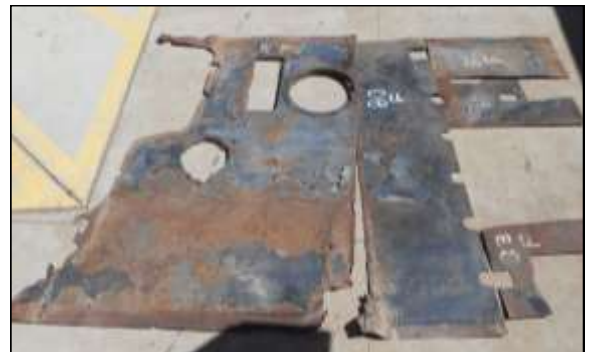
Right: Using brown paper on a work table or concrete slab, the pattern crew spread the rotted pieces of jacketing in as near to the original shape and size as possible. They then traced the shape on the paper. In some cases, the original pieces were so deteriorated that the pattern was close, but not exact. That required additional fitting and adjustments in place on the locomotive.

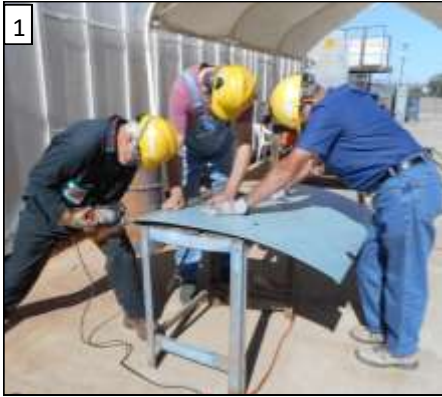
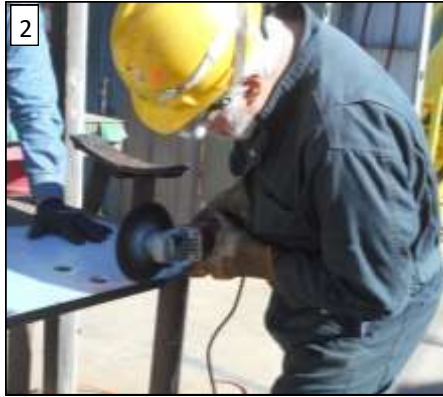
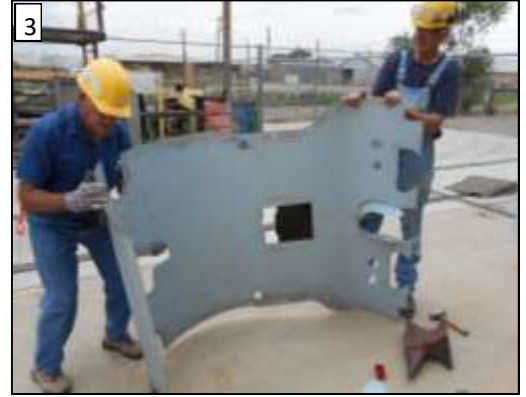
Once the patterns were replicated in sheet metal, the newly formed jacket parts were returned to the site for exact fitting. The final fitting of the new jacket parts kept several members busy in final shaping, especially with the larger items (Photos 1,2,3). Some of the parts had many holes that were fitted with sleeves. Some of the small pieces pictured in photos 4 and 5 had many holes and sleeves. They had to be precise, and fitting them required a lot of time and patience.

After trimming, grinding, and maybe a bit of bending, the parts were ready for the next step. That next step was a final coat of glossy black paint. They were securely stored (Photo 6) to avoid damage until they could be hauled to the paint shop.

In Photo 7, Lewis and Martin are holding a piece of jacketing just returned from the paint shop. A few dozen more like that, and 2926 will wear a new metal coat. But before that can happen, there is the little issue of **Insulation**—a lot of it behind the new sheet metal jacket.

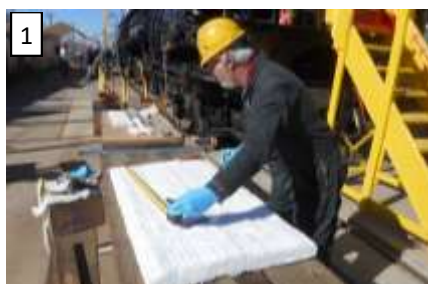
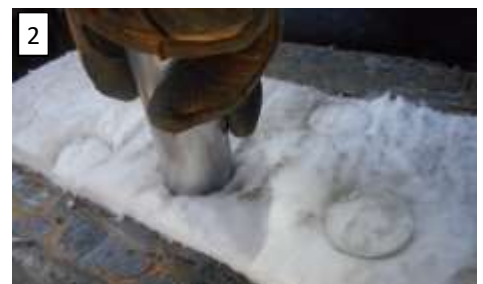
Photo 1 provides a synoptic view of the 2926 backhead near the end of the insulation fitting process. That view may explain why some of the 2926 volunteers compare the jacketing and insulation task to a jigsaw puzzle. Photo 2 depicts the fitting of a single large piece jacket insulation around the firebox door. Photo 3 shows the backhead after insulation and some jacketing has been replaced along with a number of instruments and controls. The cutting and fitting of the jacket insulation was just as complex as the metal jacketing, but it was done on site. There was no running back and forth to the metal shop or paint shop. It did allow the volunteers the opportunity to gain some unusual experience. In Photo 4, it appears that Gary W. has the objective of becoming a master insulation hole cutter on his bucket list,

With rolled blanket insulation, and a flat work table, trimming to fit jacketing pieces looks easy, (Photo 1 below). That was not always the case. There were many bolts, pipes, appliances, and other appurtenances on and around many areas where the insulation was to be fitted. That was especially true in the case of the backhead jacketing. Photo 2 Shows some of the cutting process. Photos of the complex fitting of insulation and jacketing on the backhead are on the next page.

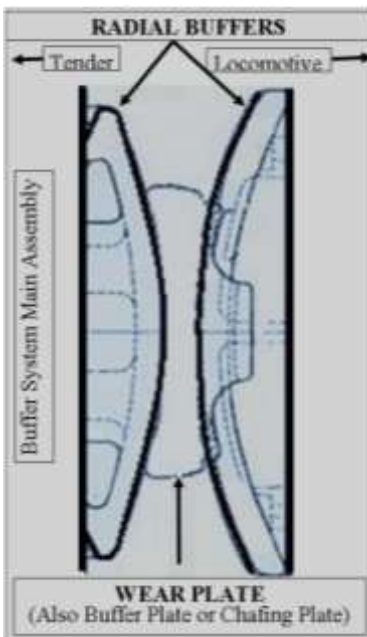
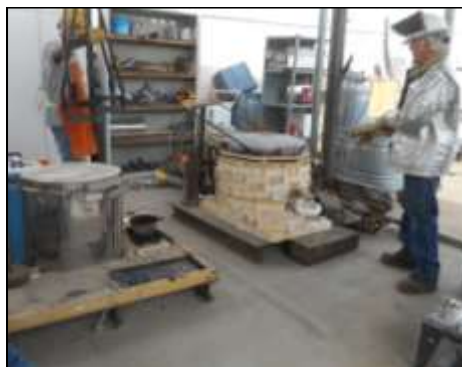
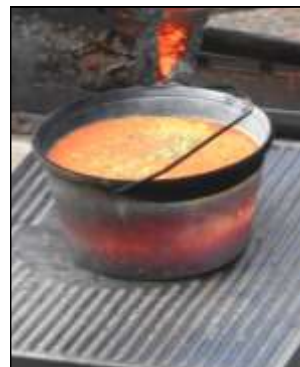
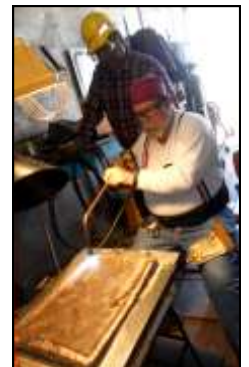
Parts replacement and reassembly of the radial buffer was described in the last newsletter. Then, only one small final component, remained. That was the expendable wear plate between the curved surfaces of the radial buffers. (Sketch at left). On site manufacture of a new wear plate revealed some of the best metal working skills of the 2926 volunteers. The three photos below depict the process. In the first, Ron T. is dressed for some extreme furnace heat. In the second, a future wear plate exists in liquid form. In the third, Lewis M. watches as Carlos O. works on the final product. See more photos of the wear plate production on the 2926 website.

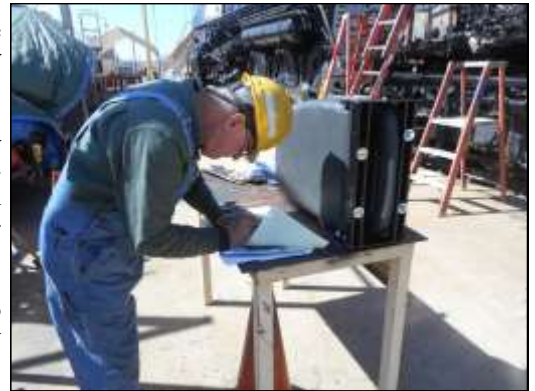
Additional cab space was needed for components associated with the currently required brake system, and related control items. That created a need for adjustments to cab seating. The original four seats,—engineer, fireman, and an additional seat behind each—was changed to three full seats plus a jump seat in the now reduced space behind the engineer.

In the photo at right, Dave V. is shown working on the jump seat.

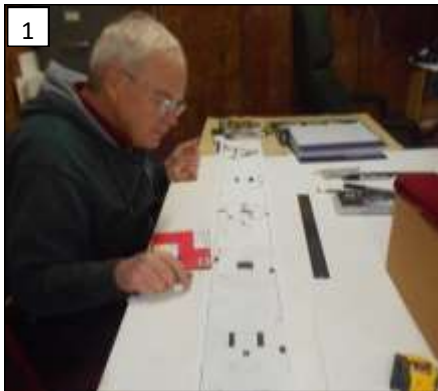
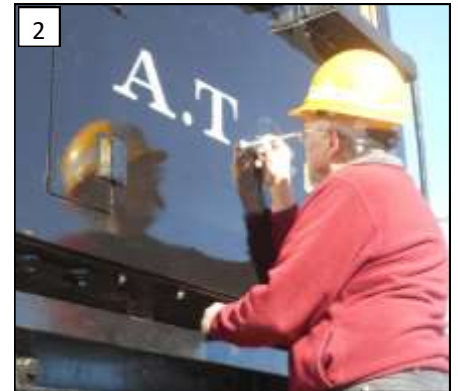
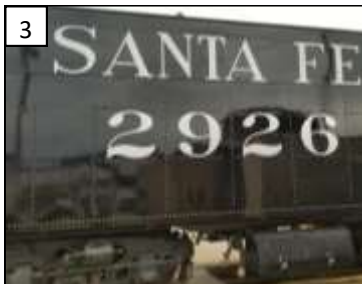
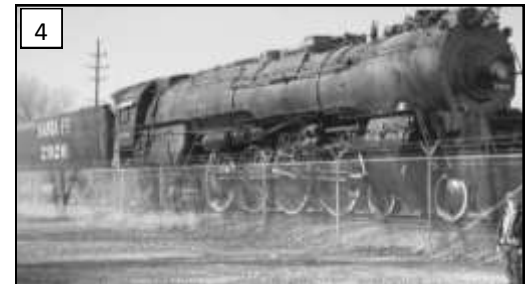
A lifelong rail photographer and narrow gauge historian, he also proved to be pretty good at putting the locomotive's identification in its proper place, and doing it right. In Photo 1 at right, he is working quietly in the reefer preparing templates. In the second photo, he is carefully detailing the letters on the cab. The third photo shows the finished lettering on the tender.

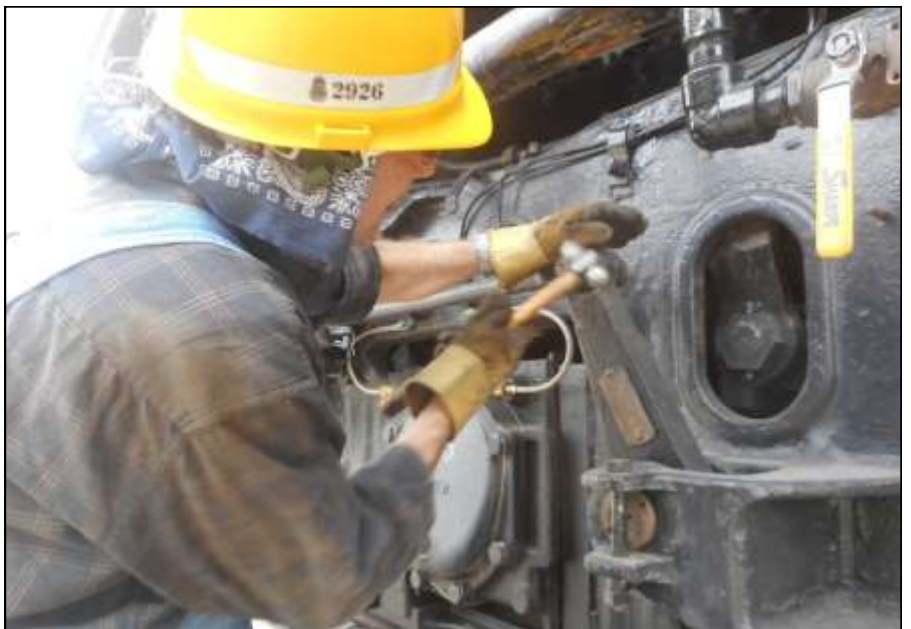
In the photo at right Rob E., one of the founding members of the Society, is checking some of the myriad cotter pins and other retaining devices on previously secured bolts and nuts.

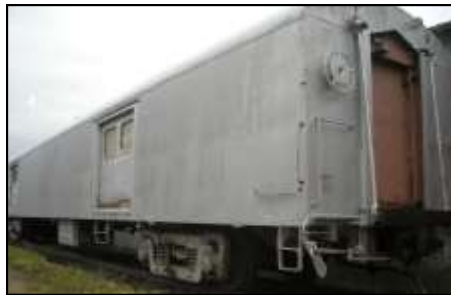
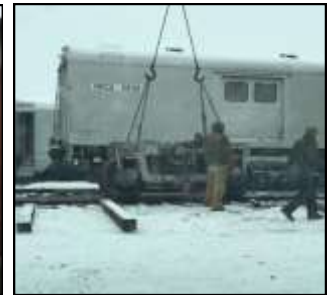
Former Amtrak baggage car RPCX 3939, donated by Curt Potter is pictured at right. Currently located in Bellevue, Ohio, it is under the care of Mark Magers, and has been renamed NMSX 3939. It is undergoing inspection and any needed repairs to ensure roadworthiness. In the second photo, the body of the car is being lifted from the trucks and placed on cribbing.

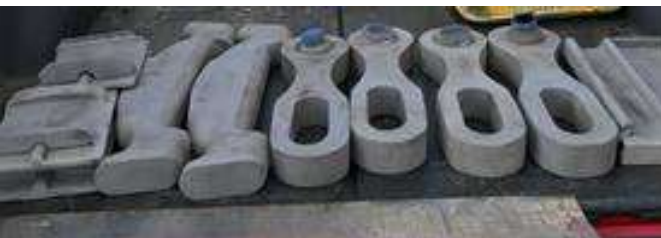
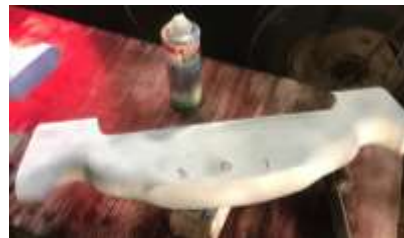
The trucks are disassembled for inspection and any needed repairs. Work on the parts is underway in Ohio. The pictures below show some of the freshly cleaned parts being dye checked for cracks. They will be cleaned and prepped for paint. The trucks will be painted silver as seen on past photos while the car was in service.

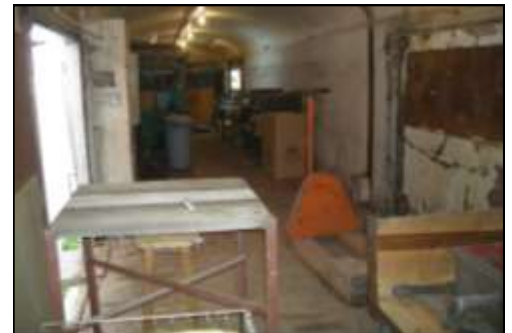
Not A Tool Car Yet: The inside of RPCX3939 at this time indicates a need for a bit of cleanup before installing storage, equipment, and tools.
