BIG STEAM NEWS

NEW MEXICO STEAM LOCOMOTIVE & RAILROAD HISTORICAL SOCIETY

Vol. XVII No 4

THEN AND NOW RESTORATION OF NEW MEXICO'S RAIL HERITAGE ICON

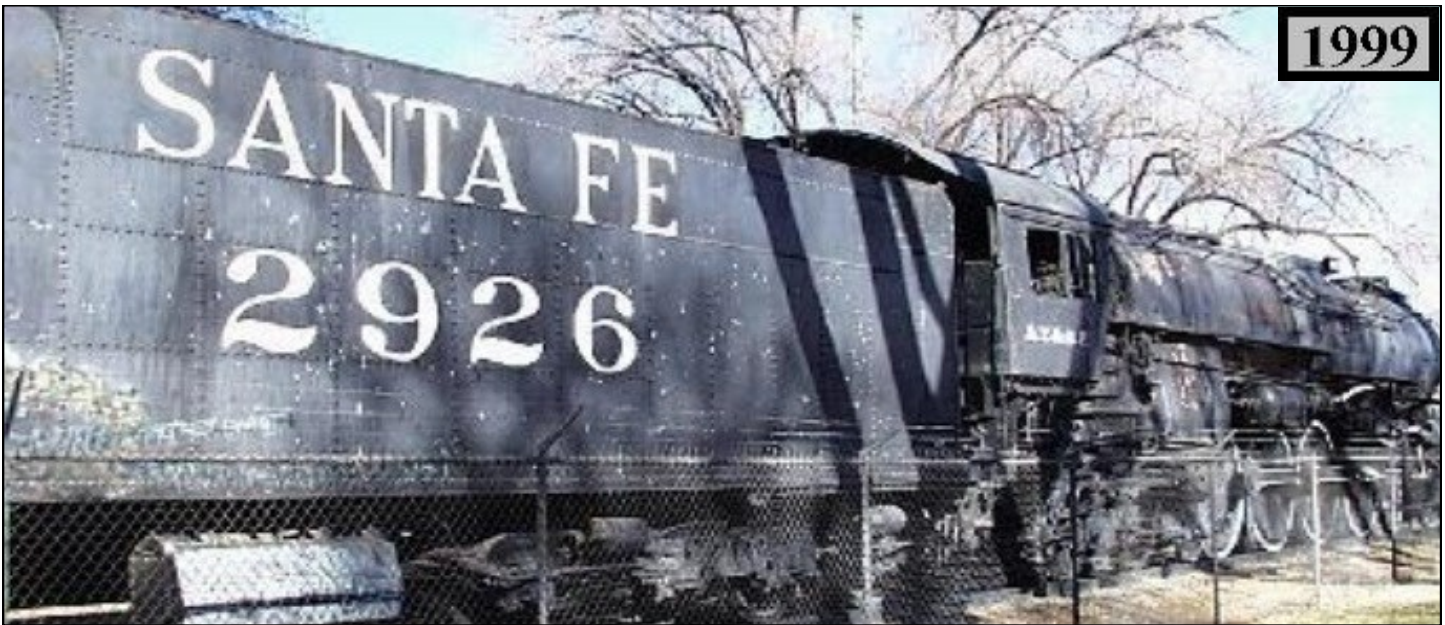
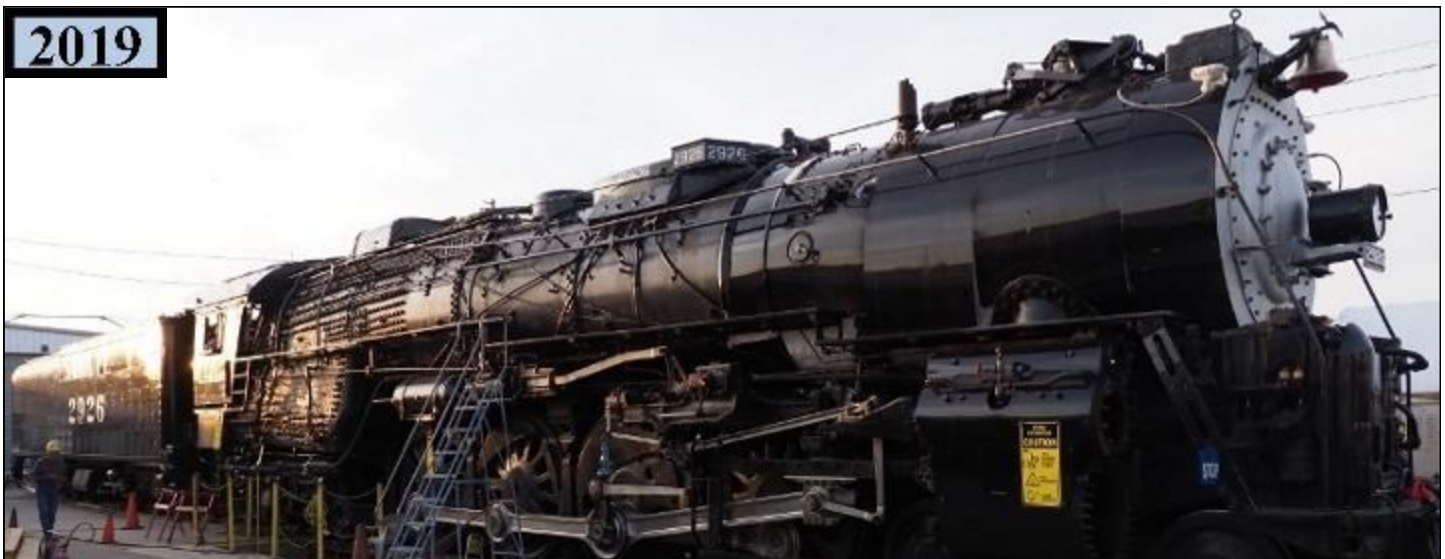
THEN 1999: Near the end of the 20th century, AT&SF Steam Locomotive #2926 was resting—and rusting—in an Albuquerque park, (Top Photo). That was about to change. In 1995, a group of New Mexicans organized to save the huge machine from further deterioration. Dedicated to preserving New Mexico's rich rail heritage, they dreamed of restoring #2926 to operation as a living history icon. In September, 1999, the group accomplished their first objective. They purchased the locomotive from the City for \$1. Support from members and the public enabled a move from the park to a siding, and ultimately to the current restoration site.

NOW 2019: As the year 2018 came to an end, the restoration effort was near completion. In August, a fire was ignited, and the #2926 boiler produced steam for the first time in six decades. A bit more work, (*i.e. sheet metal, checking leaks, and testing*), and Santa Fe 2926 will again be ready for action. Now, (Bottom Photo) it soon will be a living exhibit of New Mexico's rail heritage.

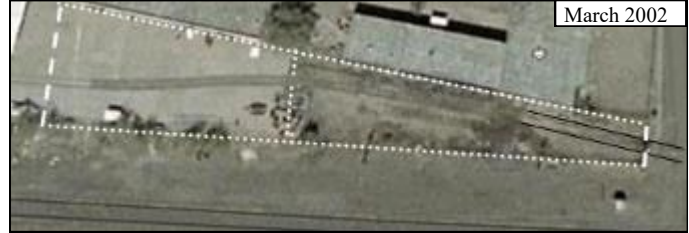
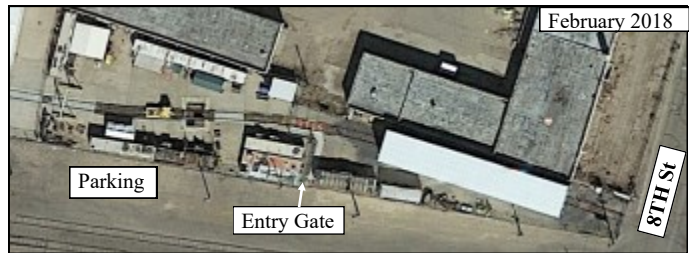
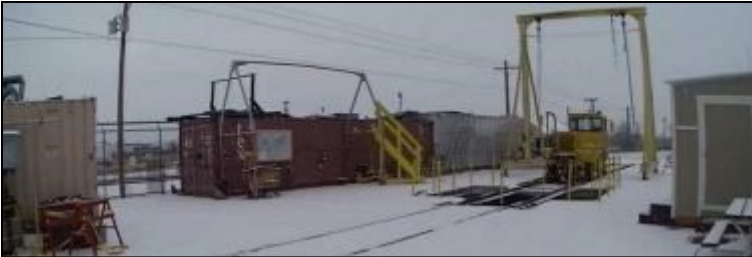
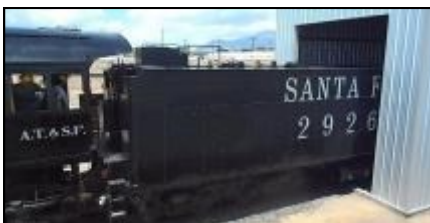
The photos below show early preparation tasks. *Photo 1:* Trash and brush removal uncovers track that was laid in 1937. *Photo 2:* After track repair, #2926 was rolled in. Elm forest is still in place. *Photo 3:* Elm removal, fence work, and another entry gate added. *Photo 4:* A heavy rain resulted in flooding of the new parking space created by elm removal. That revealed a challenge that would recur throughout the restoration—*coping with weather issues.*

Site Prep: *The Site Then And Now*, pictured at right, shows the site sandwiched between ancient storage facilities and a rail spur that once served a sawmill. The rail spur is still active, connecting the BNSF main line to Old Town, Albuquerque. The dirt lot was cleared, and rails were repaired. On May 2, 2002, #2926 was rolled across and onto the paved lot and site prep proceeded.

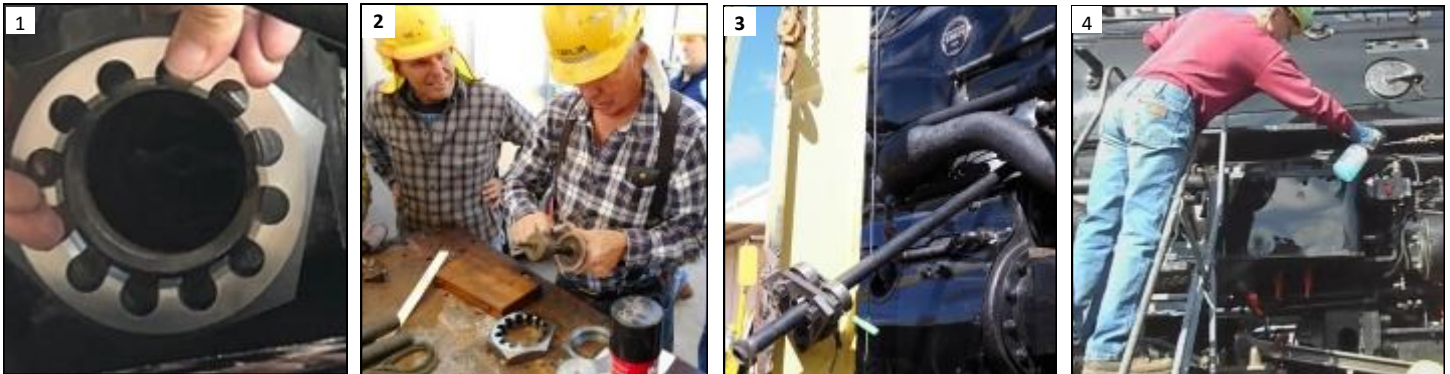
Replacement Of Root Valve: The volunteers who worked on the root valve task will verify that it is a difficult to reach location. Access required removal of several other pipes and connections that had already passed leak tests. Not only did the valve have to be removed, the large pipe to which it was fitted had to be rethreaded. That required a **large, expensive** thread die shown in photos 1 and 2. In photo 2, John R., watches Ron T. work on the valve. In the first photo, the die is shown in place on the pipe. A special tool was needed to reach the end of the pipe for rethreading. The tool was an old drive shaft held by a jig clamped to the gantry crane, Photo 3. In Photo 4, the valve has been installed, other pipes reconnected, and a leak check is underway. The NMSLRHS web site has photos and videos with more details at <http://www.nmslrhs.org/Photos/2018/11-03/DSCN3241.html>.

After replacement of the root valve, and reconnection of pipes and fittings that were removed for the valve work, it was back to leak checks, using air pressure. Sometime in early 2019, weather permitting, another steam up will be done for further testing. When that is complete, the pistons will be installed, and the jacketing replacement will be finished.

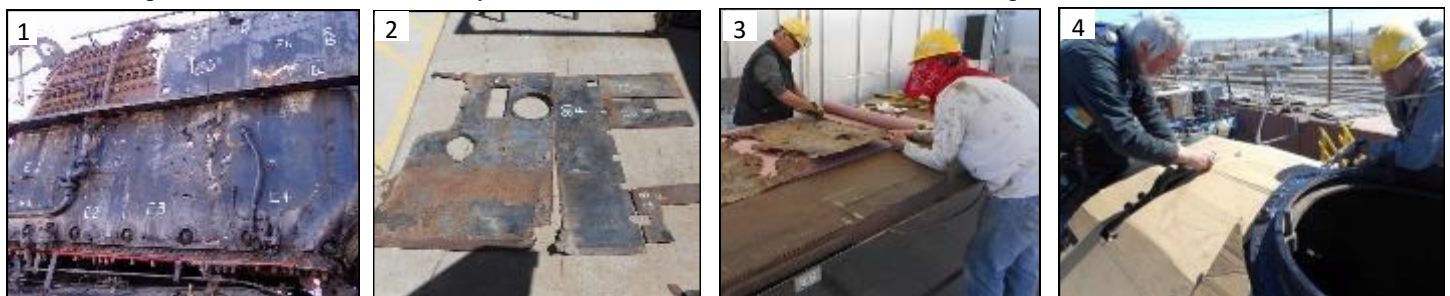
Sheet Metal Jacketing: When #2926 left the park, half a century exposure to weather and vandalism had left its sheet metal jacketing rusty, bent, and full of holes. It needed total replacement. That proved to be a long running task much like a jigsaw puzzle. The jacket was removed for asbestos abatement in early 2008. It consisted of innumerable pieces in many shapes, sizes, and levels of deterioration. All pieces were labeled by location before removal as shown in Photo 1 below. The pieces were then stored for use in producing patterns for new ones. The jacket replacement task turned out to be multi step process both on and off site.

Pattern production was done on site by #2926 volunteers. Photos 2, 3, and 4 below depict

steps in the production of patterns. Some parts were too damaged for pattern making. Those were created on the body of the locomotive as shown in Photo 4. Metal forming and painting portions of the sheet metal task were done by outside professionals. The patterns produced on site were sent to an off site shop to be replicated in sheet metal and primed. The new sheet metal parts were then returned to the site for final fitting, photos 5 thru 9. Precision fitting around pipes and other appurtenances was in many cases quite challenging as indicated in photos 8 and 9. After fitting, the pieces went to A Real Body Shop for finish painting. The final finish is mirror like as pictured in photo number 10, where some portions of the new jacketing have already been installed. Other parts must wait until final leak checks are completed.

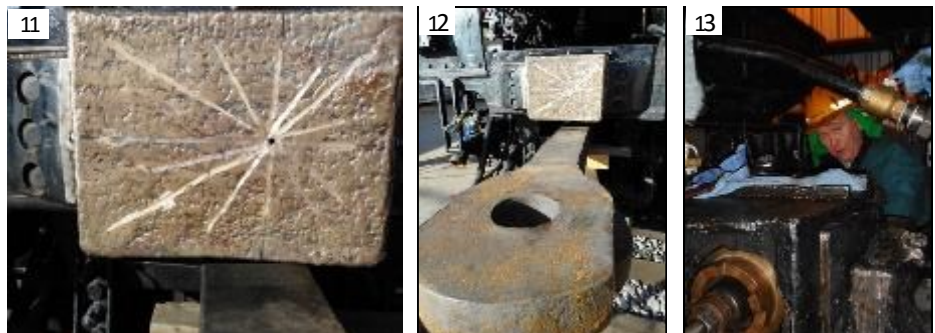
Reassembly: In Photo 6, the wedges and springs have been installed on the shaft. In Photos 7 and 8, the new buffer is slipped into the pocket over the wedges. In Photo 9, the tender side of radial buffer assembly is finished. In Photo 10, the drawbars have already been installed in the locomotive, and Bill is checking the wear plate position on the locomotive buffer. Locomotive and tender are almost ready to hook up.

Connected: Photo 11 is a close up of the wear plate in photo 10. The hole and grooves are lubricant channels. In Photo 12, it is in place above the top drawbar. The wear plate is not the last step in connecting the tender and the locomotive. That comes when the tender end of the drawbars are pinned. And wrestling the pins in place is hard labor.

Photo 13 shows complete connection. Not sure what historian John T, is doing in there. He should get out before 2926 moves or 13 might prove to be a prophetic number.

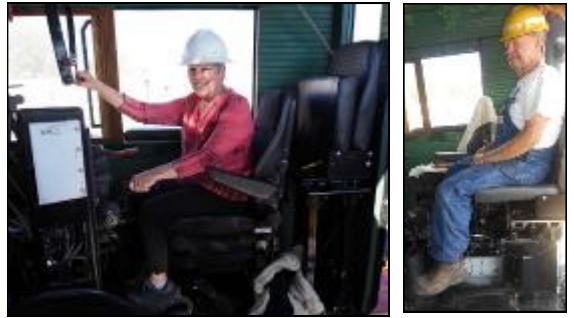
Folding Jump Seat: For 2926 to be operational, a new brake system was required. A 26L brake system was installed. To accommodate the new brake controls, the engineer's seat was moved back. That left no room for the original seat behind the engineer. The solution was a folding jump seat that could be dropped from behind the engineer's seat. In the first photo at right a visitor sits in the engineer's seat with the jump seat folded behind it. In the second photo, seat designer Dave V. demonstrates the jump seat unfolded.
