# NEW MEXICO STEAM LOCOMOTIVE & RAILROAD HISTORICAL SOCIETY

Vol. XII, No. 4 Tel. 505 246-2926 Oct--Nov--Dec.2013

# BANGING ON A 2900

## The Franklin Railway Supply Company Automatic Compensator And The 2926 Pit Rats

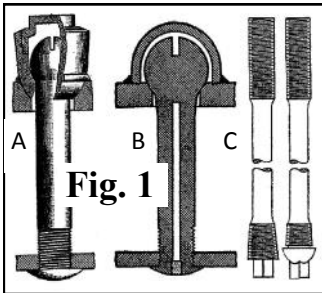
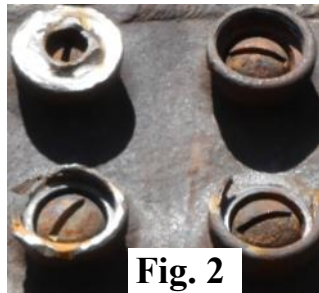
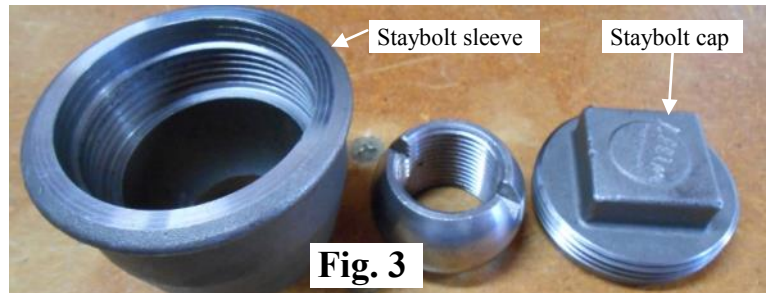
*Staybolt assemblies vary. Parts of some staybolt assemblies and deterioration examples are shown above. Fig. 1 shows three types. The first (A) shows a three piece assembly with the bolt head seated in a removable sleeve with a threaded cap. In a two piece type, (B) the seat is permanently fixed on the boiler wall. Two types of crown sheet staybolts are shown in (C). In Fig. 2, at least three (and maybe all four) of these staybolt assemblies will require some parts replacement. Variations go beyond just length or fixed versus flexible. There are also different sizes of sleeves and caps. Fig. 3 shows some of the replacement parts.*

Restoration (repair or replacement) of the hundreds of staybolt assemblies probably caused more discussion, and certainly more unprintable commentary, than any other single task in 2013. All staybolt assemblies had to be checked, cleaned, and evaluated for repair or replacement. Many sleeves and caps, (and even a few bolts) required replacement.

At virtually all work sessions, whether hot, cold, or windy, some of the crew could be found removing staybolt caps, and cleaning, scraping, and brushing, the components of each staybolt assembly. Decisions were made regarding reuse or replacement. All reusable parts required cleaning and refurbishing. The removal and cleaning was all manual labor with lots of dirt and grime. Fortunately, a number of our volunteers seem to be very qualified for that type of grunt work.

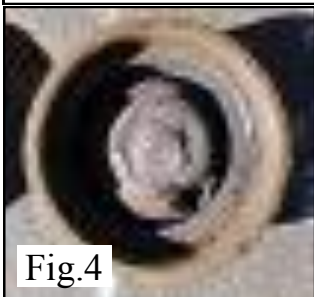
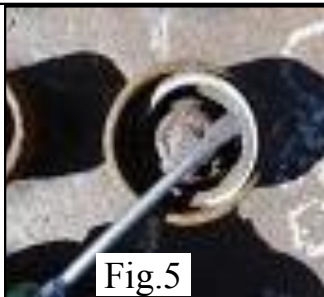
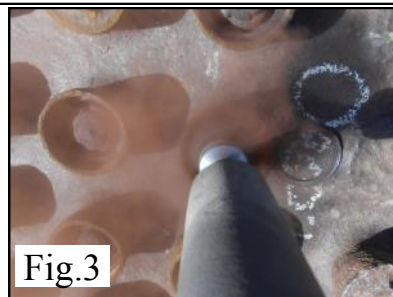
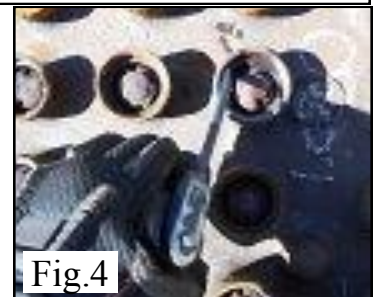
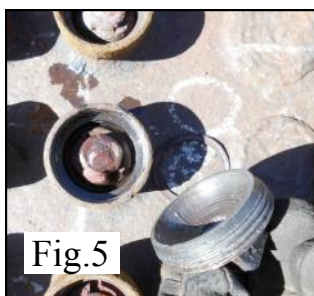
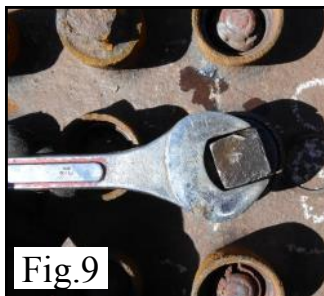
***ALL** staybolt assemblies must be cleaned, inspected and have a new copper sealing washer installed. Those components that are deteriorated beyond reuse must be replaced. Parts that are to be reused are cleaned and held for reassembly.*

*Fig. 4: A typical corroded staybolt assembly with cap removed, looks like it may only need cleaning and a new washer. Fig. 5-9: The old washer is removed. Using a wire brush, the corrosion is removed with a cloud of rust. To prevent more corrosion while waiting for the new copper gaskets to be acquired and shaped, 30 - weight oil is squirted into the sleeve and a clean cap is installed.*

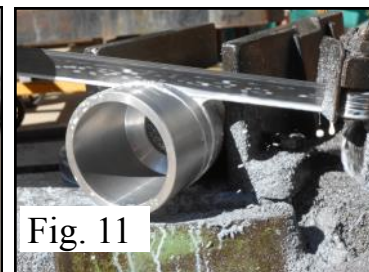
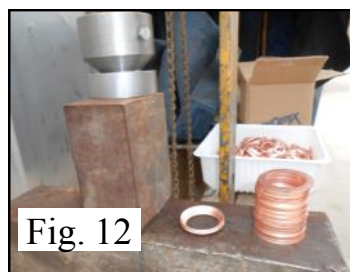
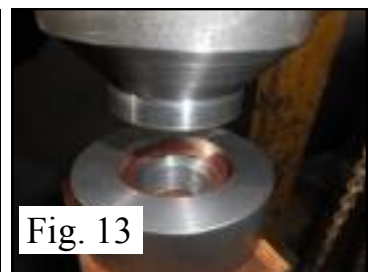
*Fig. 10-11: George Trever is caught sitting down on the job, but he has a good reason. He is operating the metal saw to prepare staybolt sleeves. Though many of the staybolt components were purchased from suppliers in other parts of the country, there was much cutting, fitting and shaping work to be done on site. Fig. 12-13: In several instances, 2926 crew members had to come up with innovative solutions. In this case, flat copper washers were purchased and a tool was made to reshape them.*

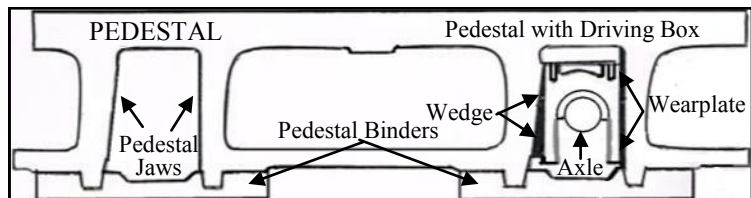
Sketch of a locomotive frame segment with two pedestals, one with a driving box. This shows an earlier non-automatic model with only one shoe

If the wheels of a locomotive are out of alignment, wear is also a problem. With no steering capability, there is a serious alignment issue. Misalignment could lead to overheating of wheel bearings or even derailment--and a serious train wreck. When a steam locomotive’s axles are at right angles to the frame, the locomotive is said to be ‘in tram’ and the wheels are properly aligned. To deal with track curvature, suspension movement, and other actions, the axles must be allowed some vertical and lateral movement. To allow the movement and stay aligned, a system of ‘shoes and wedges’ is employed on both ends of each axle to absorb wear and maintain alignment. (NOTE: Because they absorb wear, shoes are also called wearplates.) The shoes and wedges are inserted in the frame pedestal between the pedestal jaws and the ‘driving boxes’ that carry each end of the axle.

Wearplates fore and aft of the drive box and a wedge between the rear pedestal jaw the wear plate position the drive box in the frame. On older locomotives as wearplates wear, the wedges must be adjusted from time to time to compensate for thinning of the wear plate. Once the shoes and wedges are worn beyond adjustment, the locomotive must be shopped and worn or broken parts machined or replaced.

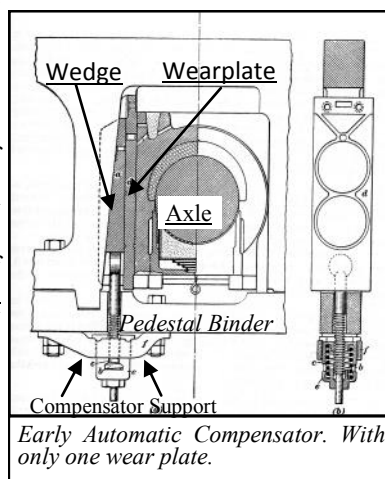
Early Automatic Compensator. With only one wear plate.

Pete found some diagrams of the device in his copy of Steam Locomotive Home Study Course, Volume 1 (1923). Pages 118-120 briefly discuss the mechanism for automatically adjusting the wedge plate in the rear of each drive box to compensate for vertical and to and fro wear in the drive box and pedestal jaws. The wedge is automatically adjusted to keep the driver axle perpendicular to the frame. The one diagramed is an earlier version of the Automatic Compensator. On the 2926 the automatic compensator is a little different with two wear plates, one on each side of the axle, but the principle is the same.

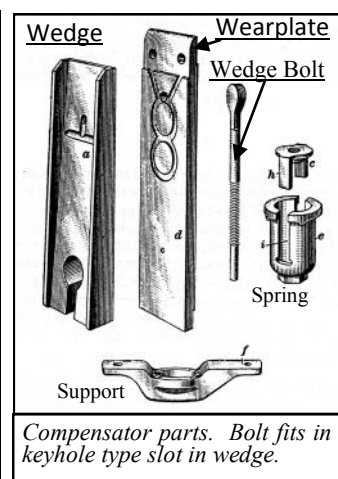
Compensator parts. Bolt fits in keyhole type slot in wedge.

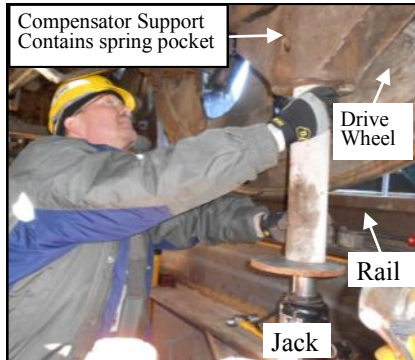
A: Lowering compensator support. In the pit working next to the drive wheel.

Did I mention that the Franklin Automatic Compensator is **HEAVY** and hangs overhead in the pit from bolts and studs in the pedestal binder under the drive box with nut sizes ranging up to 2 3/16 inches with little room to swing a wrench? The pit rats were nervous about the first one because somebody knew there was a **BIG** spring inside and it wasn't clear if it was going to 'sprong' when the last nut came off. It didn't. With remarkably tenacious crud the whole assembly was glued into one piece. After serious work with wire wheels, scrapers, and the parts washer, actual metal was liberated for inspection. It was a serious day's work to get it greased up and back on before the sun went down. (See picture series A-F below)

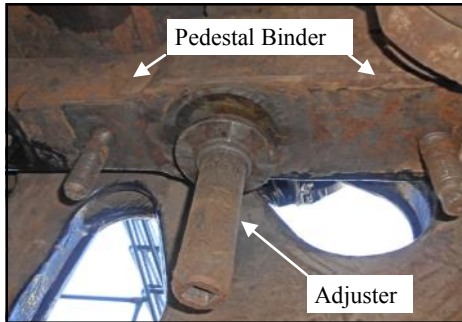
B. The pedestal binder after the automatic compensatory body and springs are removed. Note square drive, mushroom head adjuster is still in place on the threaded wedge bolt.

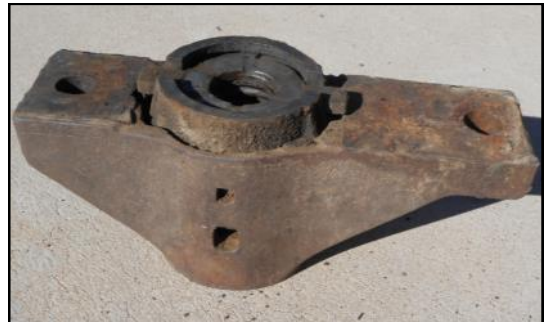
C. Removed compensator support, spring follower and springs still cemented together with historic dirt and grease.

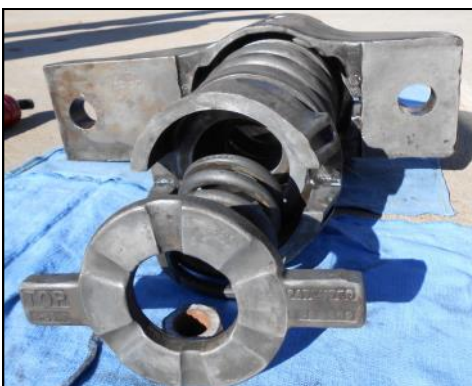
D. All cleaned up and ready for re-install.

The tenacious pit rats got better at the job with practice. Each subsequent winter work session saw one or two gotten off, cleaned up and back on. As hard as it was to unwind the nuts holding the automatic compensators on it was even harder if they got in a bind on the way down. Just when victory was in sight the project hit a snag. The wedge bolt on the left side #1 drive box was found broken off even with the pedestal binder. Who knows how long it had been that way. All the others were intact.

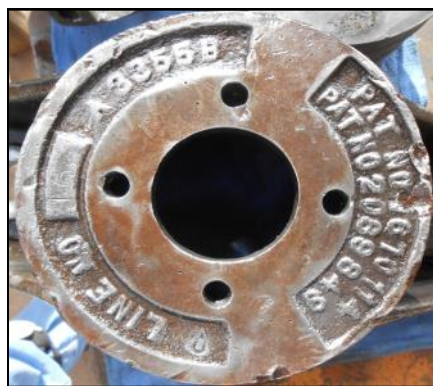
E. Bottom of the body of the automatic compensator.

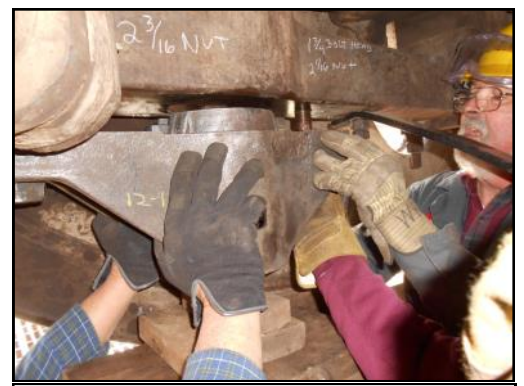
F. It takes several pairs of hands to get it back in place.

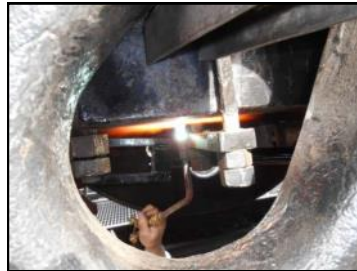
I: Heating pedestal binder bolt as seen through drive wheel.

With nuts backed down about 1/2 inch the pedestal binder was heated by Ron on one end and Danny on the other. As the ends of the pedestal binder got to about 500 degrees Fahrenheit, Scott placed a 30 ton pancake hydraulic ram on top of the binder and started pushing. (Pictures I, J) **BLAM!** Down it came that magic 1/2 inch just as the rest of the crew returned from lunch.

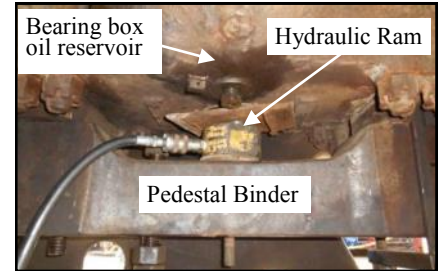
J: Ram placed between bottom of bearing box housing and pedestal binder.

After that it was a tedious process of jacking, cribbing, re-rigging chains and slowly getting the very heavy pedestal binder down safely. With the binder coming down, the wedge and its adjacent wear plate began to slip down breaking the bonds of really old grease and grit. Getting the wear plate down was relatively easy but the wedge only dropped a few inches and stopped.

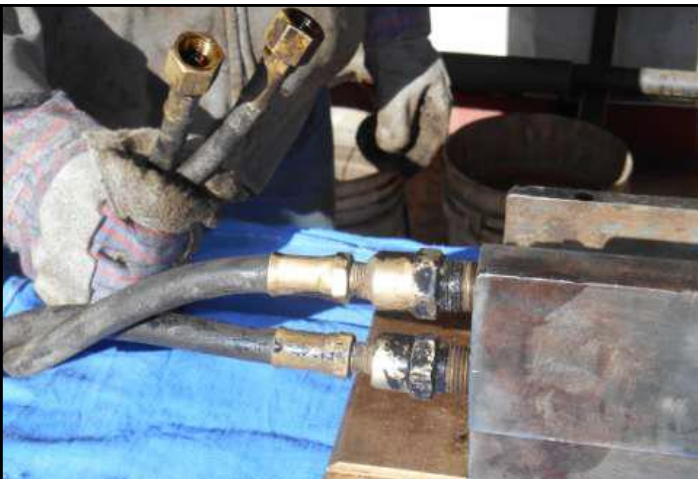
K: The 2926 "modern" lubrication lines attached to the top of the wedges provided a learning opportunity for the pit rats.

After some interesting theories were tried it was discovered that the wedge was suspended from the lubrication lines, (Picture K). Our 1923 wedge diagrams did not show the modern lubrication system on the 1944-built 2926. When the lines were removed gravity was once again our friend and enemy as the wedge was coaxed down, then rearwards, and finally slipped out on a wood bridge over the rail behind its driver.

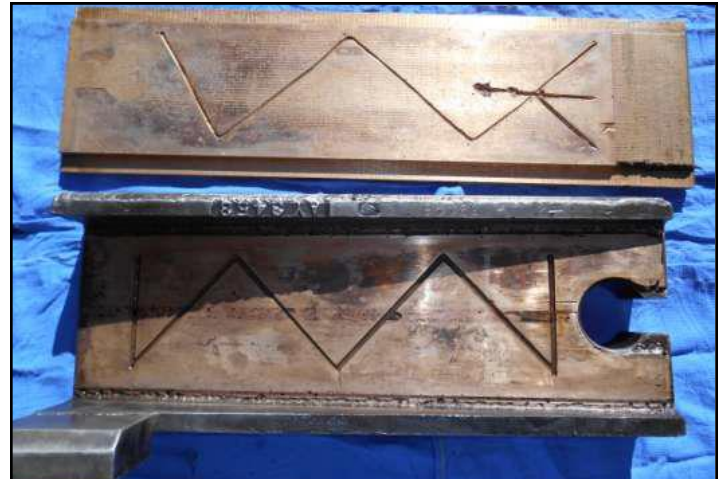
L: Wear Plate (top) and wedge (bottom) show lubrication grooves and little wear. Gap on right end of wedge is slot for wedge bolt head.

After that exercise cleaning up the wedge and wear plate for inspection was anticlimactic. The wear plate at installation, is higher than the wedge. It drops as it wears, its position related to the wedge determines need for replacement. The top of the wear plate was found to be 3 inches above the wedge top, indicating that there was very minimal wear on the plate, and the wedge was in fine shape, (Picture L).

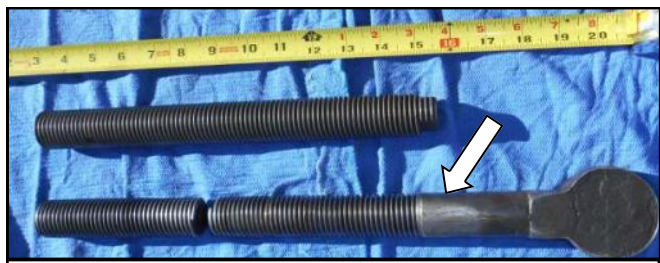
M: Broken wedge bolt is cut at arrow. A 13 inch section of threaded rod is welded and trued up for use. Just another day in the life of the folks banging on a 2900.

The broken wedge bolt (Picture M), will need a little fixing. Using some available threaded rod, we know just the guy to do it. The victorious pit rats expect a lot more heavy learning about drive boxes as the 2926 restoration continues.

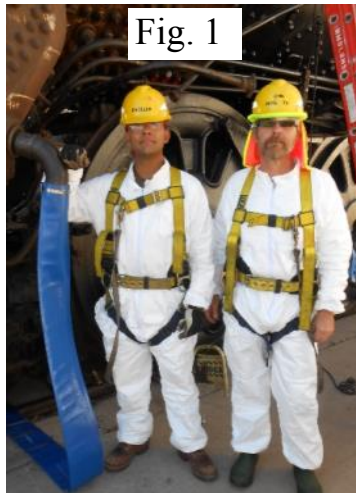
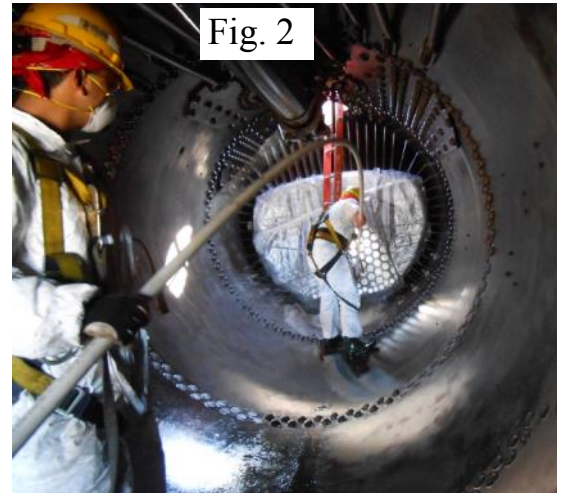
*Yep, inner space. Anthony and John are all dressed up for a trip inside the 2926 boiler for an internal washdown.*

**Fig. 2: Connecting to a convenient fire plug, the two intrepid travelers take a high pressure hose inside the boiler.**

*The high pressure wash is used to scour the inside walls of the boiler removing scale and accumulated sand.*

*There is another very important step to be done before the flue tubes and superheater tubes can be installed. That is the application of a protective coating to the inner walls—an improved coating that did not exist when the locomotive was built.*

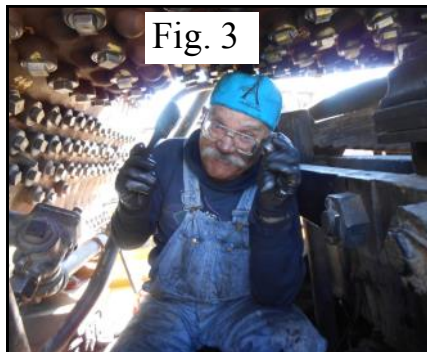
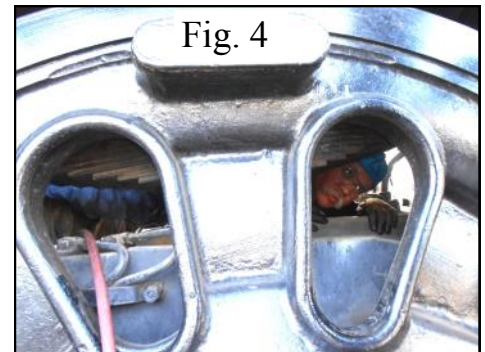
**Fig. 3: There are more cramped spaces than inside the boiler. In Fig. 3, Martin is under the combustion chamber. What he is working on? Saybolt caps, of course.**

**Fig. 4: Here, looking through a drive wheel, Martin's head is barely visible at right center. At left center, the end of the locomotive's huge leaf spring can be seen.**

*Crawling into such spaces was unnecessary when 2926 was active. In the shops, the boiler was lifted from the frame by a huge crane.*
