## RESIDENTIAL REPORT

1234 Main st.  
Seattle, WA 98125

Buyer Name  
08/22/2022 9:00AM

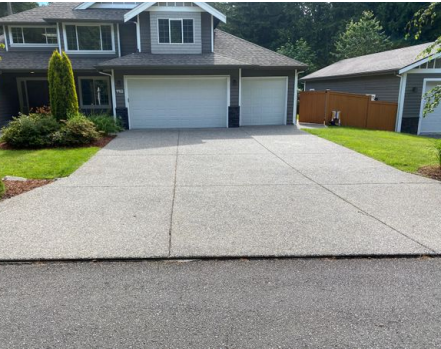
**Walkways, Patios & Driveways:**  
**Driveway Material**  
Concrete, Gravel

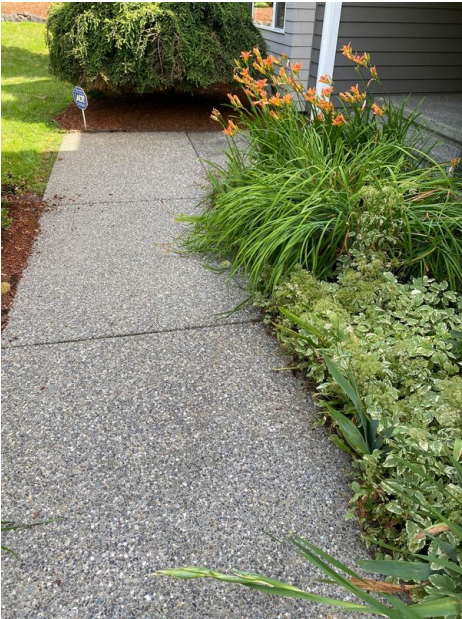
**Walkways, Patios & Driveways:**  
**Walkway Material**  
Concrete

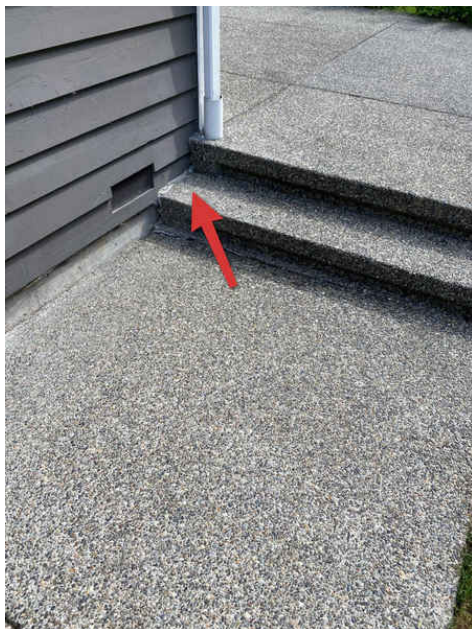
The concrete walkways and patio covered a portion of the siding. This can allow rain water to pour down between the siding and concrete and cause moisture damage to the structure. Recommend that the concrete be removed where too high and any moisture damaged wood be repaired by a qualified contractor.

Recommendation  
Contact a qualified concrete contractor.

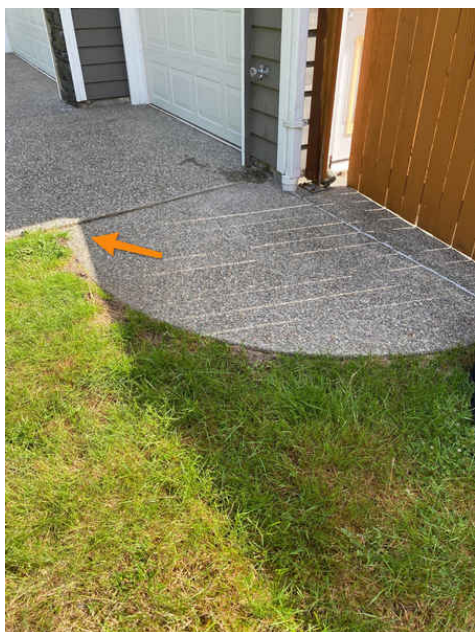
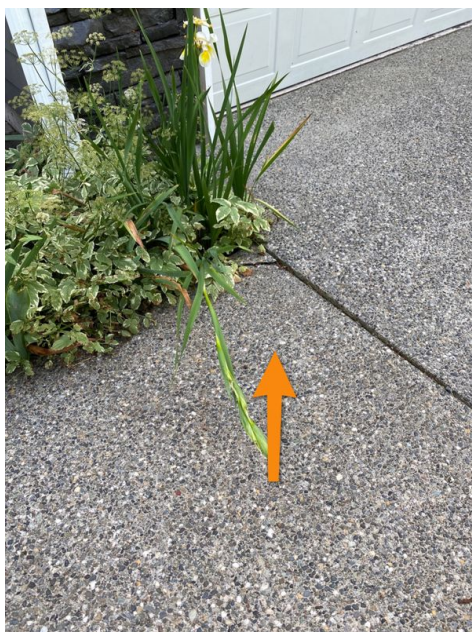
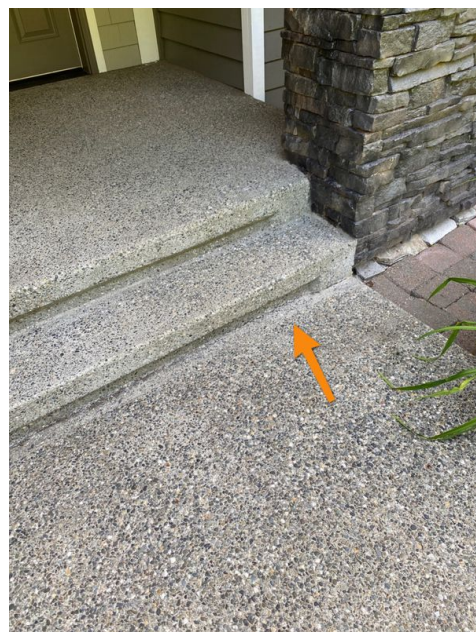
### 2.1.2 Walkways, Patios & Driveways

#### **WALKWAY/PATIO - SETTLING**

Concrete walkway and patio have settled in areas. There are some potential trip areas. Recommend that a qualified contractor further evaluate and make any needed repairs or replacement.

Contact a qualified concrete contractor.

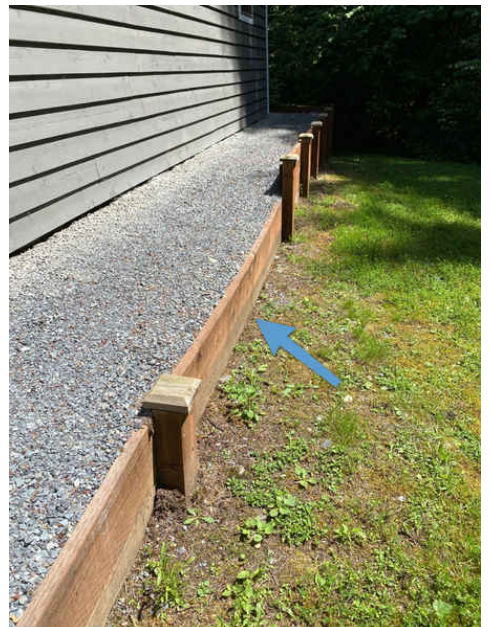
### 2.3.1 Vegetation, Grading, Drainage & Retaining Walls

#### **RETAINING WALL - DETERIORATION**

Retaining wall was showing signs of bulging. A thicker material may be needed for retaining the gravel. Recommend qualified contractor evaluate the retaining walls and make any needed repairs.

Contact a qualified landscaping contractor

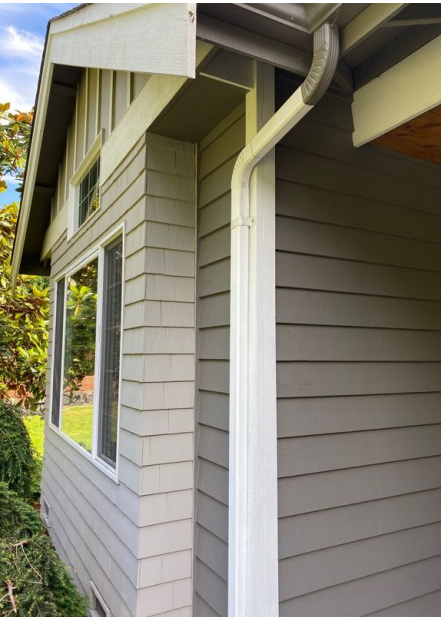
Siding, Flashing & Trim: Flashing Material

Sheet Metal

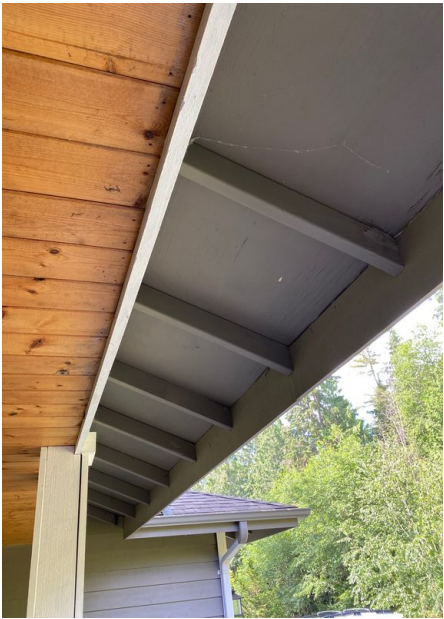
Eaves, Soffits & Fascia: Eaves  
Material  
Plywood

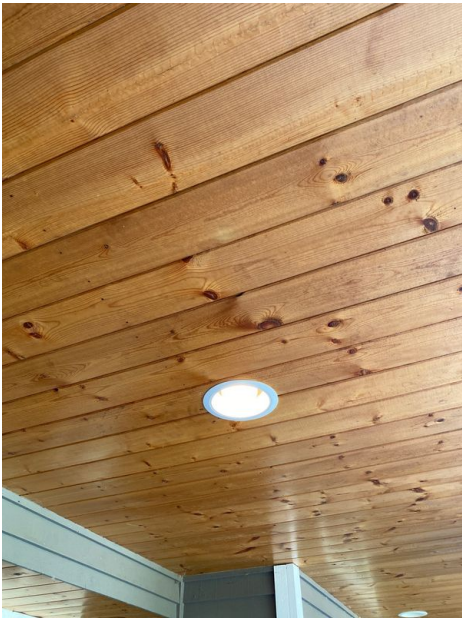
Eaves, Soffits & Fascia: Soffit  
Material  
Wood

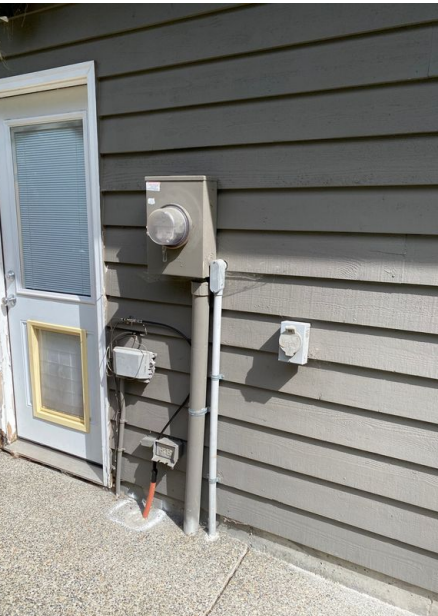
**Service Entrance Conductors:**  
**Electrical Service Conductors**  
Below Ground

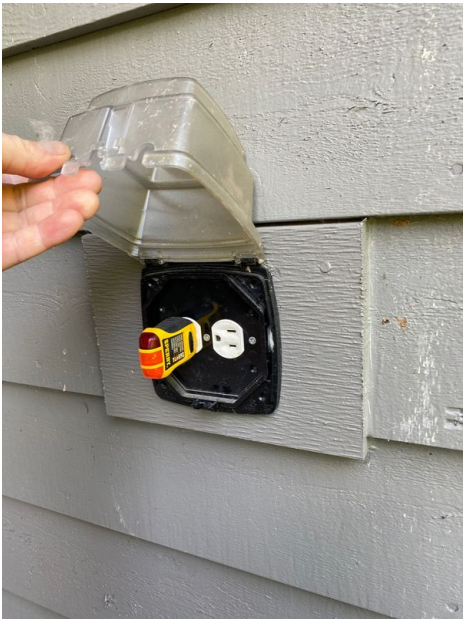
**Exterior lighting and receptacles:**  
**Exterior Receptacles**  
Operable, GFCI Protected,  
Weatherproof cover

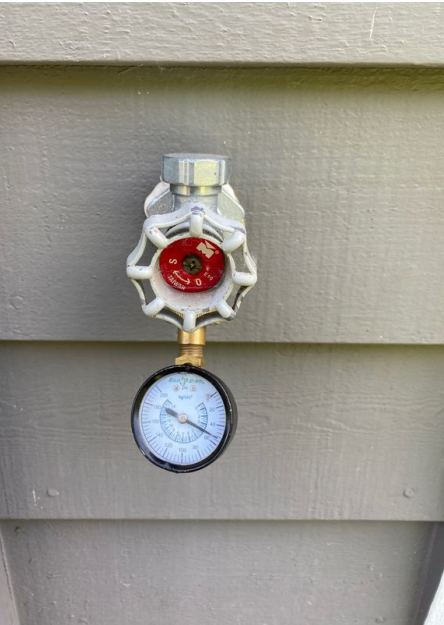
**Hose Faucets:** Hose Faucet Water Pressure  
52 psi

Typical residential water pressure is between 50-80 psi, ideal pressure is 60-75.  
Water pressure over 80 psi will stress the plumbing supply lines and can lead to leakage or failure.

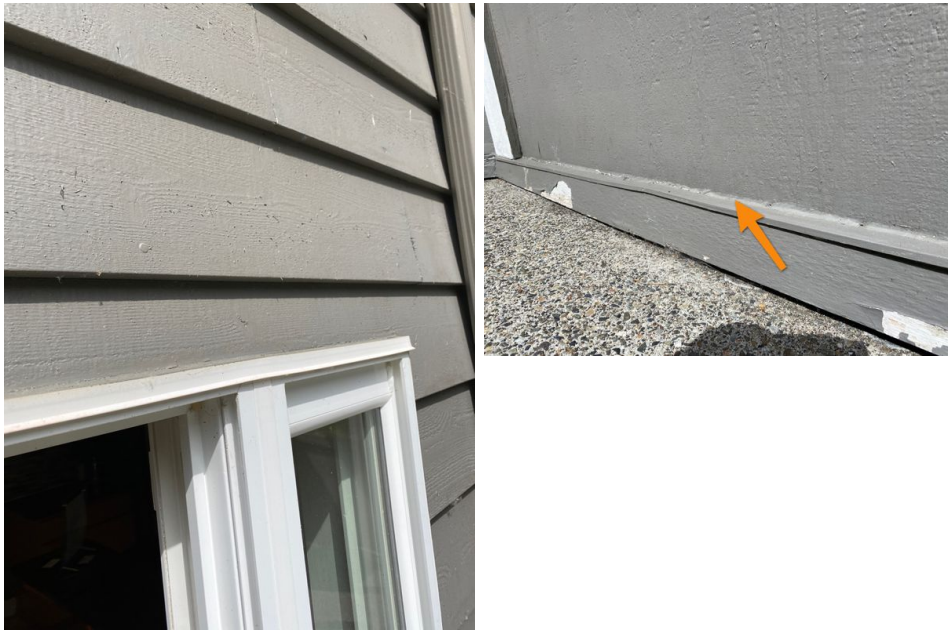
There should be at least a 1/4" gap between the bottom of siding and top of the flashing to allow any moisture behind the siding to exit. Recommend that a qualified siding contractor evaluate and make necessary repairs.

Contact a qualified siding specialist.

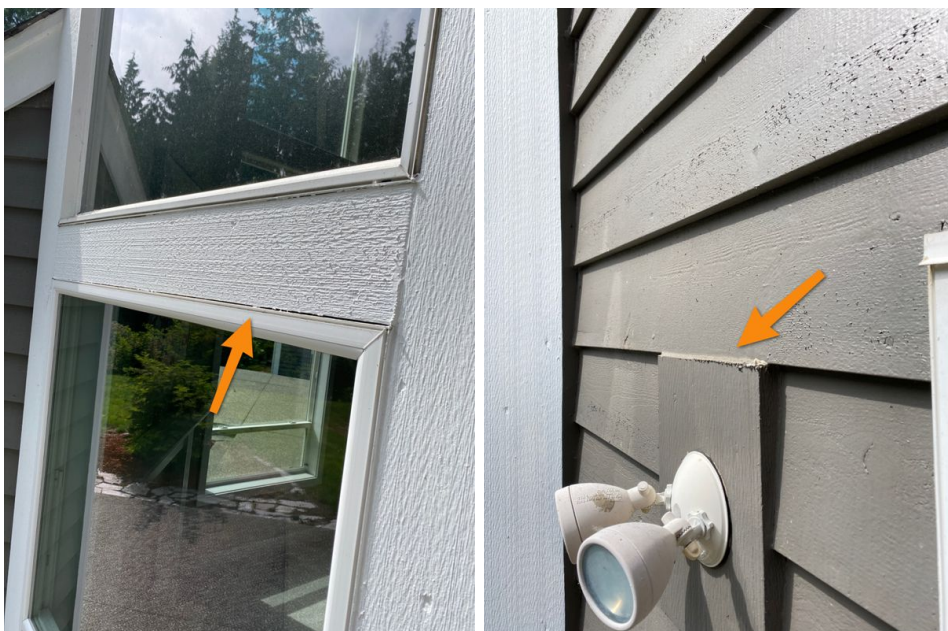
3.1.2 Siding, Flashing & Trim

**FLASHING - MISSING**

Flashing was not observed at the time of inspection over the windows, doors, and light blocks. Siding material requires flashing near windows, doors, and siding transitions. Recommend that a qualified contractor evaluate and repair as needed.

Contact a qualified siding specialist.

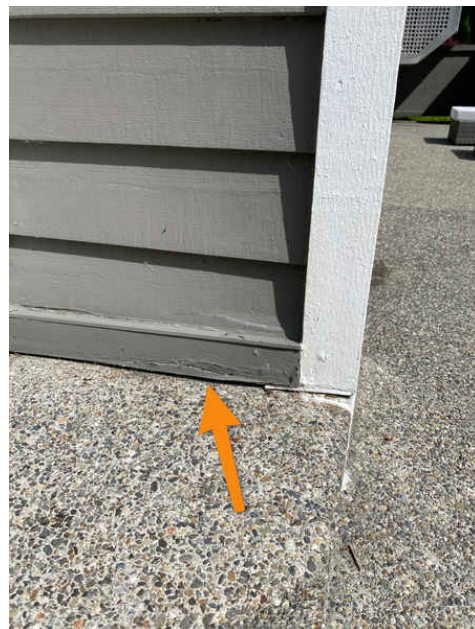
## 3.1.3 Siding, Flashing &amp; Trim

**SIDING/TRIM - WATER INTRUSION**

Siding and trim showed signs of damage from water intrusion. Recommend a qualified siding contractor, general contractor, or handyman evaluate and repair.

Contact a qualified siding specialist.

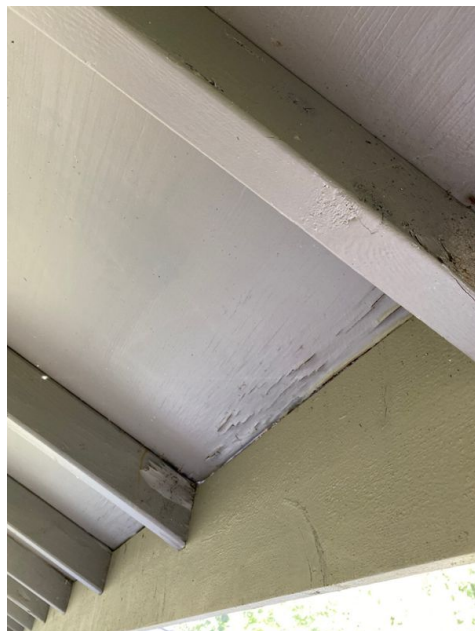
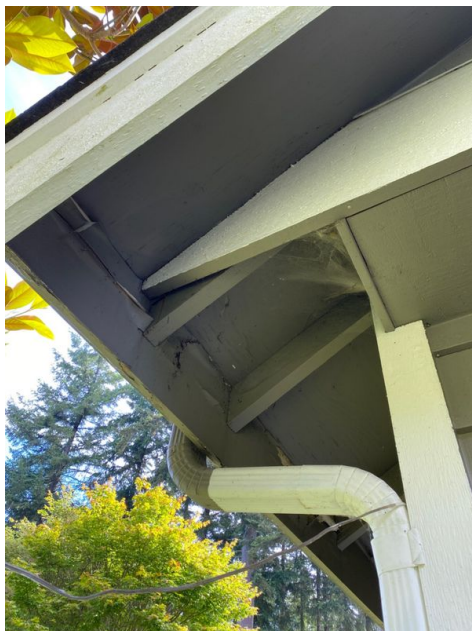
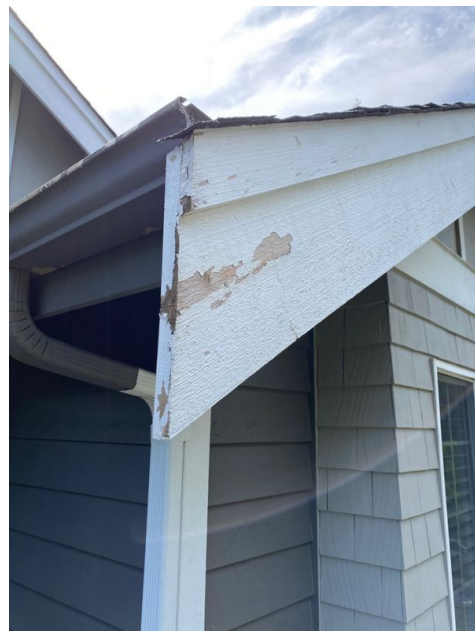
## 3.2.1 Eaves, Soffits &amp; Fascia

**EAVES - PEELING PAINT**

Peeling paint was observed on eaves area. Recommend qualified contractor to perform normal paint maintenance to prevent moisture damage to these areas.

Contact a qualified painting contractor.

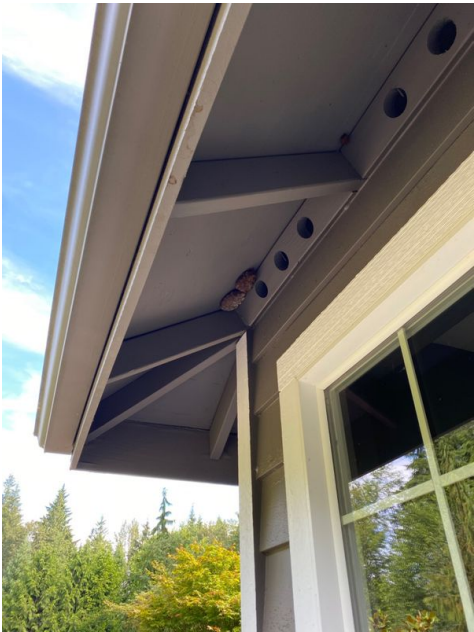
3.2.2 Eaves, Soffits & Fascia

Wasp nests were visible under the soffits. Recommend a qualified exterminator evaluate and remove.

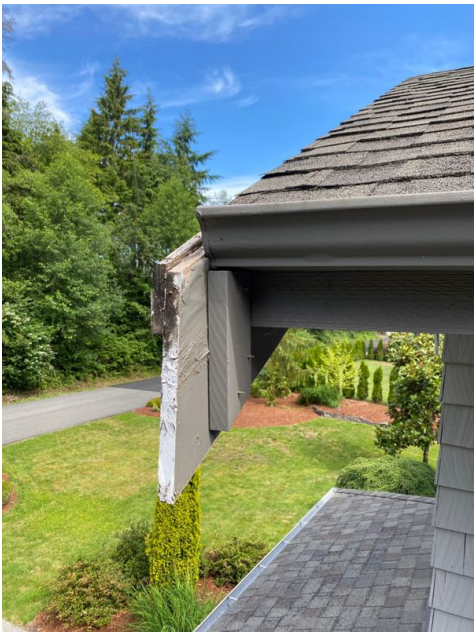
3.2.3 Eaves, Soffits & Fascia

**FASCIA - MOISTURE DAMAGE**

Some of the boards were showing moisture damage. Recommend that a qualified contractor make any needed repairs or replacement.

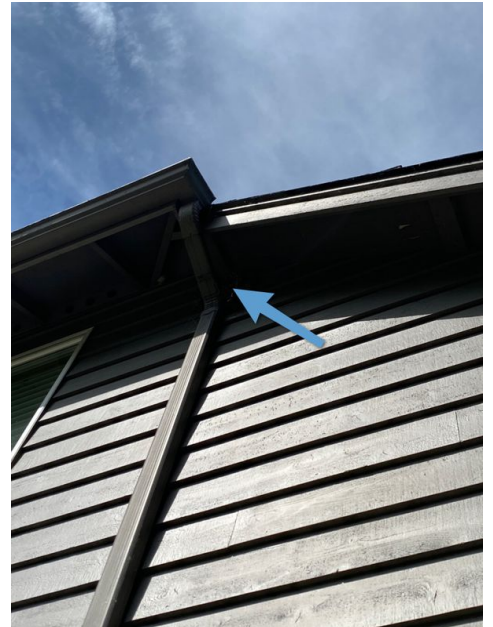
## 3.2.4 Eaves, Soffits &amp; Fascia

Birds appear to have made some nests. Recommend that they be removed.

Contact a qualified pest control specialist.

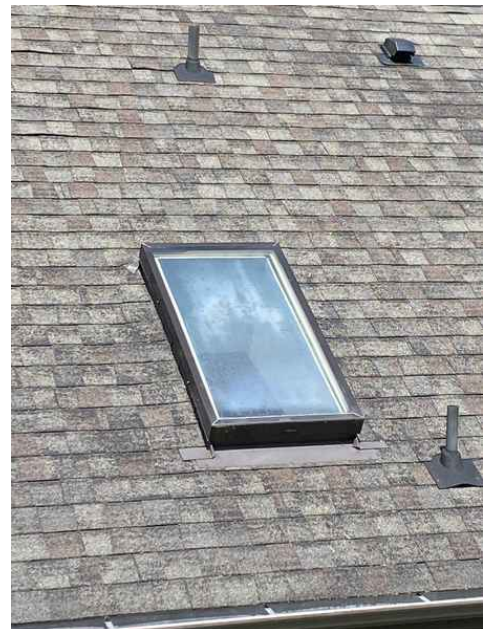
## 3.3.1 Exterior Windows

**WINDOW SEAL FAILURE**

Observed condensation between the skylight panes, which indicates a failed thermo pane seal. Recommend qualified window contractor evaluate & replace.

Contact a qualified window repair/installation contractor.

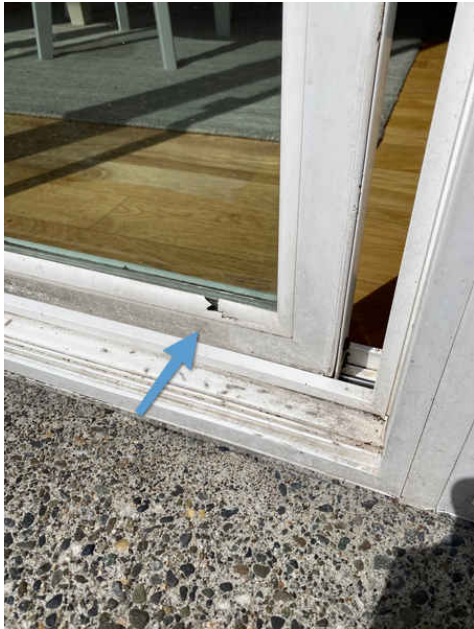
## 3.4.1 Exterior Doors

**DOOR STOP - DAMAGED**

Door glass stop was damaged. Recommend that it be replaced.

Contact a qualified door repair/installation contractor.

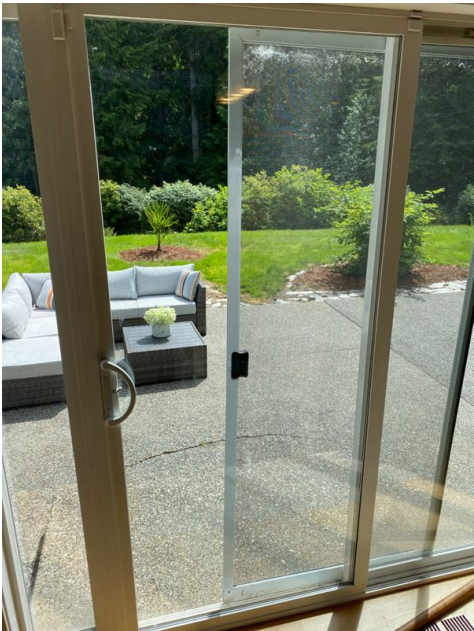
3.4.2 Exterior Doors

**SCREEN DOOR  
DAMAGE**

Screen door was difficult to operate. Recommend repair or replacement as needed

Contact a qualified door repair/installation contractor.

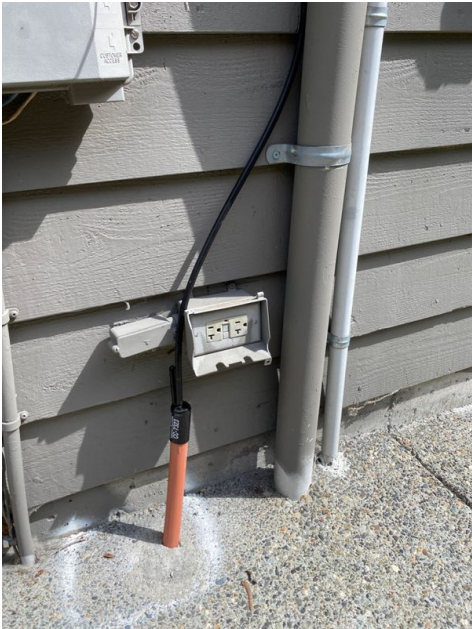
3.7.1 Exterior lighting and  
receptacles

**WEATHERPROOF COVERS - DAMAGED**

One or more exterior receptacles had a damaged weatherproof cover. Recommend replacement by a qualified electrician.

Contact a qualified electrical contractor.

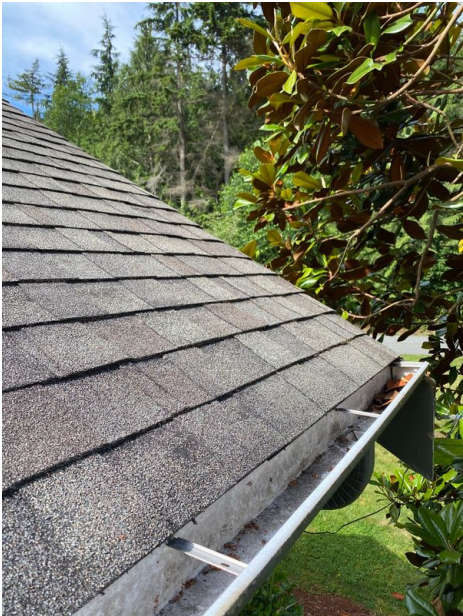
<b>Inspection Method</b> Roof	<b>Roof Pitch</b> Steep Slope	<b>Roof Type/Style</b> Gable, Hip, Combination
<b>Coverings: Material Approximate Age</b> 11-20 years	<b>Coverings: Material Type</b> Architectural Asphalt	<b>Coverings: Layers of Material</b> 1

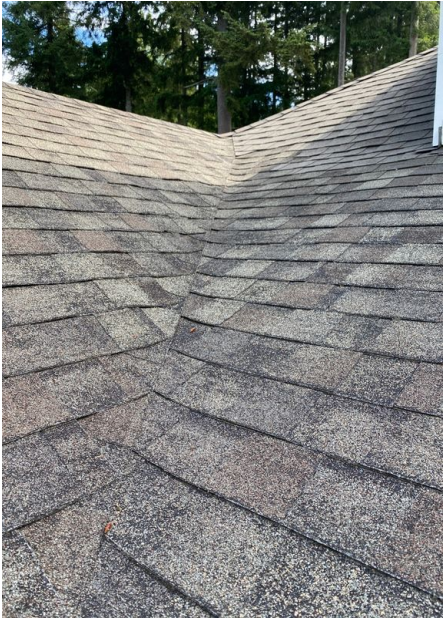
Coverings: Valley Type  
Cut

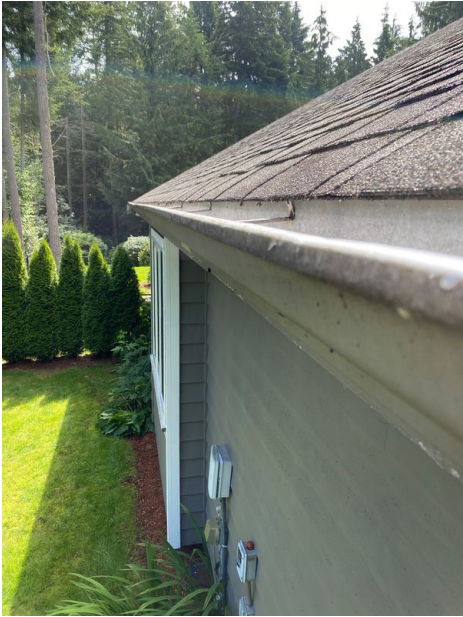
Roof Drainage Systems: Gutter  
Material  
Aluminum

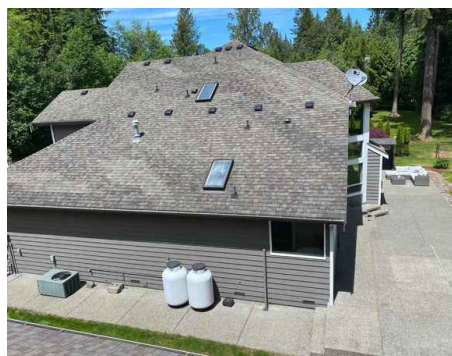
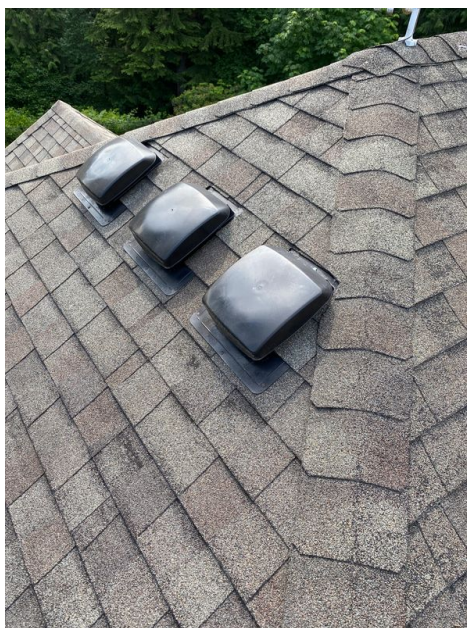
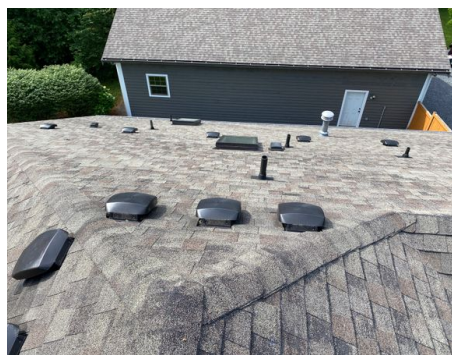
## Skylights, Chimneys & Other Roof Penetrations: Vent Type

Plumbing Vent Pipe, Bathroom Exhaust Termination, Roof Box Vent

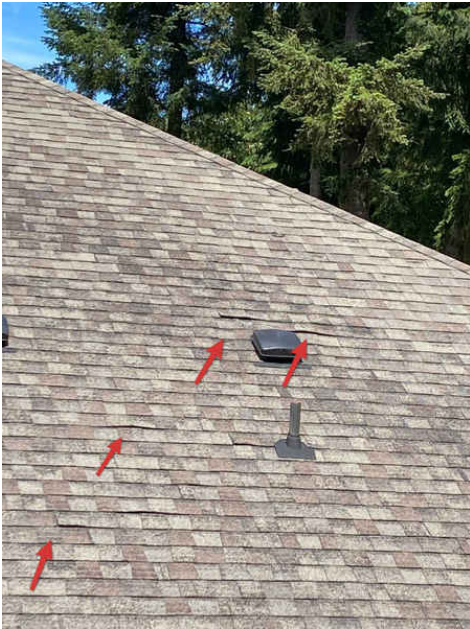
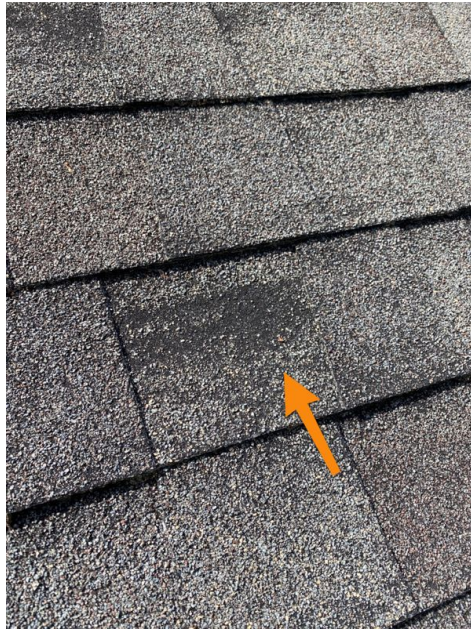
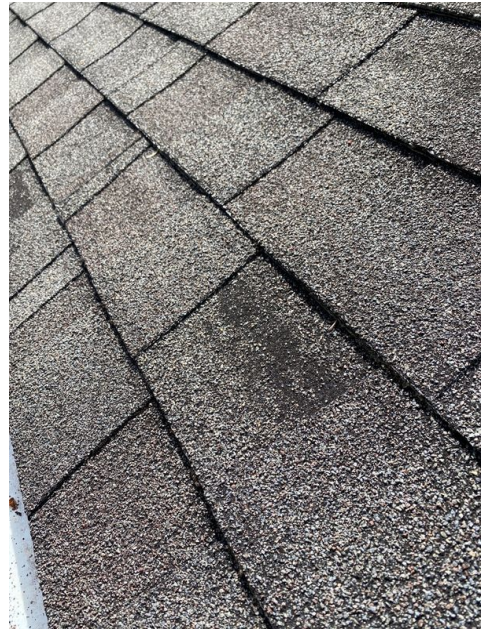
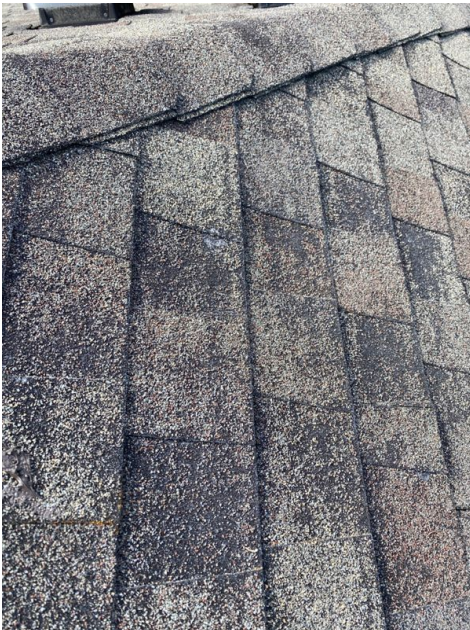
#### **GRANULES - MISSING**

The granules on the roofing shingles were worn away. Granule loss greatly reduces the life expectancy of a roof. Some shingles were curled up. This roofing material appears to have reached the end of its lifespan. Recommend that a qualified roofer replace the roof.

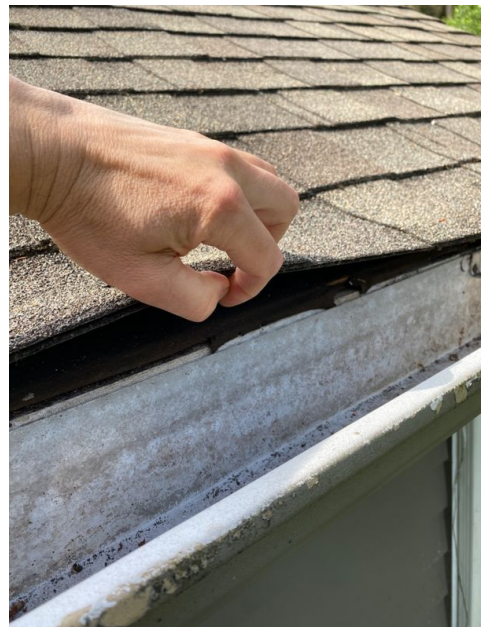
#### 4.3.1 Flashings

### DRIP EDGE FLASHING - MISSING

Drip edge flashing was not installed at the edge of the roof. This flashing directs rain water away from the structure and into the gutter. Recommend that a qualified roofing contractor install the flashing as needed.

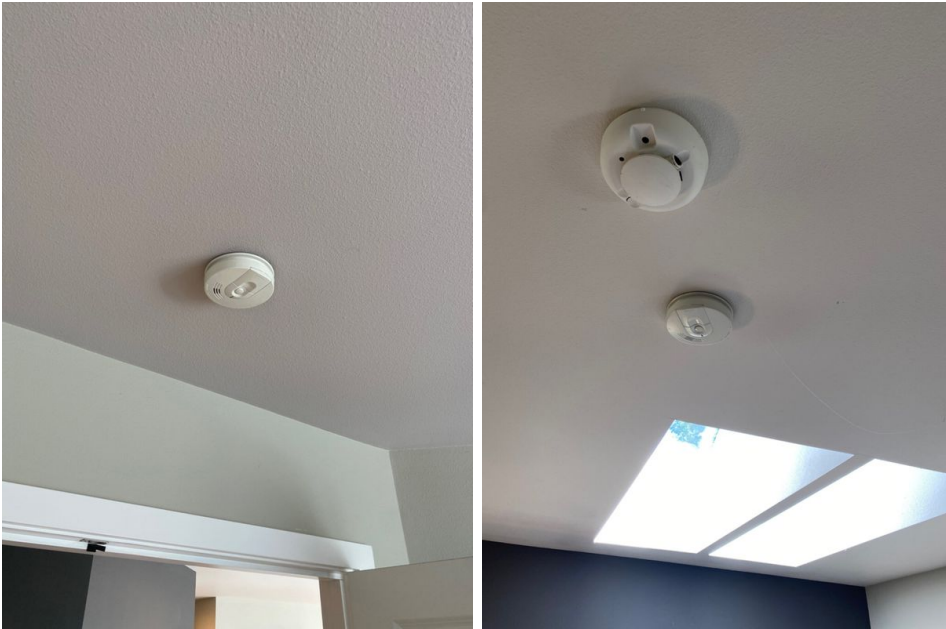
Smoke detectors appear to be beyond normal life expectancy. Recommend replacement every 10 years or per manufacture instruction.

Contact a handyman or DIY project

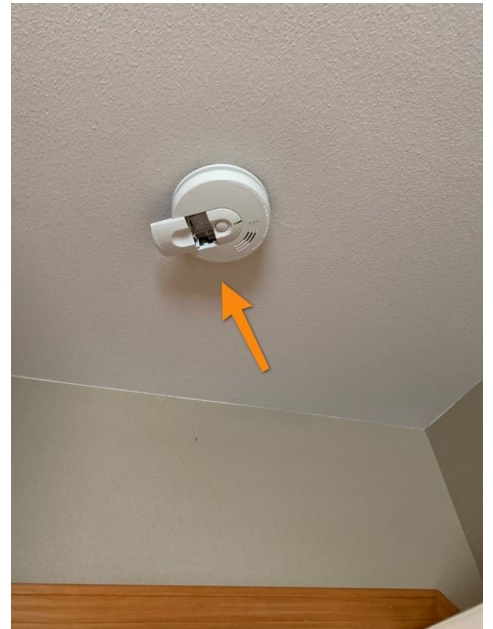
## 5.1.2 Smoke and CO Detectors

Smoke detector batteries were removed. This is a safety hazard and should be corrected.

Contact a handyman or DIY project

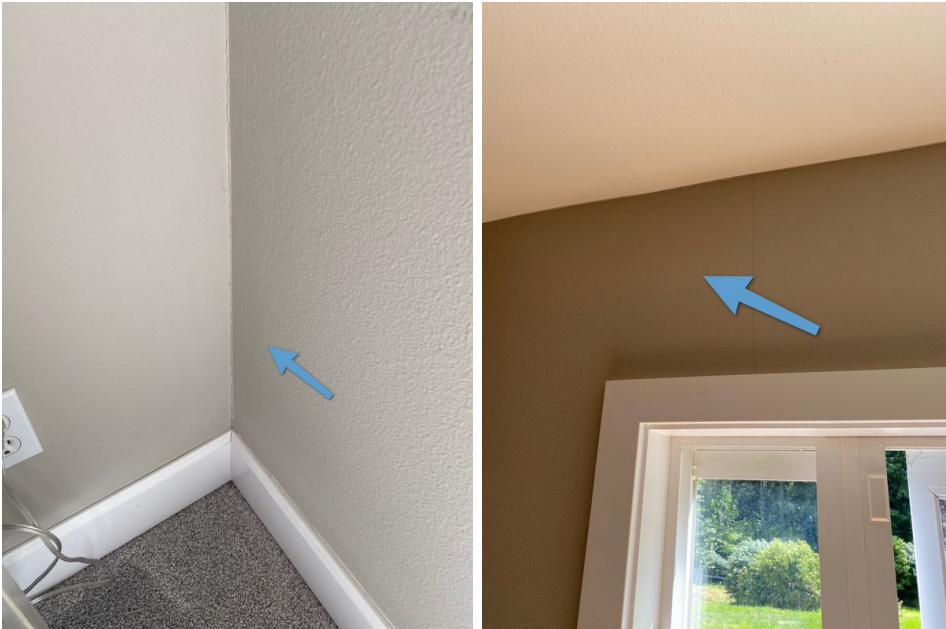
## 5.2.1 Walls and Ceilings

**DRYWALL - DEFECTS**

Typical cracks in drywall/plaster were observed. These cracks may develop due to normal aging of a home, minor settling, as well as moisture/temperature changes. Recommend repair as needed. No evidence of structural defect observed at time of inspection.

Contact a qualified drywall contractor.

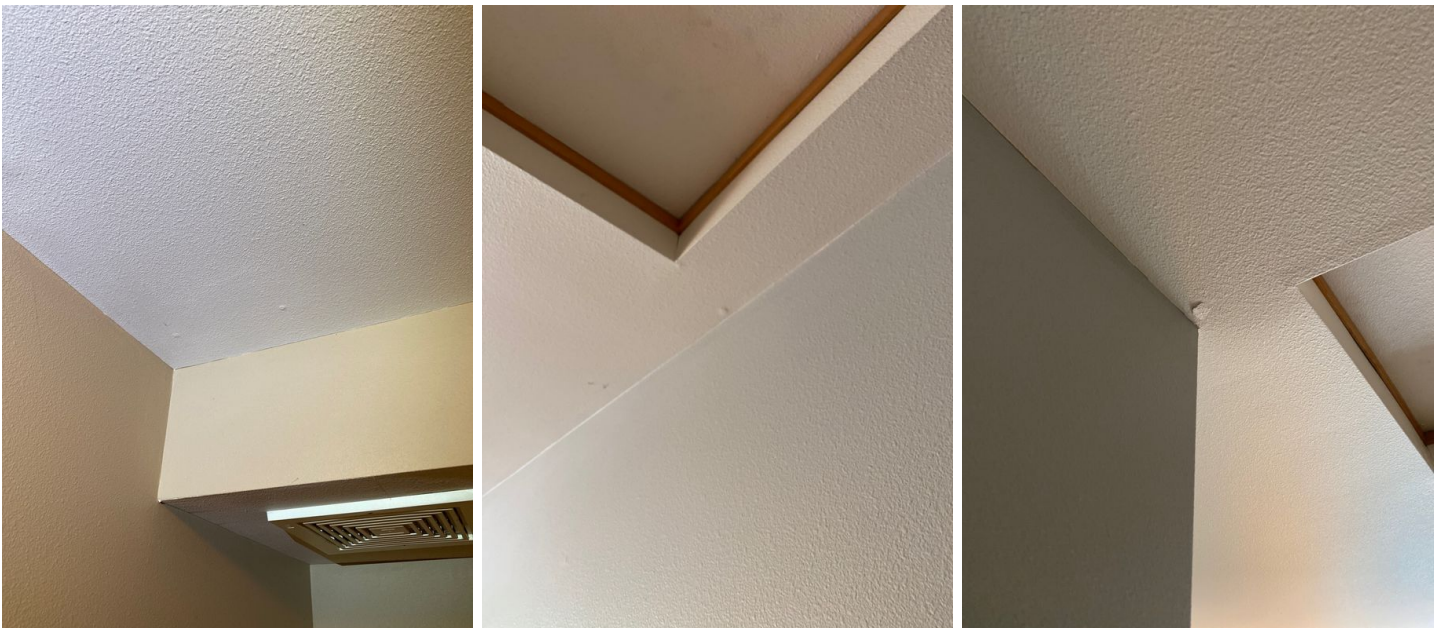
### 5.2.2 Walls and Ceilings

#### **NAIL POPS**

"Nail-pops" were observed. Recommend repair as needed by a qualified handyman, painter or drywall contractor. Moisture meter did not indicate a presence of moisture.

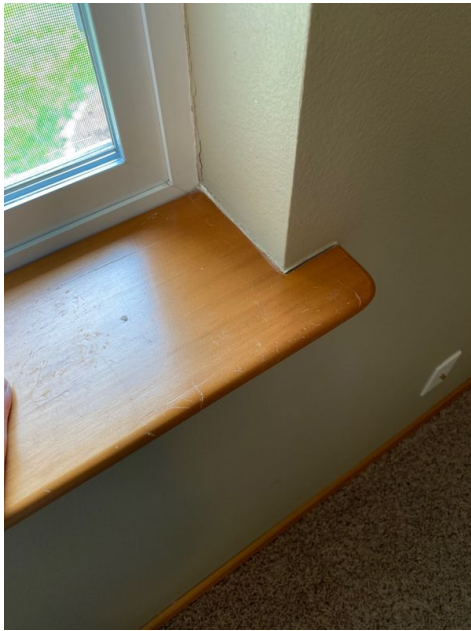
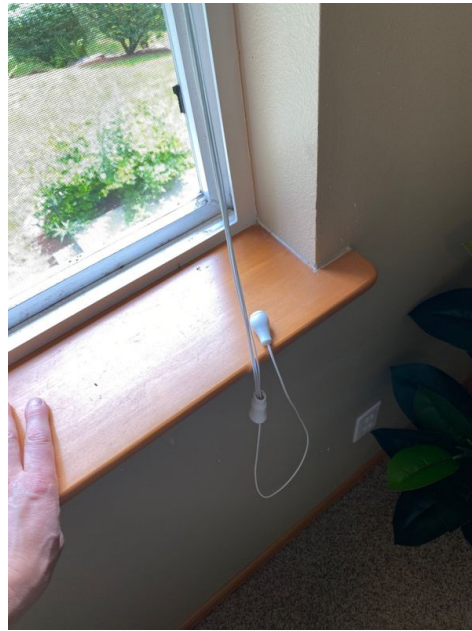
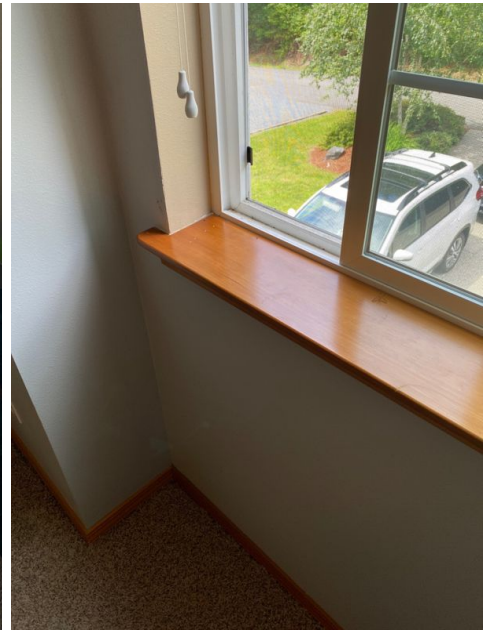
### 5.3.1 Windows

#### **SILL LOOSE**

Window sills were loose. Recommend repair.

Contact a qualified handyman.

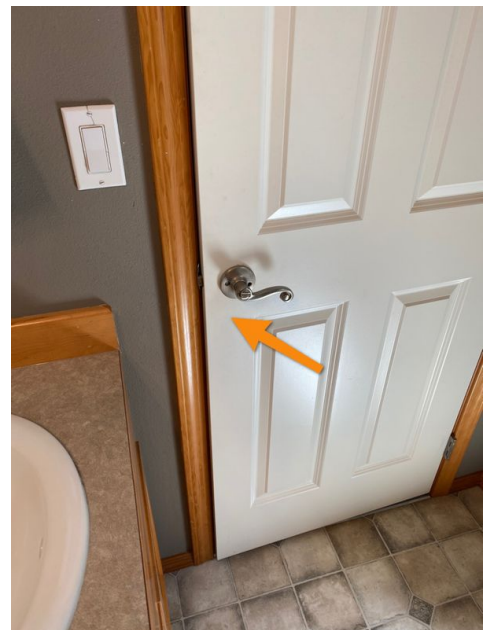
#### 5.4.1 Doors

Door didn't latch properly. Recommend handyman repair latch and/or strike plate.

Contact a qualified handyman.

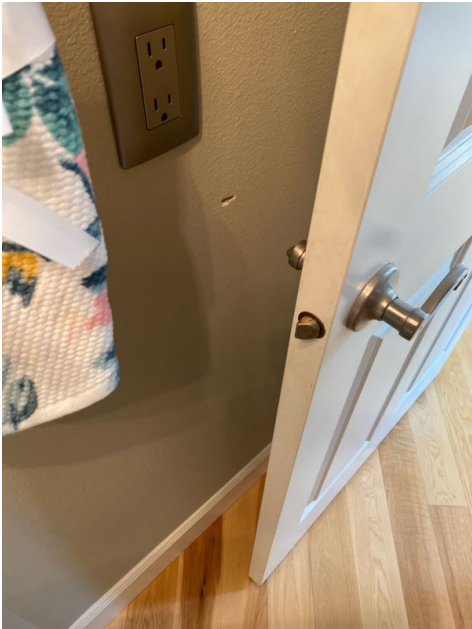
#### 5.4.2 Doors

### DOOR STOP - MISSING

Doors did not have stops. Recommend that door stops be installed to protect the wall finish from damage.

Contact a handyman or DIY project

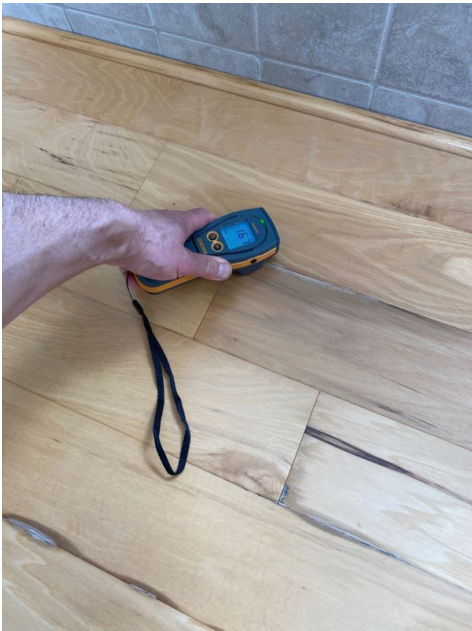
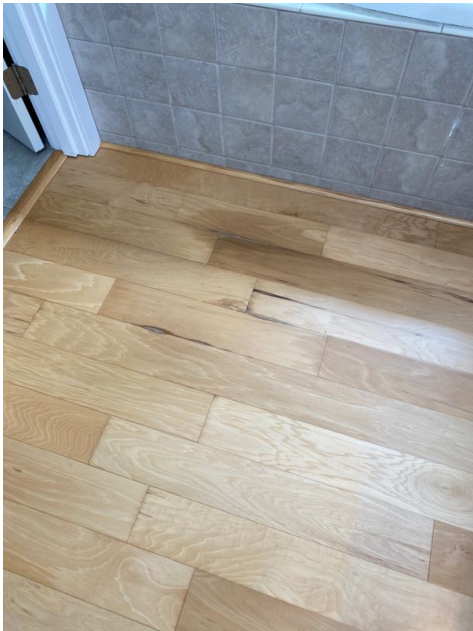
5.5.1 Floors

**MOISTURE DAMAGE**

Floors had areas of moisture damage. Moisture meter showed normal levels. Recommend a qualified flooring contractor evaluate & repair as needed.

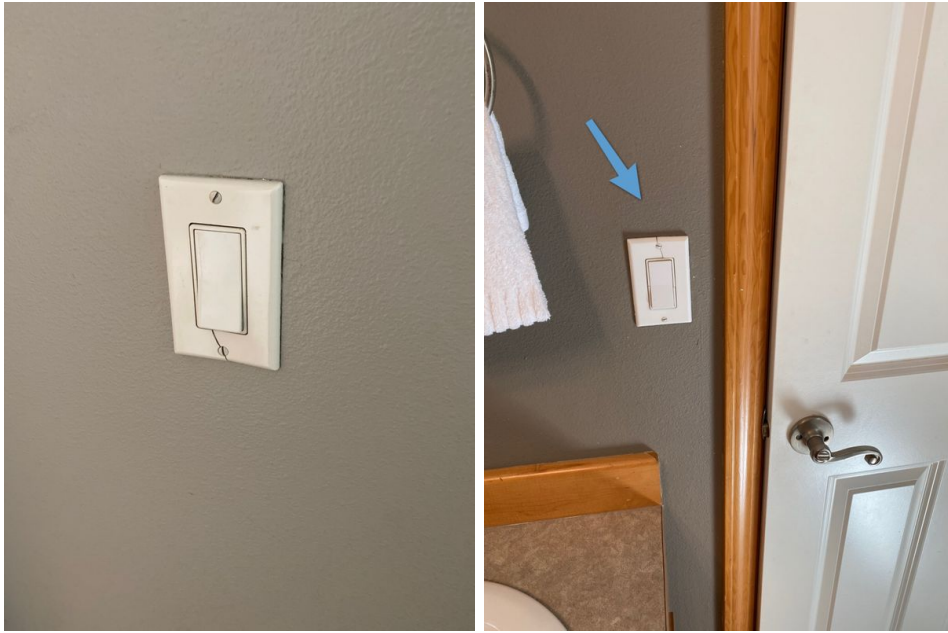
5.7.1 Electrical components

**COVER PLATES DAMAGED**

One or more receptacles had a damaged cover plate. Recommend replacement.

Contact a qualified electrical contractor.

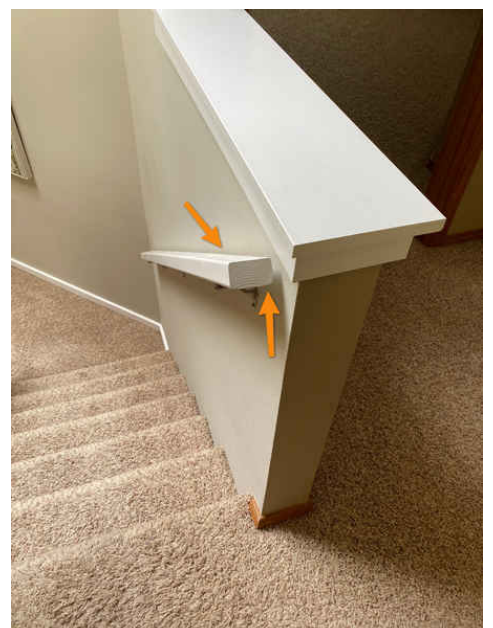
**HANDRAIL IMPROPER**

Interior staircase handrails do not meet current safety standards. Railing did not return to the wall and could not be grasped because the rail was too close to the wall. Recommend qualified contractor to repair to current safety standards to prevent possible injuries.

Contact a qualified carpenter.

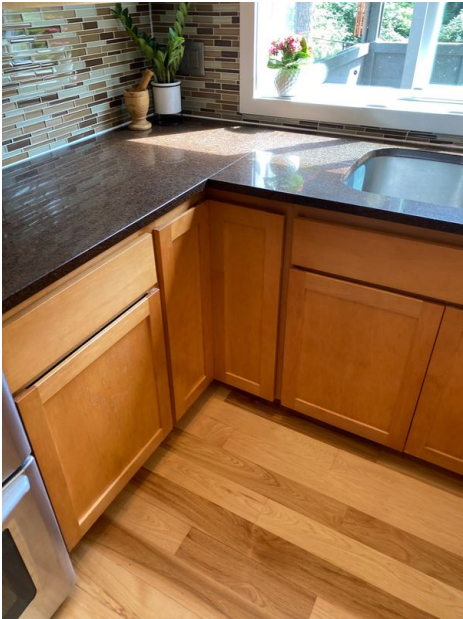
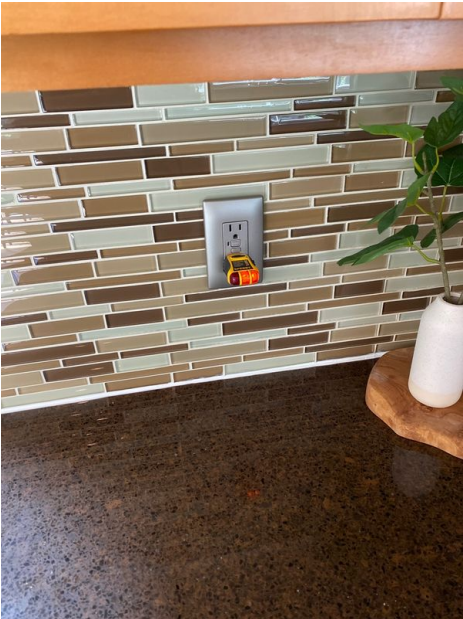
**Electrical Components: GFCI/AFCI**  
**Protected Receptacles**  
Present, Tripped when tested

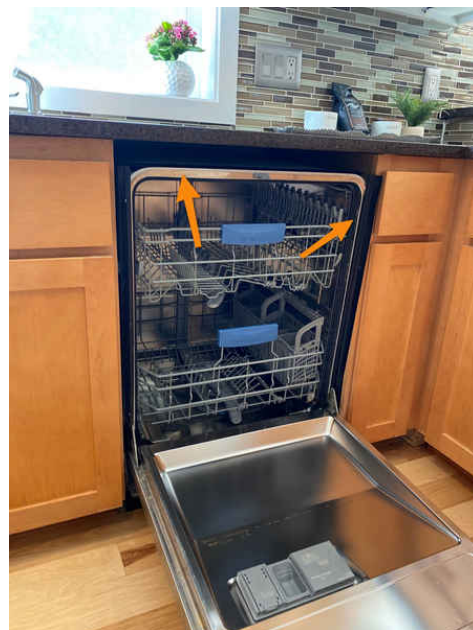
## 6.3.1 Dishwasher

**DISHWASHER - NOT SECURED**

Dishwasher was not secured in opening. Recommend that a qualified contractor repair as needed.

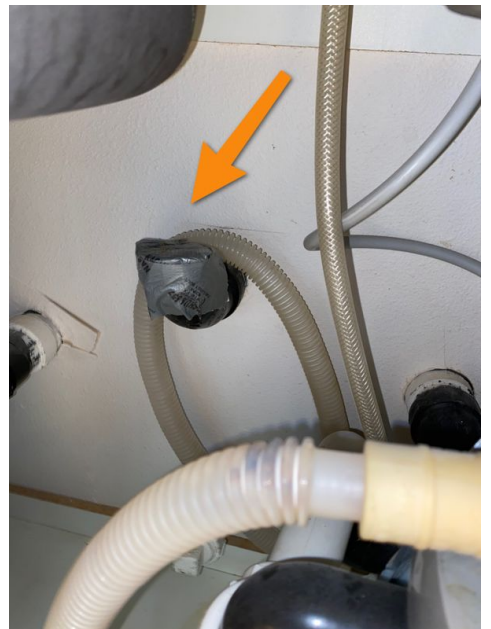
## 6.8.2 Sink

**IMPROPER CONNECTIONS**

Contact a qualified plumbing contractor.

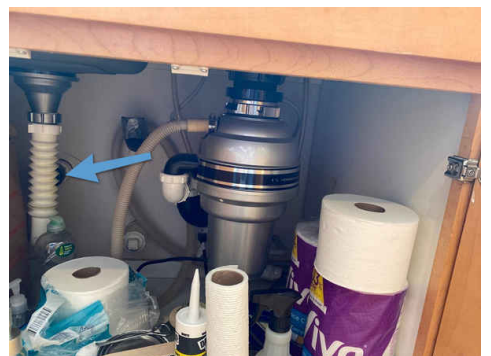
## 6.9.1 Garbage Disposal

**GARBAGE DISPOSAL ON SEPTIC SYSTEM**

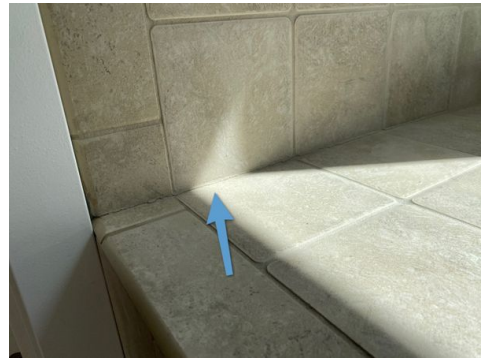
## 7.4.2 Bathtub/Shower

**BATHTUB - CRACKED**

Tubs were cracked or chipped. Recommend that a qualified contractor evaluate and make any needed repairs or replacement.

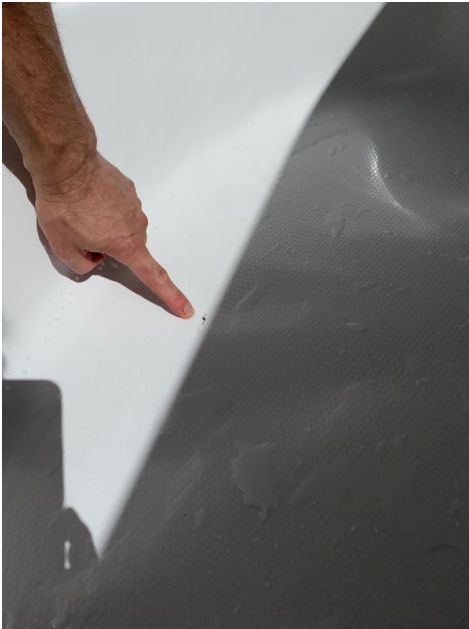
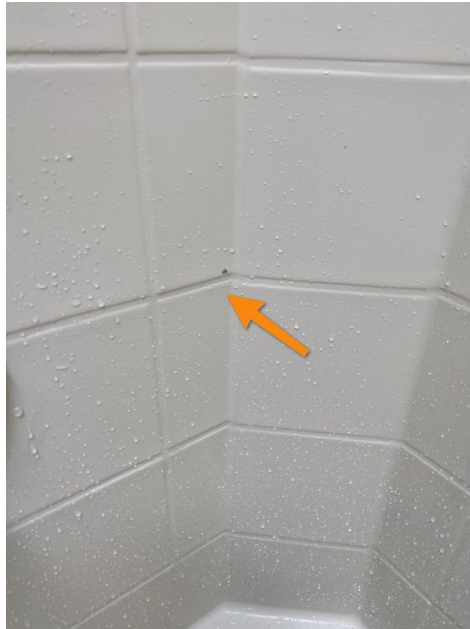
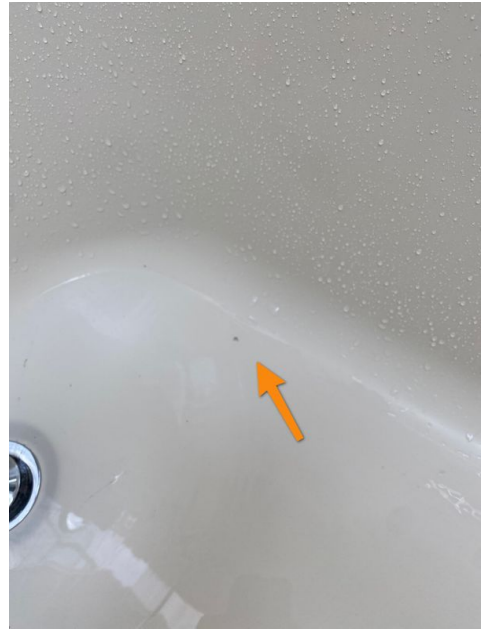
#### 7.4.3 Bathtub/Shower

### **SHOWER HEAD - LEAKING**

The shower head leaked when the valve was turned on. Recommend that a qualified plumber make any needed repairs.

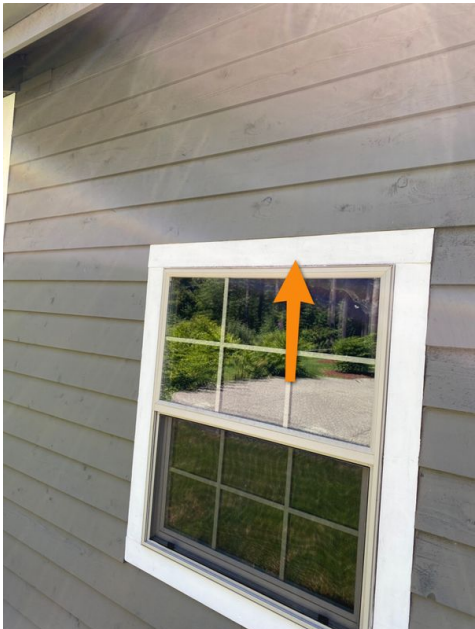
10.3.1 Siding, Trim, Fascia, Soffit,  
Eaves

Flashing was not observed at the time of inspection over the windows. Siding material requires flashing near windows, doors, and siding transitions. Recommend that a qualified contractor evaluate and repair as needed.

Recommendation  
Contact a qualified siding specialist.

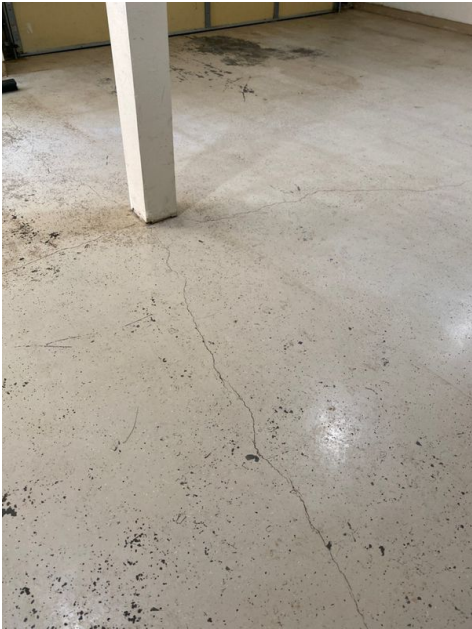
10.4.1 Floor

**CRACKING**

Typical cracking/settlement observed in concrete. If settling worsens and cracks become a trip hazard recommend that a qualified concrete contractor repair to prevent injuries.

Recommendation  
Contact a qualified concrete contractor.

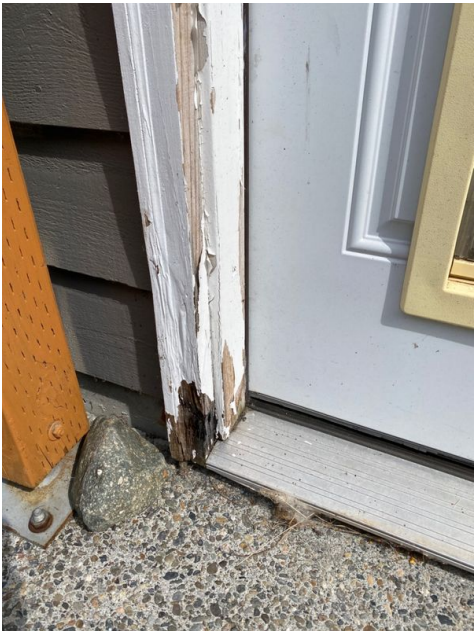
10.7.1 Manual door

**DAMAGE**

Contact a qualified door repair/installation contractor.
