## RESIDENTIAL REPORT

1234 Main st.  
Seattle, WA 98125

Buyer Name  
08/22/2022 9:00AM

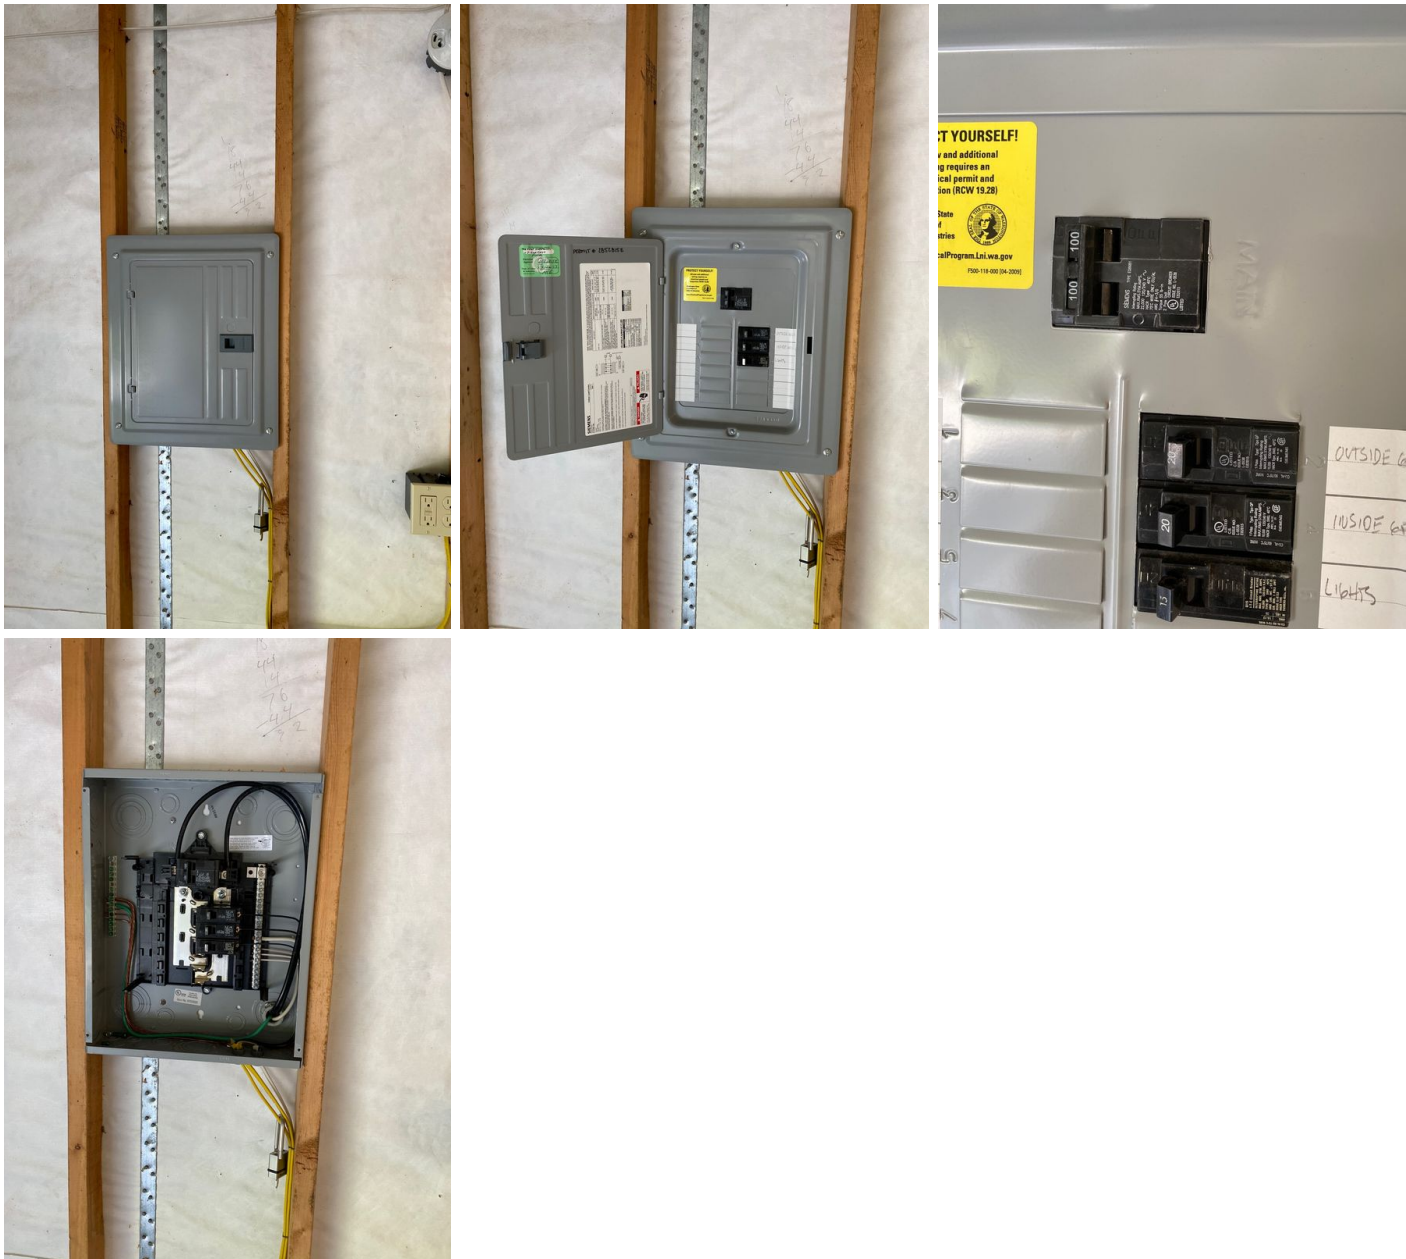
11.1.1 Main & Subpanels, Service & Grounding, Main Overcurrent Device

It appears that 14 gauge wiring was on a 30 amp breaker. This may be a fire hazard. Recommend that a qualified electrician evaluate and determine if a smaller breaker is needed.

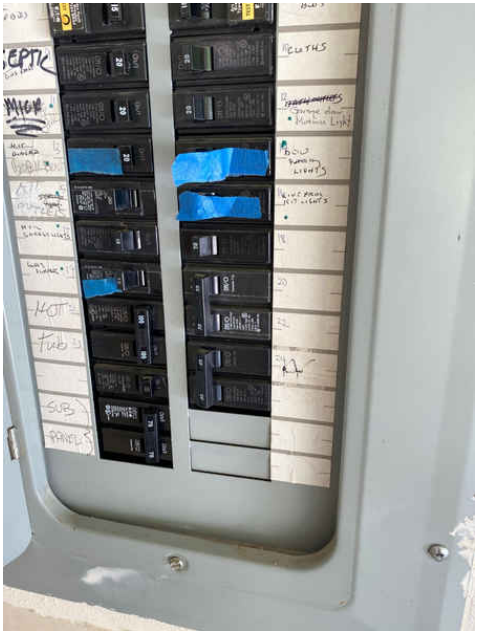
**MISSING LABELS ON PANEL**

At the time of inspection, panel was not fully labeled. Recommend a qualified electrician identify and map out locations.

Contact a qualified electrical contractor.

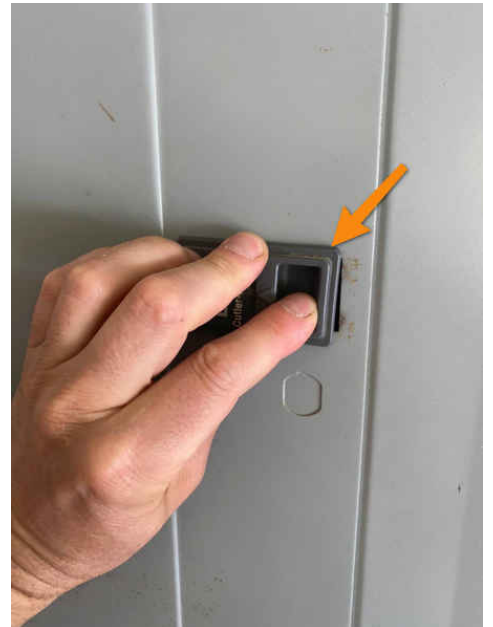
### **PANEL COVER - DAMAGED**

Panel cover lock was damaged. Recommend that it be replaced.

Contact a qualified electrical contractor.

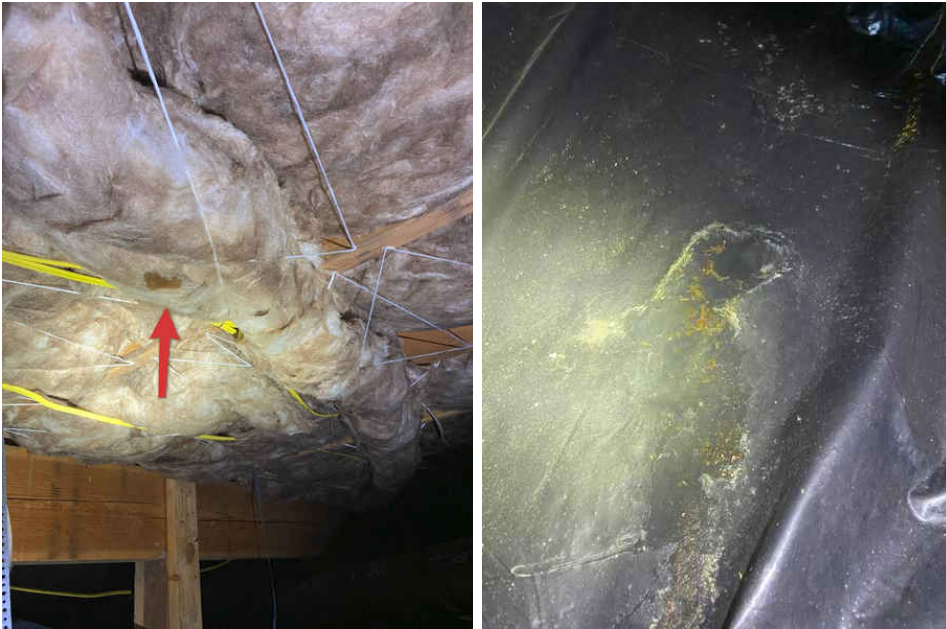
DISTRIBUTION PIPE LEAKING

Distribution pipe was leaking at the time of inspection. Recommend a qualified plumber evaluate and repair as soon as possible.

Major Defects/Safety Hazard

Recommendation  
Contact a qualified plumbing contractor.

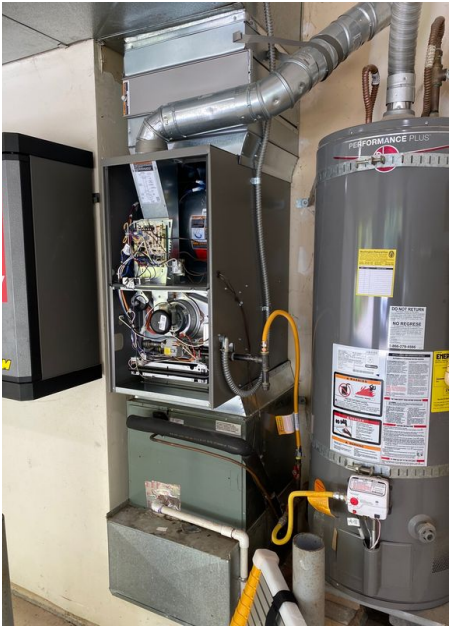
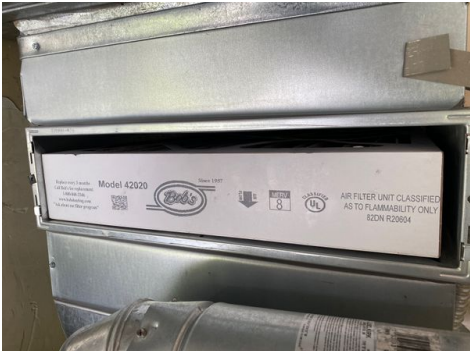
LENNOX DALLAS, TEXAS		ASSEMBLED IN MEXICO
M/N	ML180DF090E48B-53	
S/N	1722A05785	
HEATING DATA		
EQUIPPED FOR USE WITH NATURAL GAS		
INPUT (BTUH)	88,000	
OUTPUT (BTUH)	72,000	
MANIFOLD PRESSURE (IN. W.C.)	3.5	
GAS SUPPLY LINE PRESS (MAX/MIN IN. W.C.) FOR PURPOSE OF INPUT ADJUSTMENT	13.0/4.5	
MAXIMUM OUTLET AIR TEMP. (°F)	180°	
TEMPERATURE RISE (°F)	30-60	
MANUFACTURER RECOMMENDED ORIFICE SIZE (IN.)	.0625	
MAX. STATIC PRESSURE (IN. W.C.)	0.5	
FOR ALTITUDES TO (FEET)	0-4500	
SEE INSTALLATION INSTRUCTIONS FOR INSTALLATIONS ABOVE (FEET)	4500	
CONVERSION KIT AS SUPPLIED BY THE MANUFACTURER, MUST BE USED TO CONVERT THIS UNIT TO PROPANE	004888-12 / 11K49	
MFG'S RECOMMENDED ORIFICE SIZE (IN.)	.034	
MANIFOLD PRESSURE (IN. W.C.)	10.0	
FOR INDOOR INSTALLATION IN A BUILDING CONSTRUCTED ON SITE IN HEATED OR UNHEATED SPACES.		
NOTE: SPECIFY MODEL NO. & SERIAL NO. WHEN ORDERING REPAIR PARTS.		
CLEARANCE		
THIS FURNACE IS APPROVED FOR DOWNFLOW INSTALLATIONS. MIN. CLEARANCES TO COMBUSTIBLE CONSTRUCTION (IN.). CLEARANCE ABOVE DOES NOT CHANGE WITH FURNACE ORIENTATION.

VENT 12" MIN.		
* MIN. FRONT SERVICE CLEARANCE FOR ALCOVE, CLOSET, & ATTIC INSTALLATION.		
** VENT HOSE REQUIRED IF 12" SINGLE WALL VENT IS USED.		
*** VENT MUST BE USED IF 12" MIN.

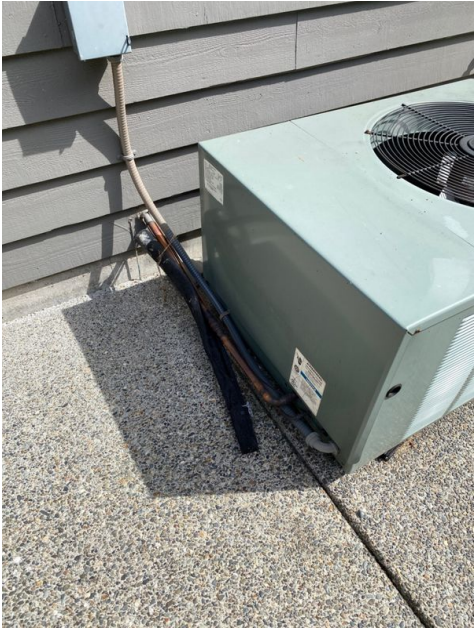
INSULATION MISSING OR  
DAMAGED

Missing or damaged insulation on refrigerant line can cause energy loss and condensation. Recommend that a qualified heating contractor replace the insulation.

Contact a qualified HVAC professional.

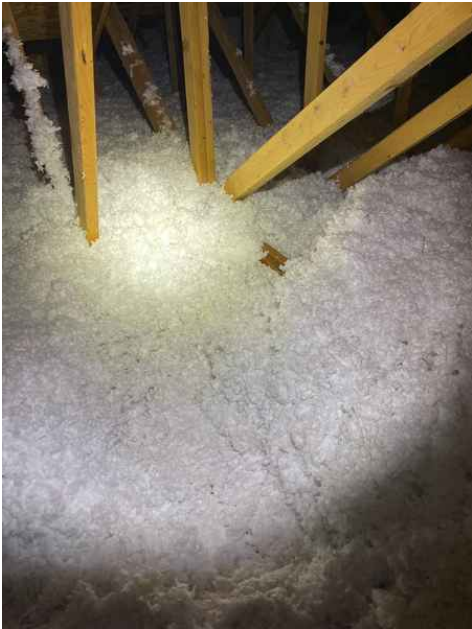
INSULATION - MISSING

Insulation was moved aside in some areas. Recommend that the insulation be moved back by a qualified insulation contractor.

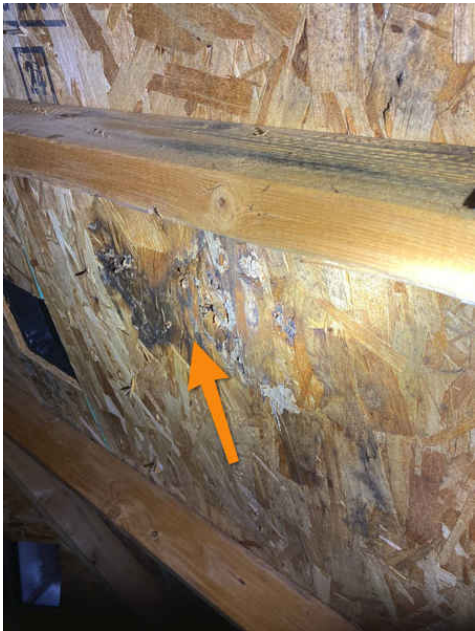
14.2.1 Structure and Framing

**MOISTURE DAMAGE/ACTIVE LEAK**

Contact a qualified roofing professional.

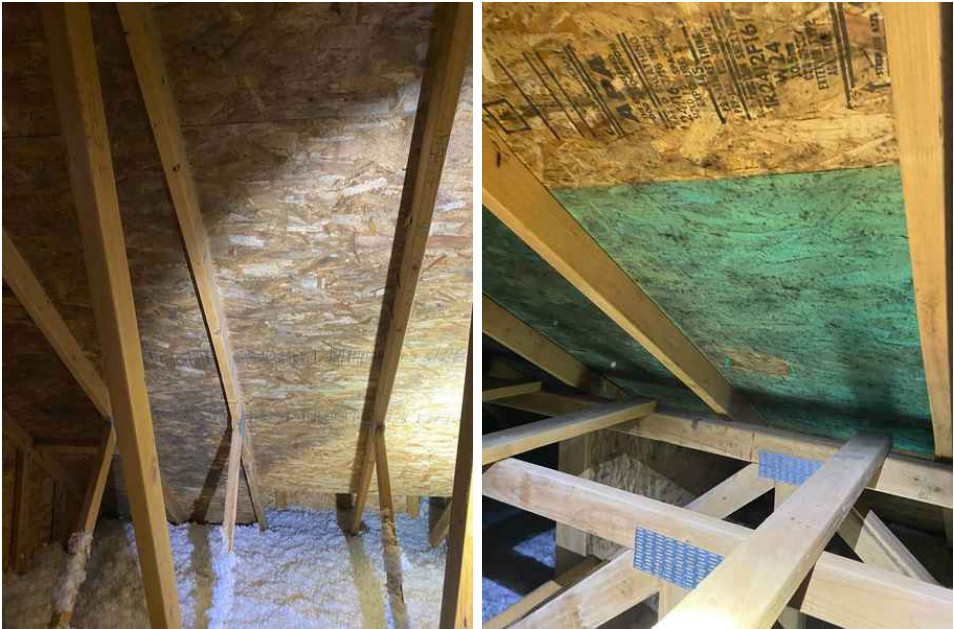
14.2.2 Structure and Framing

**ROOF SHEATHING - DISCOLORATION**

Contact a qualified environmental contractor

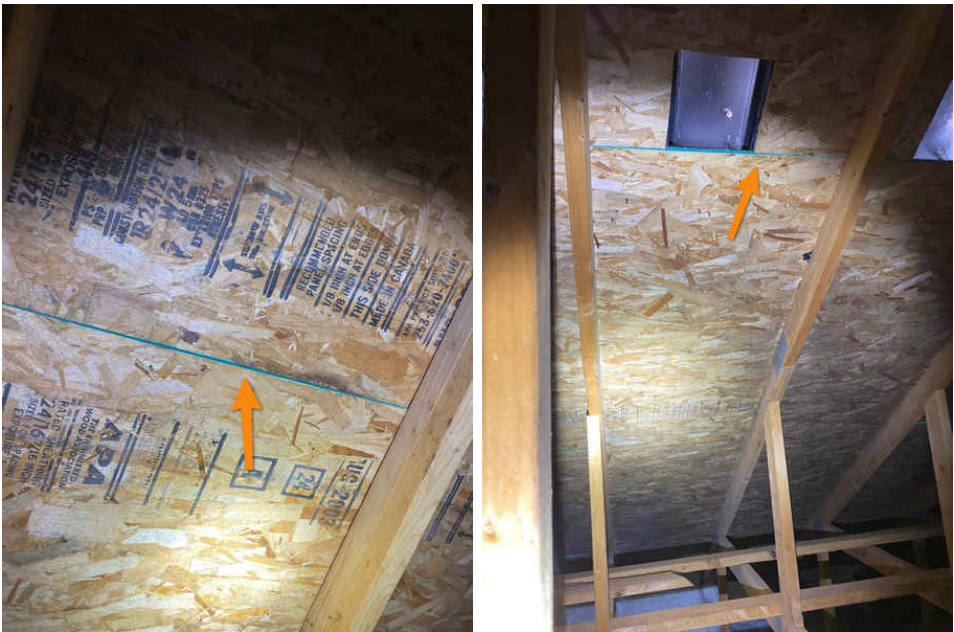
14.2.3 Structure and Framing

**ROOF SHEATHING IMPROPERLY INSTALLED**

Roof sheathing was installed without gaps. This can cause the plywood to buckle when is gets moist. Which can cause damage to the roofing materials. Recommend that a qualified roofing contractor examine the problem and determine if any action to protect the roof shingles is necessary.

Recommendation  
Contact a qualified roofing professional.

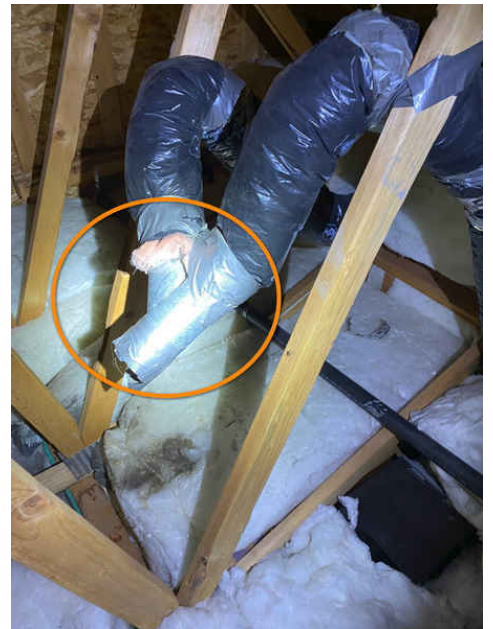
14.4.1 Exhaust Systems

**BATHROOM VENT - IMPROPER**

Contact a qualified handyman.

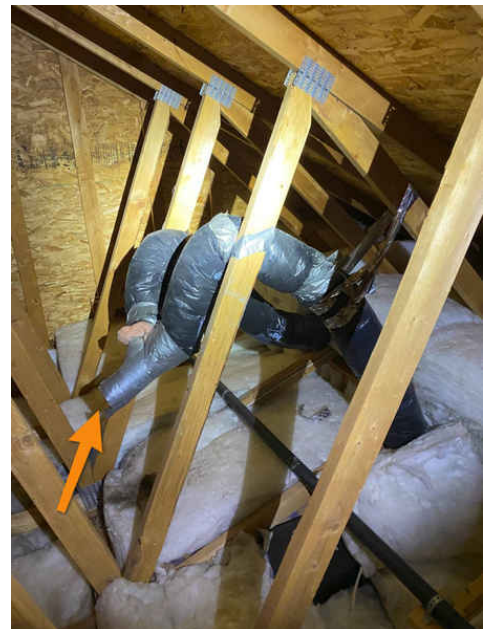
#### 14.4.2 Exhaust Systems

### **BATHROOM VENTS INTO ATTIC**

Contact a qualified handyman.

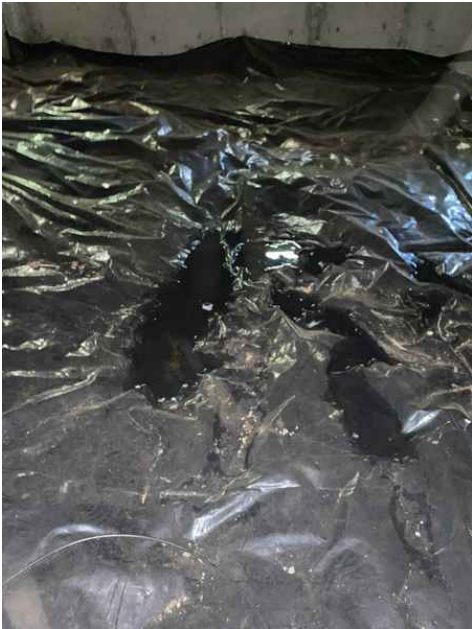
15.2.1 Floor & Wall Structure

There were signs of water intrusion in the crawlspace. This may be due to the back patio being installed over the siding. Recommend that a qualified contractor evaluate and make any needed repairs.

Contact a foundation contractor.

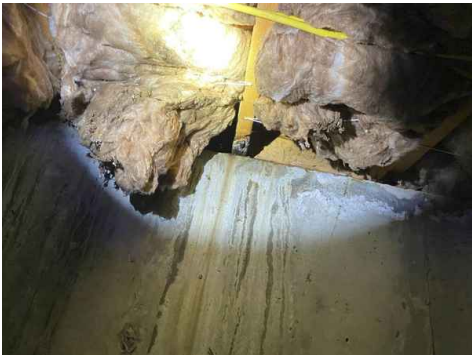
**MOISTURE DAMAGE**

The rim joist and ends of floor joists had some moisture damage. The source of moisture was probably from the back patio being installed over the siding. Recommend that a qualified contractor further evaluate and make any needed repairs.

Contact a qualified general contractor.
