Inspection Report

Property Address:
1927 Older Neighborhood Road
Jacksonville FL

Inspector: Dan Fryer
FL Lic # HI1796
904-657-5577
FryerBD.com

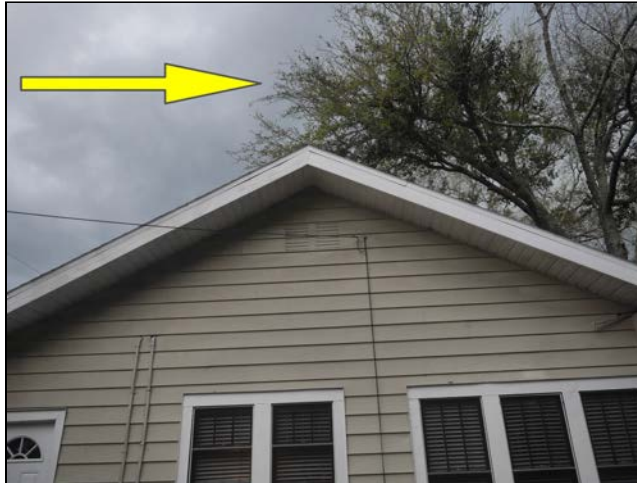
1.0 (1) Tree(s) overhanging and / or contacting roof covering.

- Potential for damage to roof structure, as well as premature aging of roof exterior coverings due to acidic byproducts created during organic decomposition exists when trees are allowed to overhang roof.
- Recommend maintaining all trees so they do not breach the vertical plane of the roof perimeter.

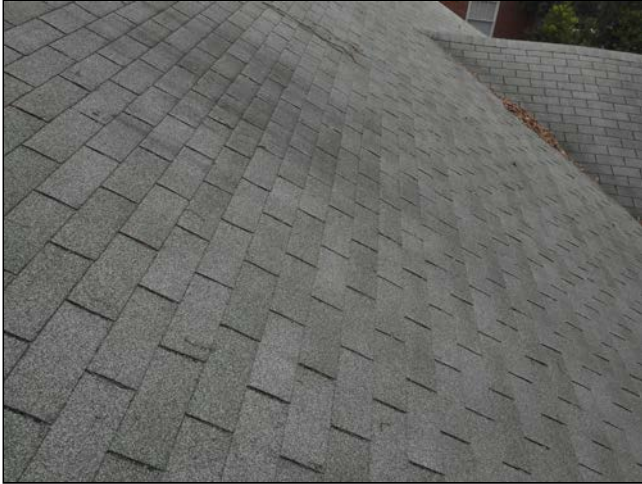
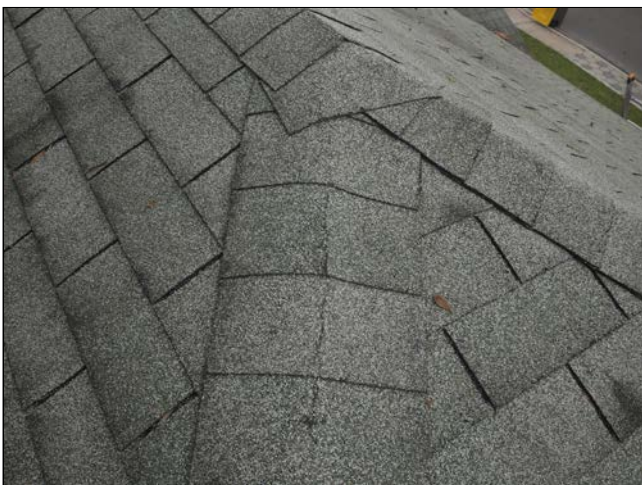
1.0 (2) Roof covering system exhibits signs of aging.

- Some surface texture material loss throughout roof exterior.
- Staining / discoloration at left side due to overhanging trees(s).
- Mechanical damage to shingles at localized areas. Recommend repair as appropriate.
- Should client have concerns regarding the remaining useful life of noted system(s), consultation with a licensed specialist is recommended.

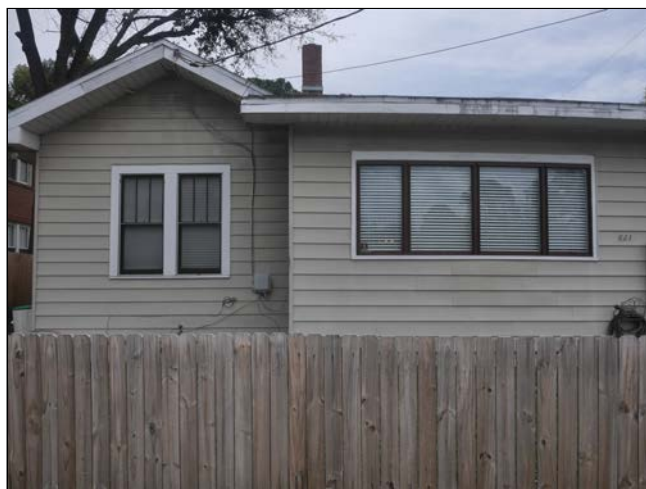
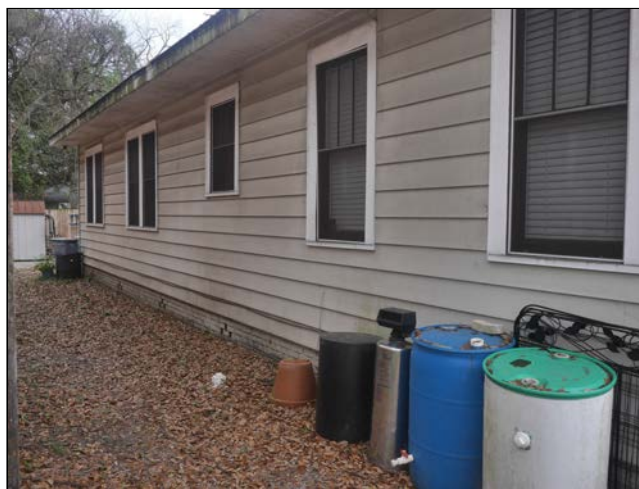
2.0 (1) Elevation photo(s). Provided for documentary purposes only.

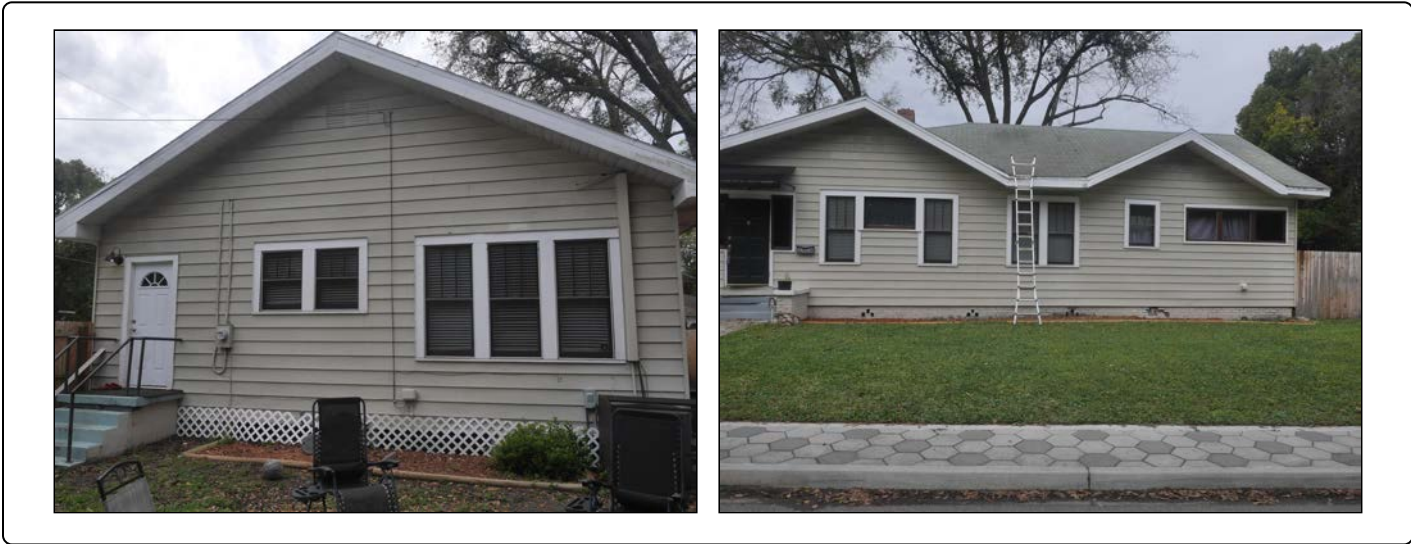
2.0 (2) Exterior window trim material damaged at some areas.

- Recommend repair as appropriate.

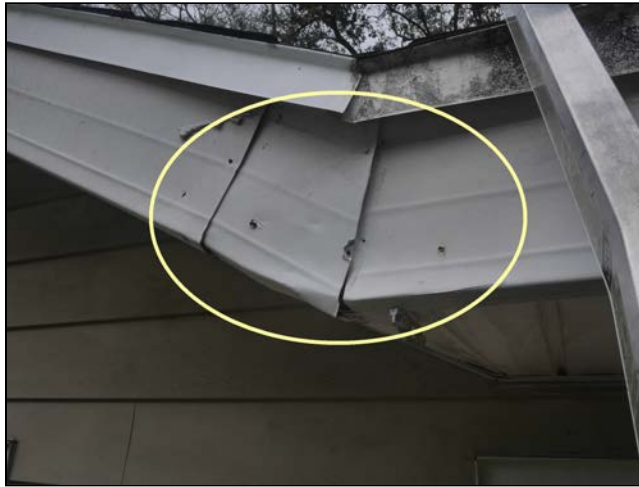
2.0 (3) Mechanical fasteners / holes driven through exterior siding / fascia.

- Potential moisture intrusion point(s).
- Recommend repair as appropriate.
- Multiple locations noted. This report is qualitative, not quantitative. Photo(s) representative of noted deficiency.

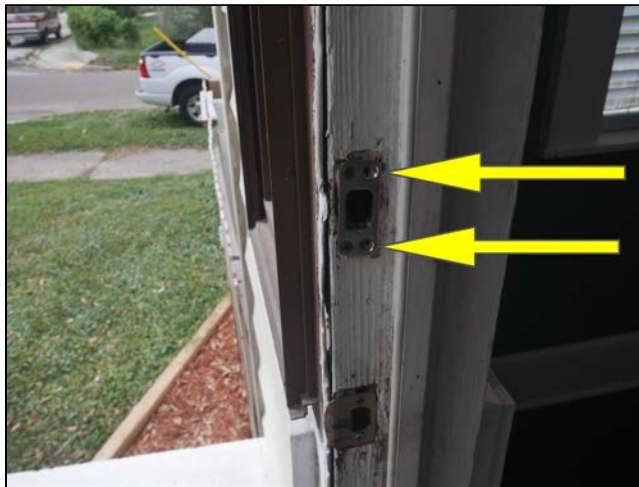
**2.1 (1)** Mechanical fasteners missing at strike at front entry door.

- Recommend repair as appropriate.

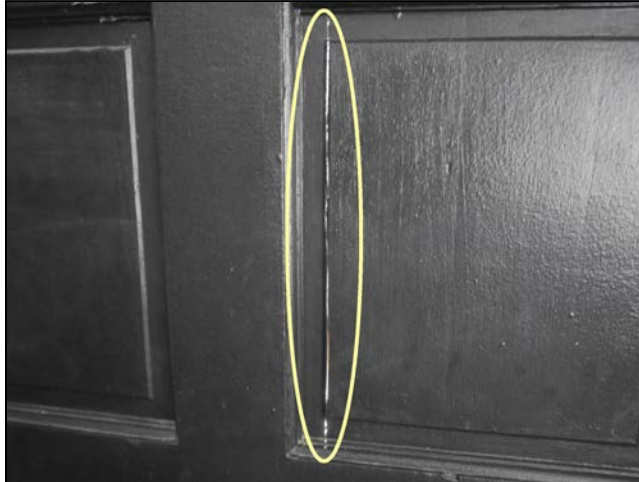
- 2.1 (2) Visible crack / separation at front entry door.
- Recommend seal / waterproof as appropriate.

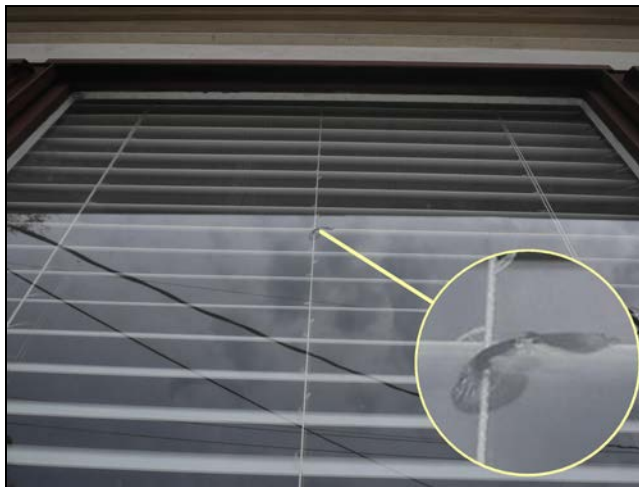
- 2.2 Damaged glazed panel at window.
- Recommend repair / replace as appropriate.

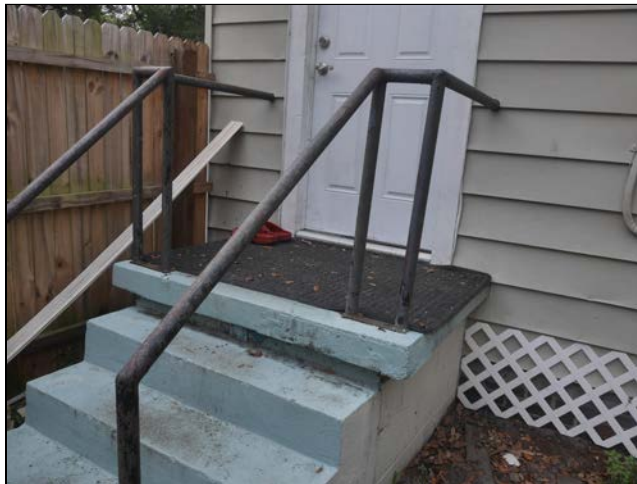
**2.3 (2)** Baluster spacing exceeds 4 inches.

- Fall hazard, especially for children and pets.
- Recommend reconfigure / repair in accordance with current building practices and safety standards.

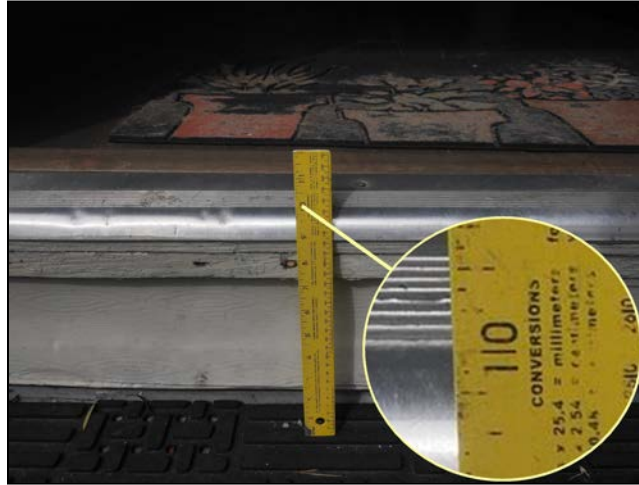
2.3 (3) Riser height exceeds 7 3/4" at step(s).

- Trip hazard.
- Recommend reconfigure in accordance with current building practices and safety standards.

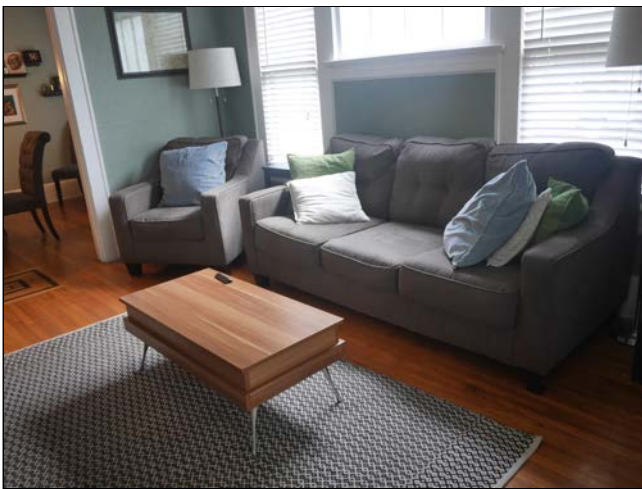
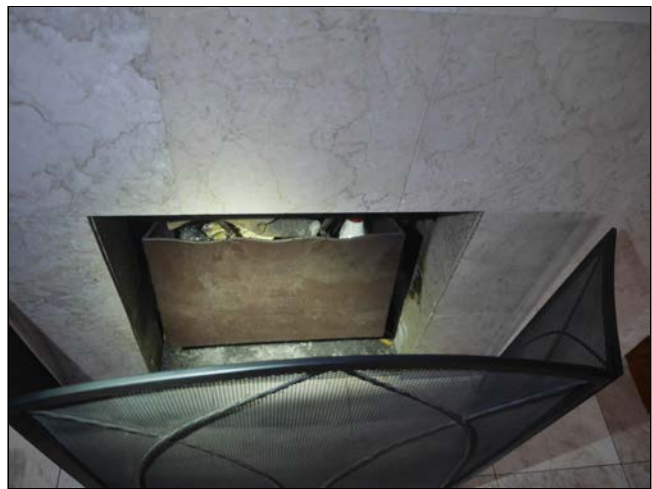
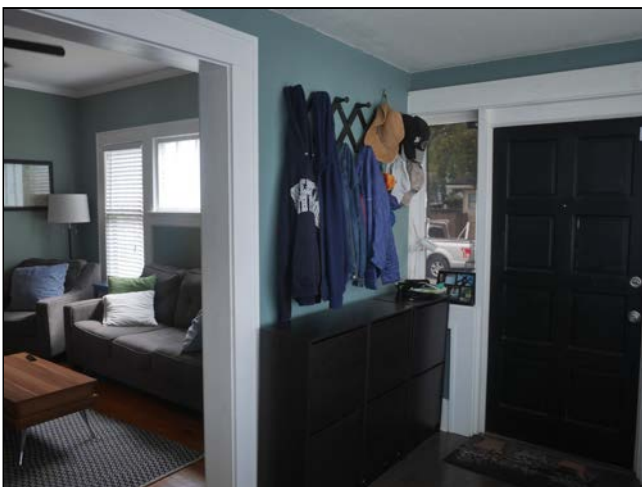
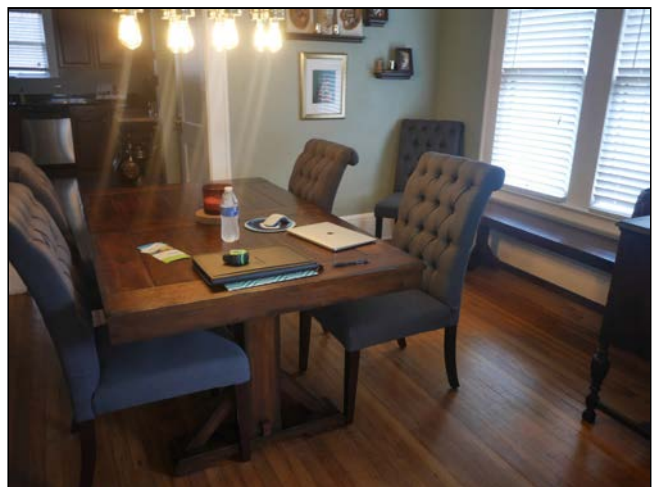
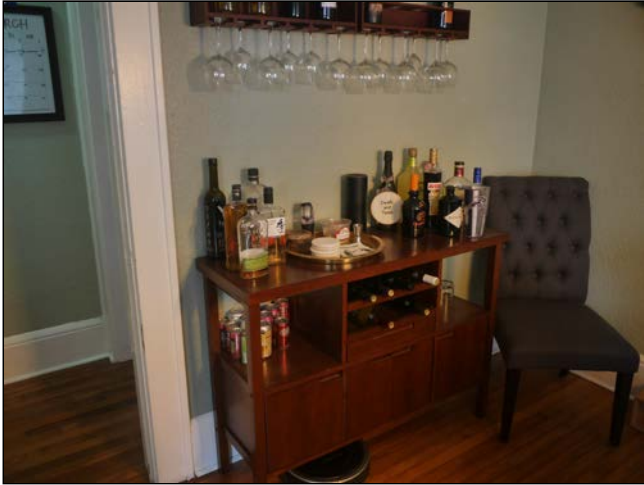
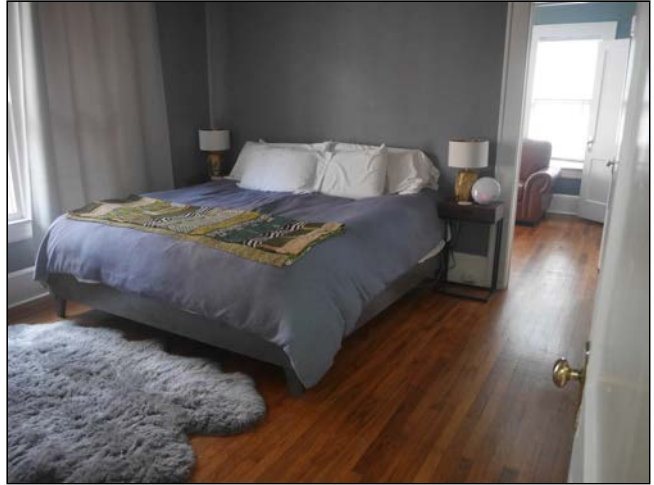
4.0 (1) INSPECTION LIMITATION - The dwelling was furnished / occupied at time of inspection.

- Furniture, personal goods, and/or equipment restricted views / access to some areas / surfaces / systems / windows / installations. Inaccessible areas are specifically disclaimed from the scope of the inspection / report in accordance with Section 3 of the Pre-Inspection Agreement on file.
- Recommend client perform a final walk-through of dwelling after contents have been removed.

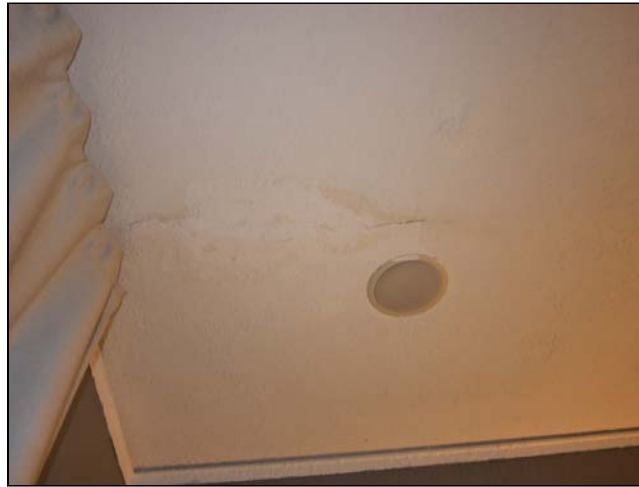
4.0 (2) Visible discoloration at ceiling drywall material.

- Note: Unless otherwise noted in this report moisture not detected at or around noted area(s) at time of inspection.

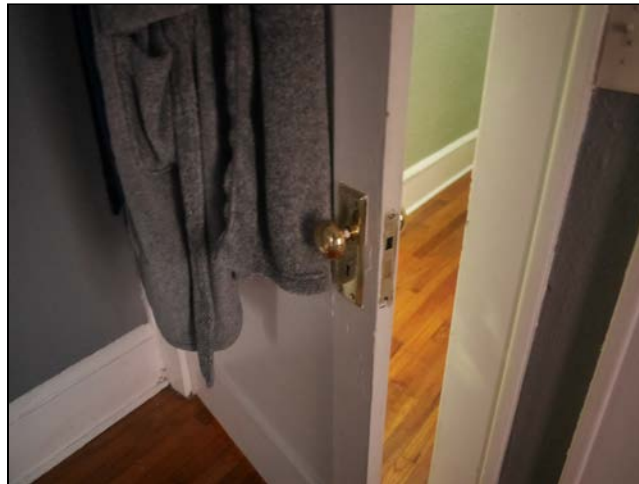
4.5 Lockset latch bolt does not return to neutral position.

- Recommend repair as appropriate.

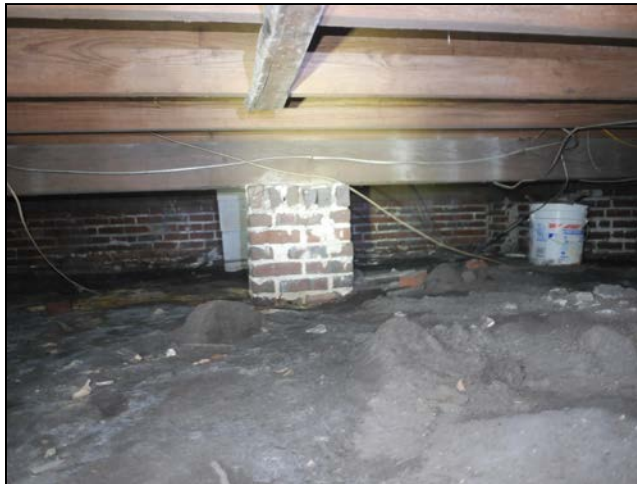
5.0 (1) Termite shields not installed between piers and wood beams as viewed from crawlspace. Multiple locations noted. This report is qualitative, not quantitative. Photo(s) representative of noted deficiency.

- Recommend installation of termite shields in accordance with current building practices and standards.

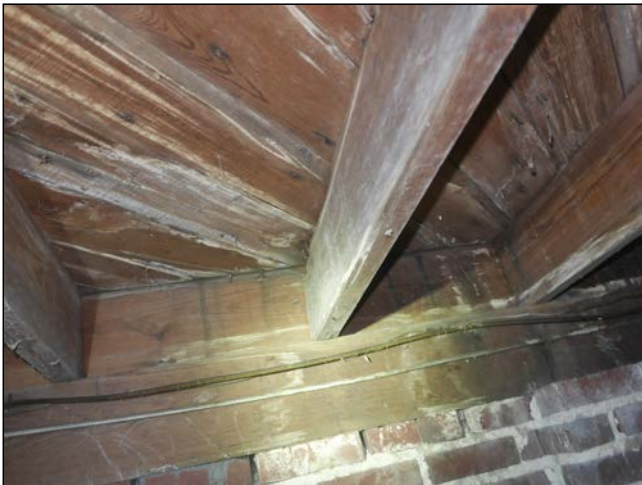
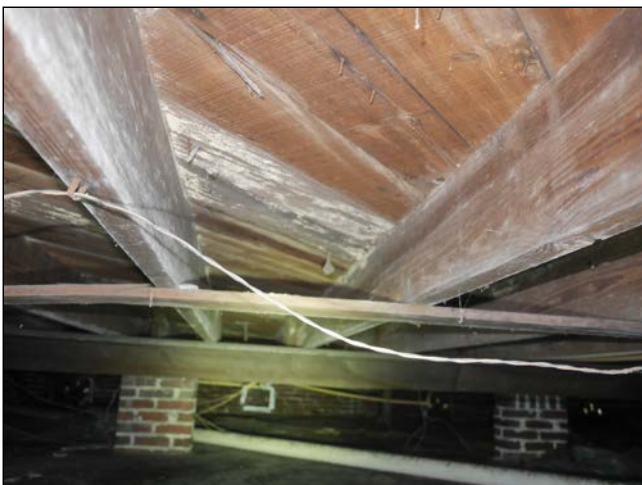
5.0 (2) Visible evidence of wood rot / wood-destroying pest activity at some areas throughout crawlspace. Multiple locations noted. This report is qualitative, not quantitative. Photo(s) representative of noted deficiency.

- Also see WDO report as applicable.
- Visible fungal / microbial growth at some noted areas.
- Recommend evaluate / repair as appropriate.

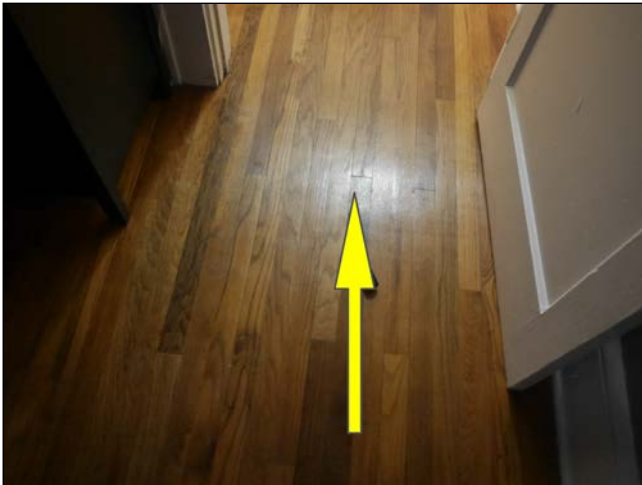
5.3 Floors out-of-level, likely the result of differential settlement and age.

- Should client have concerns regarding the floor structure, consultation with a licensed specialist is encouraged.

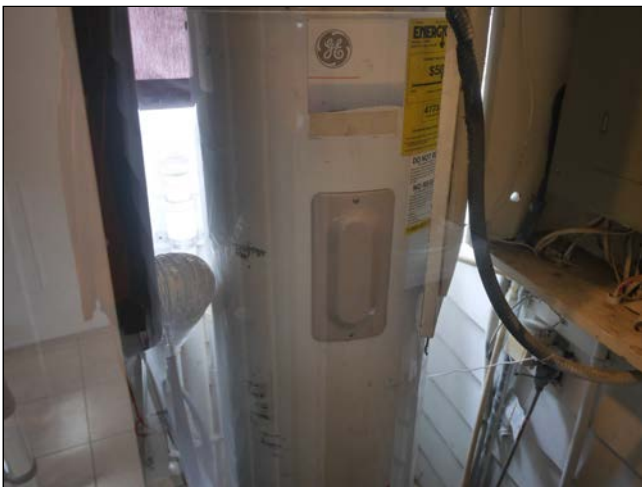
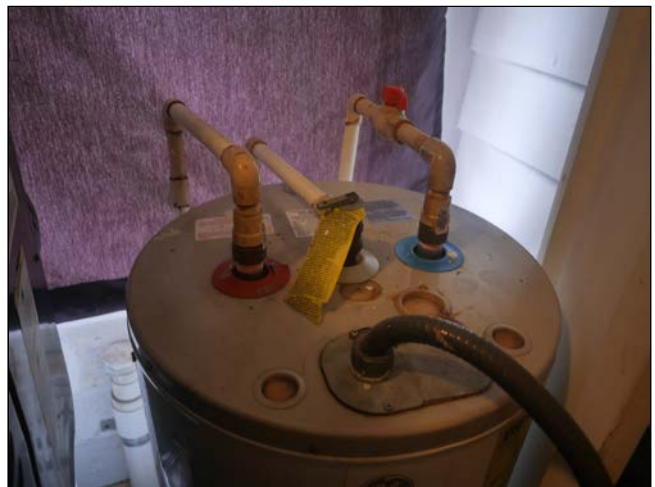
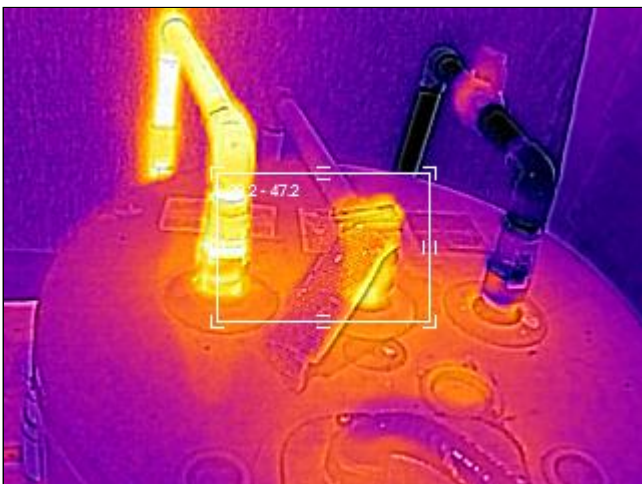
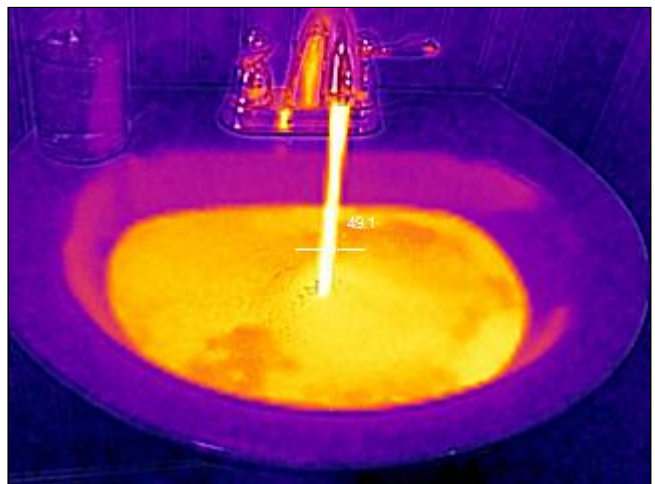
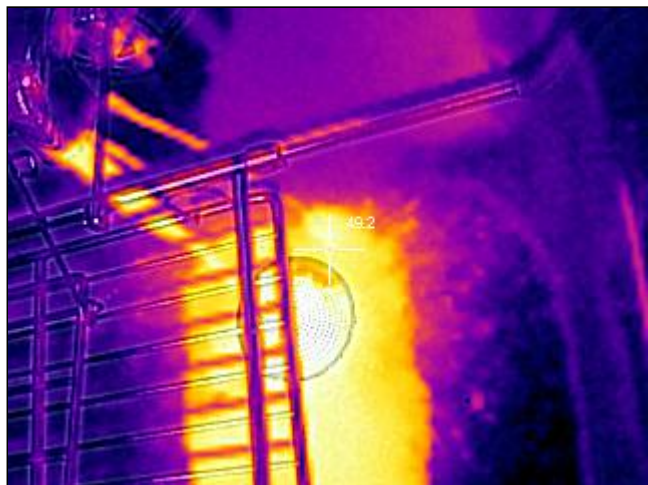
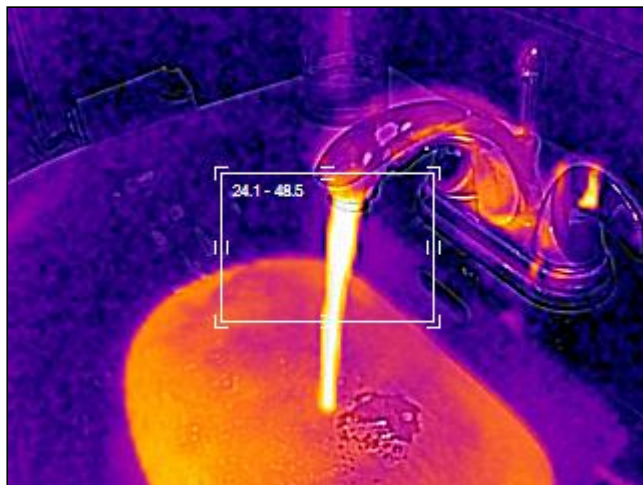
6.0 (1) Hot water system reference photo(s) / thermogram(s). Provided for documentary purposes only.

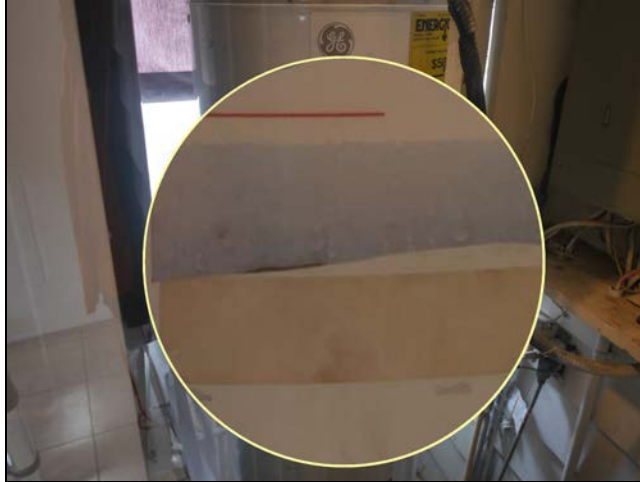
6.0 (3) INSPECTION LIMITATION - Manufacturer data plate removed from water heater.

- Basic information, including capacity and age of appliance could not be verified.

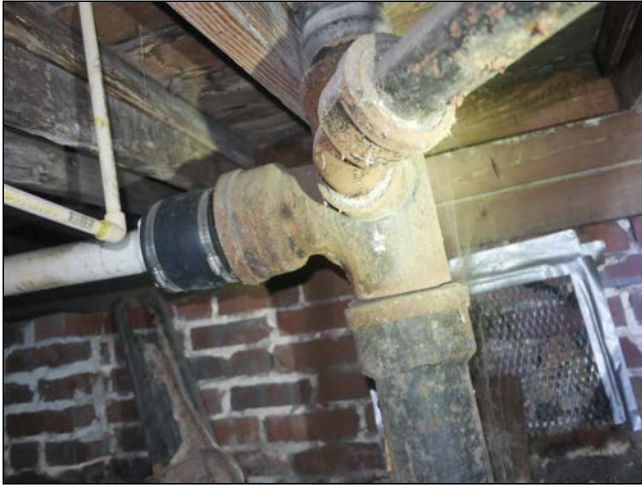
6.1 MAJOR DEFICIENCY - Rust / oxidation at cast iron drain line(s).

- Continued oxidation may result in rust-through, cracking, and failure of the waste / drainage system.
- Recommend consultation with a state licensed plumbing specialist.
- Recommend client budget for future upgrade / replacement as appropriate.
- Note: Some areas not visible at time of inspection. Should client have concerns regarding the waste / drainage system, recommend technically exhaustive plumbing system evaluation by a state licensed plumbing specialist.
- **POTENTIAL INSURANCE QUALIFYING DEFICIENCY**

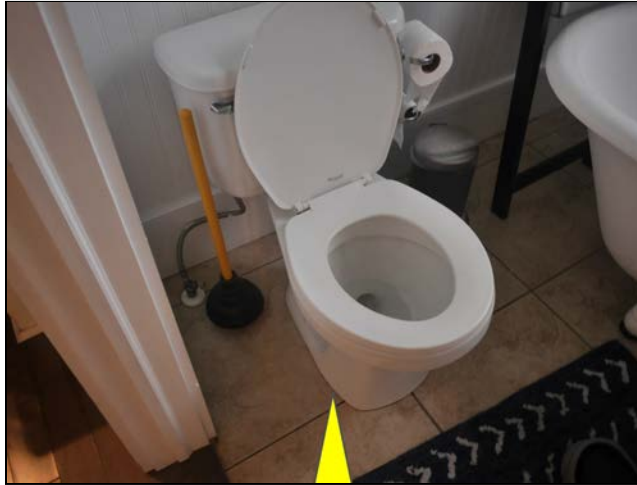
Right bathroom

6.2 (2) MAJOR DEFICIENCY - Toilet not secured to floor structure (excessive lateral movement).

- Potential moisture intrusion point(s).
- Recommend removal of toilet to evaluate condition of wax ring and repair as appropriate by a licensed plumbing specialist.
- **POTENTIAL INSURANCE QUALIFYING DEFICIENCY**

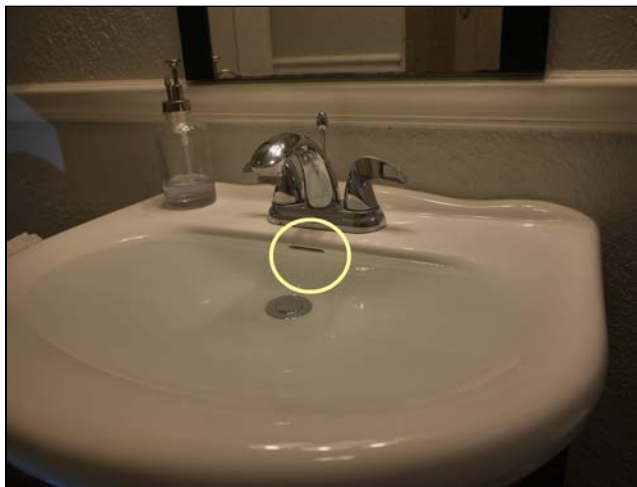
Left bathroom

6.2 (3) MAJOR DEFICIENCY - Overflow drain inoperative / clogged.

- Recommend repair as appropriate.
- Potential moisture intrusion in the event of sink overflow.
- **POTENTIAL INSURANCE QUALIFYING DEFICIENCY**

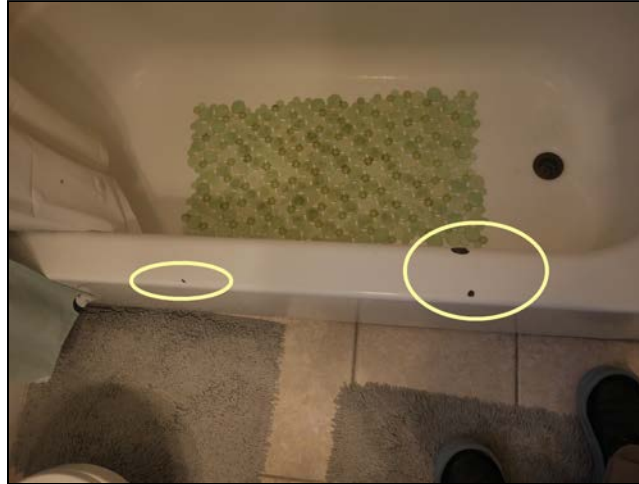
Left bathroom

6.2 (9) Glazing damaged at tub.

- Recommend repair as appropriate.

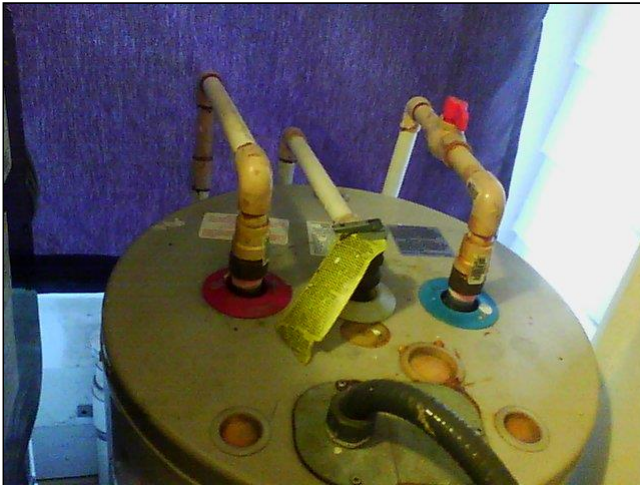
6.2 (10) Some plumbing distribution supply lines not insulated.

- Potential future point of failure in the event of frost / freeze.
 - Missing insulation may affect the efficiency of the hot water system.
 - Recommend repair in accordance with current building practices and standards. Multiple locations noted.
- This report is qualitative, not quantitative. Photo(s) representative of noted deficiency.

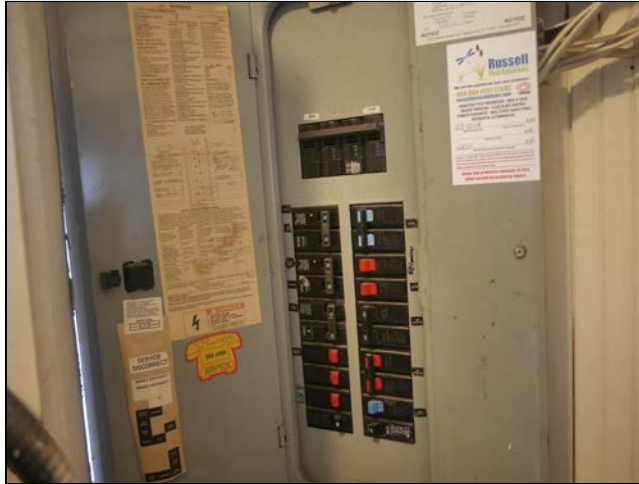
7.0 (2) Service panel legend not properly / accurately marked.

- Current building practices require service panel legend to be clear, evident and specific.
- Recommend repair as appropriate.
- **POTENTIAL INSURANCE QUALIFYING DEFICIENCY**

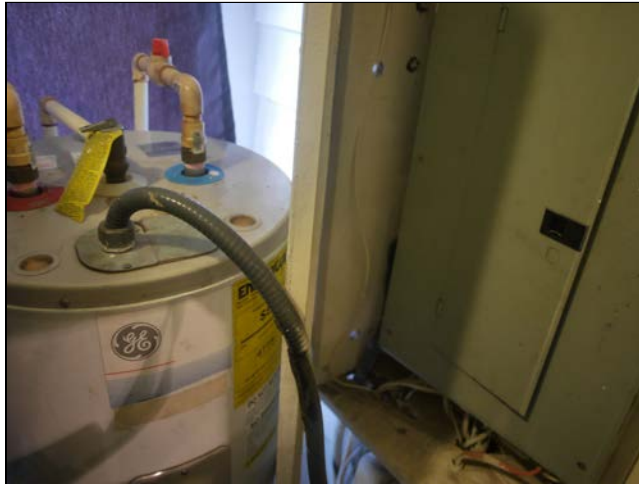
**7.0 (3) Fastener(s) missing at cover at main service panel.**

- Recommend repair in accordance with current building practices and standards.

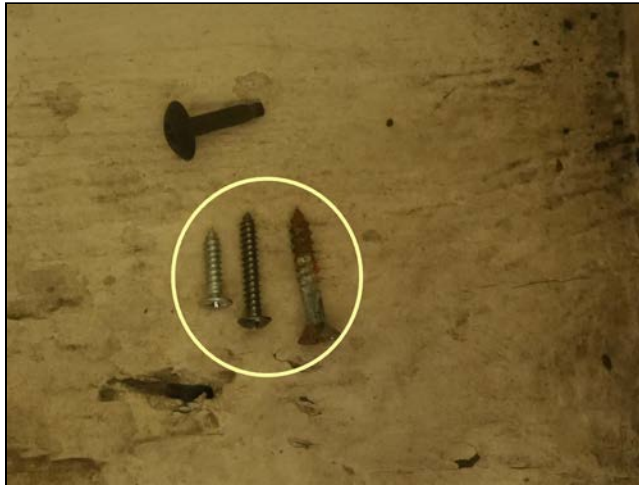
7.0 (4) MAJOR DEFICIENCY - Non-standard mechanical fastener(s) used to secure dead front to main service panel.

- Potential shock hazard. Sharp screw tip(s) may damage wire sheath, and may energize panel cover.
- Recommend installation of listed, manufacturer-approved fasteners for this type of service panel.
- **POTENTIAL INSURANCE QUALIFYING DEFICIENCY**

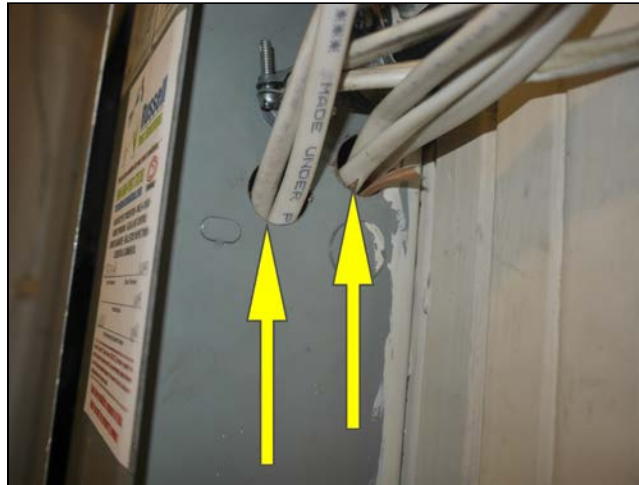
7.0 (6) Missing / detached strain-relief collar(s) at wire feed(s) at main service panel.

- Potential flame propagation hazard.
- Panel opening may damage wire sheath, energizing panel enclosure. Potential shock hazard
- Recommend repair as appropriate by a licensed electrical specialist.
- **POTENTIAL INSURANCE QUALIFYING DEFICIENCY**

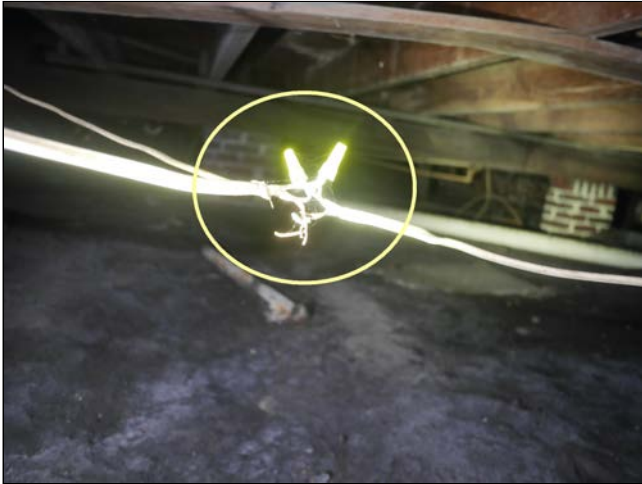
Crawl space

7.2 MAJOR DEFICIENCY - Wire splice not enclosed within junction box.

- Shock / fire hazard.
- Recommend repair / reconfigure in accordance with current building practices and standards.
- **POTENTIAL INSURANCE QUALIFYING DEFICIENCY**

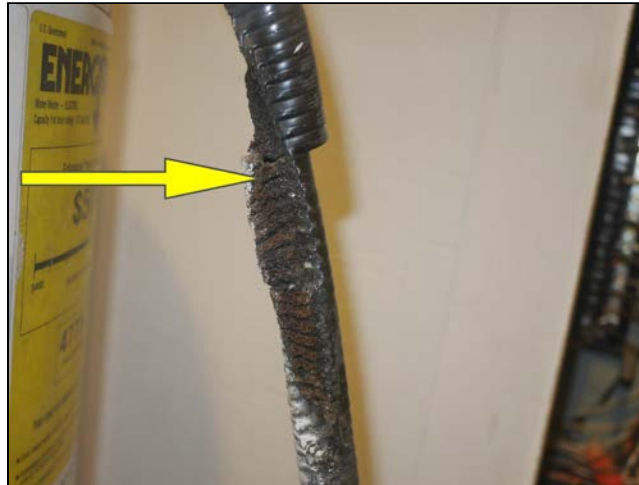
7.3 MAJOR DEFICIENCY - Scorch damage at non-metallic flex conduit at water heater electrical supply.

- Recommend consultation with a state licensed electrical specialist and disassembly / repair as appropriate.
- **POTENTIAL INSURANCE QUALIFYING DEFICIENCY**

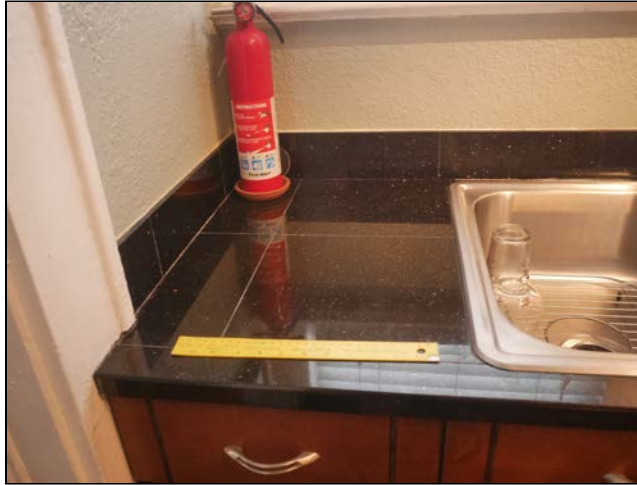
- 7.4 (1)** Electrical receptacle outlet not installed at work surface / counter top greater than 12 linear inches.
- Noted configuration may be a safety hazard because it encourages the use of extension cords.
 - Recommend reconfigure in accordance with current building practices and safety standards.

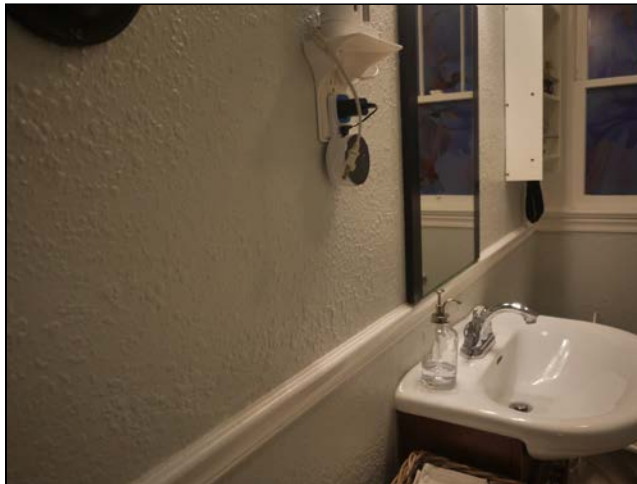
- 7.4 (2)** Electrical outlet not installed / could not be located at bathroom.
- Recommend repair in accordance with current building practices and standards.

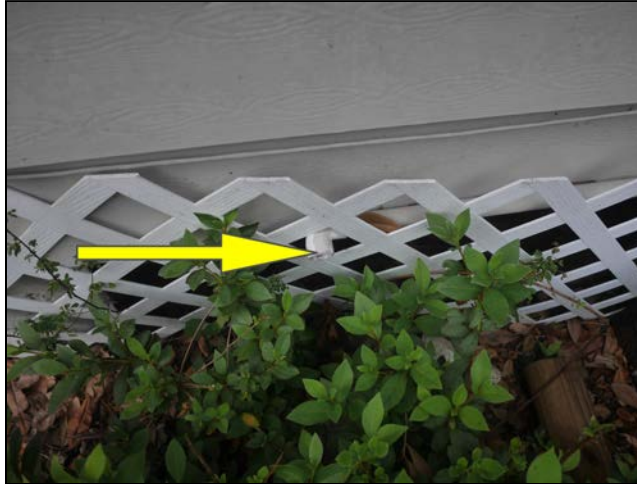
- 8.0 (2) HVAC condensate drain line discharges less than 24 inches from foundation.**
- Recommend extending drain line to discourage ponding / erosion near foundation.

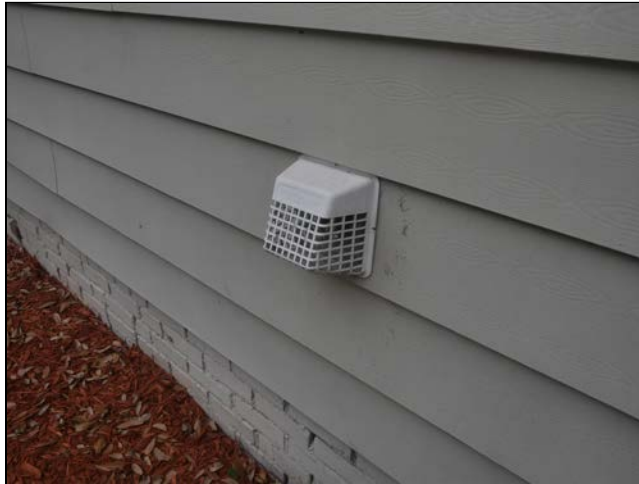
9.2 (2) Grate / cover installed at clothes dryer vent at dwelling exterior. This practice is discouraged, as dryer lint can accumulate at grate.

- Fire hazard. Dryer lint is a highly combustible material.
- Recommend installation of one-way flap that is normally closed to discourage pest intrusion, and opens only when dryer appliance is in operation.

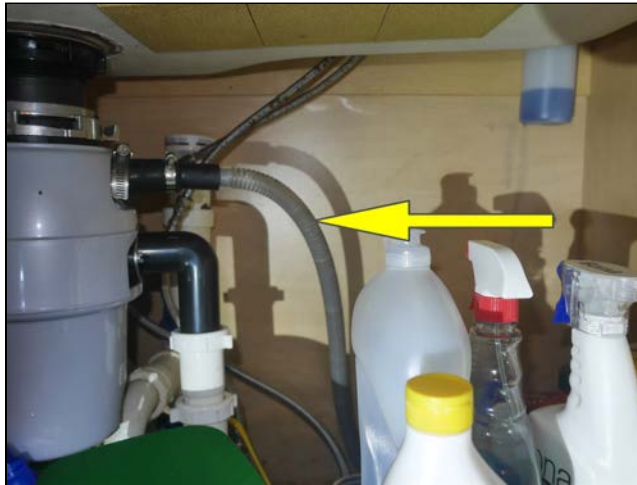
12.0 High loop not properly installed at dishwasher drain line at kitchen sink.

- Potential backflow / contamination of the dishwasher appliance from sink drain.
- Drain line should be routed and secured base cabinet above the elevation of the sink drain.
- Recommend repair / reconfigure as appropriate.
